Kaikōura Earthquake Short-Term Project

Title: Assessment of existing concrete buildings in Wellington with precast floors

Assessment of existing concrete buildings in Wellington with precast floors

S.R. Corney, K. J. Elwood & R. S. Henry

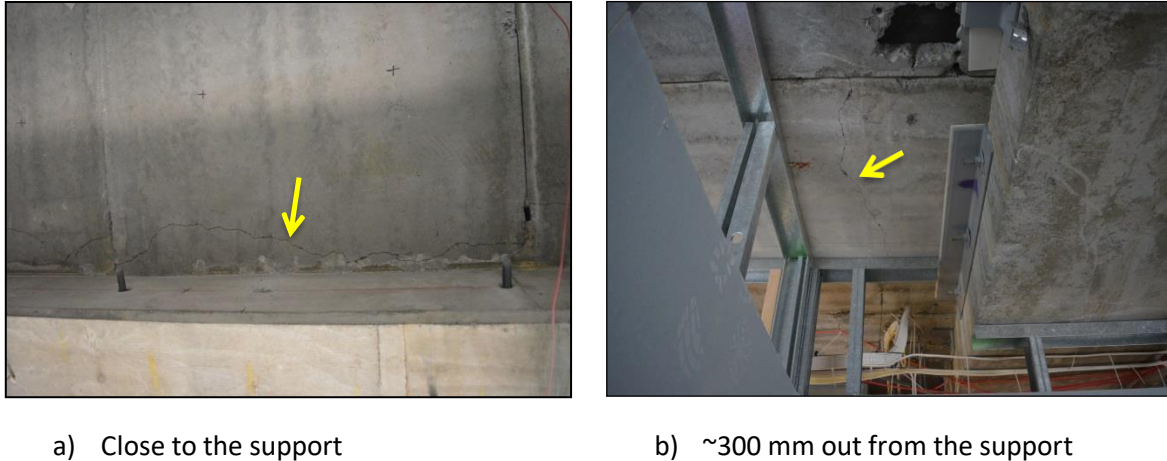
Figure 3. Transverse cracking of hollow-core units

Figure 3a shows an example of transverse cracking within 100 mm of the beam support. This type of cracking was consistent with the previously identified failure modes shown in Figure 2. The bottom flange prestressing strand is not well developed at the ends of the unit and may also be affected by strand draw-in or slip. As a result, transverse cracks near the support can significantly impact the shear capacity near the ends of the hollow-core floor units. Several buildings were also found where single transverse cracks in the hollow-core units occurred at approximately 300 mm from the support as shown in Figure 3b. The location of the crack on the top surface typically corresponded to the end of the starter bars and, in many cases, the crack was found to extend vertically through the full depth of the unit. While past research has shown that negative moments at supports may lead to cracking at the end of the starter bars (see Figure 2c), this cracking was previously found to extend into a diagonal crack in the unit's web in contrast to this observed vertical crack. Given the distance of the transverse crack from the support (typically 300 mm), the bond for the bottom flange prestress strand is likely sufficient to sustain gravity loads, but further widening of the crack in aftershocks was a concern. Note that typical retrofits of hollow-core floor systems in New Zealand only provide support for units within approximately 100 mm of the supporting beam and would not prevent collapse of units failing at vertical cracks at approximately 300 mm from the support. It was therefore identified that further research is needed to understand the cause of this cracking pattern, the capacity in future aftershocks, and potential retrofit techniques to address this failure mode.

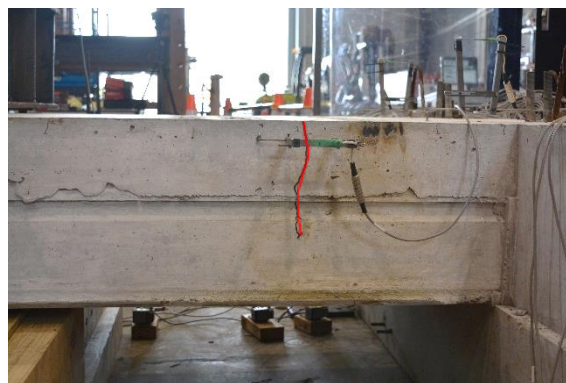
A crack formed at the top of the floor as a direct result of the setup process at a distance of 380 mm from the support beam. This distance is approximately the length to which the voids had been filled with insitu concrete during specimen construction. This crack is indicated by the red line shown in Figure 9 and it can be seen that the crack had initiated at the top of the floor and propagated vertically through the topping and approximately halfway through the 300HC unit. It was deemed that the test would be continued without inducing further damage such that the subsequent behaviour of the floor with this damage state could be determined. This damage was consistent with that observed in several Wellington buildings (Henry et al. 2017). Furthermore, this crack was also induced as a direct result of the support connection detailing.

Figure 9. HC1 induced damage (indicated by red line)

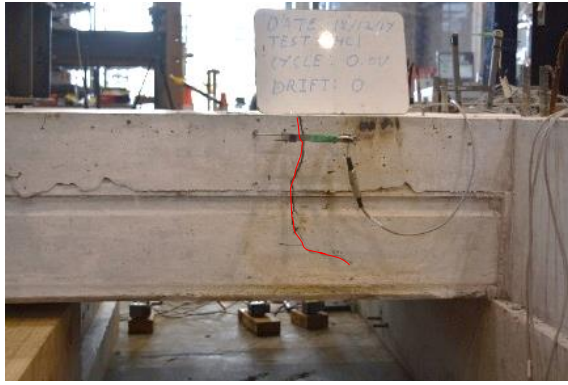
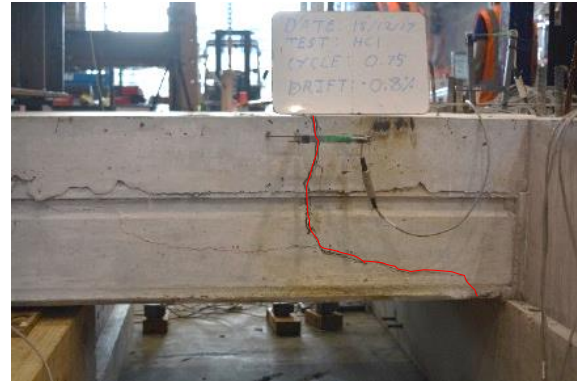
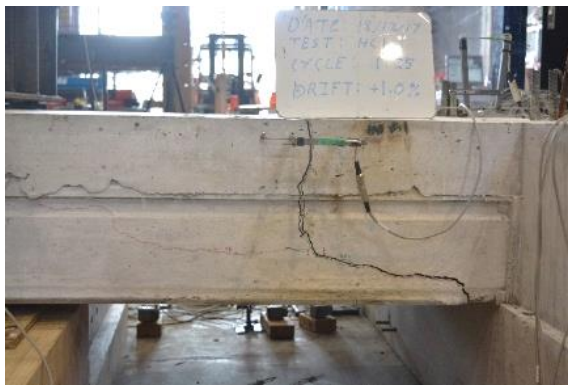
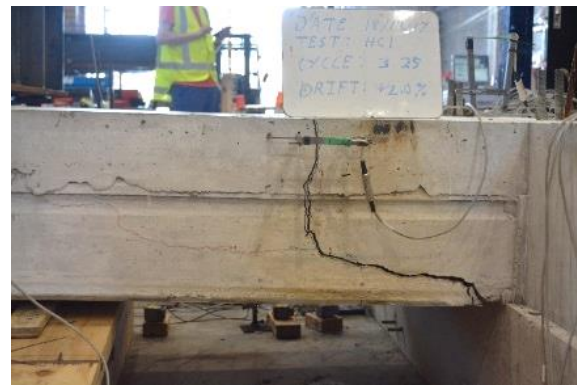
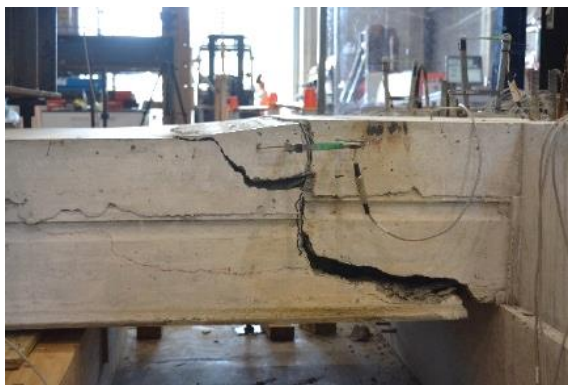
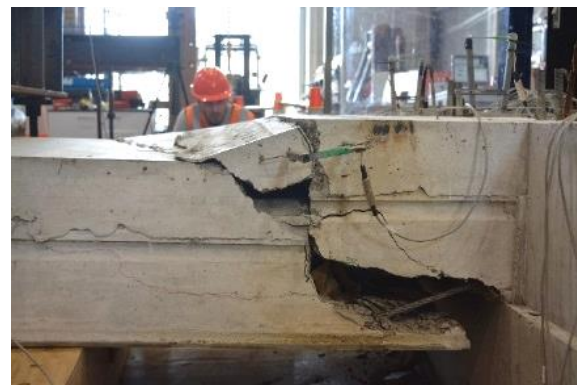
Figure 10. HC1 test progression photos (with red line indicating location of critical crack prior to becoming visible in photos)

The connection was then subjected to simulated seismic loading as Stage 3 of the test with only cyclic rotation applied during this test. The progression of damage to the support connection throughout seismic loading is shown in Figure 10b through to Figure 10f. Due to an issue with the vertical actuator, deformation to -0.9% was sustained by the connection during the first seismic loading cycle. This deformation led to the horizontal propagation of the crack above the bottom flange of the 300HC unit to within 100 mm of the support beam ledge as well as through the webs away from the support connection (see Figure 10b), resulting in a failure mechanism comparable to that shown in Figure 2c. The subsequent application of positive rotation led to this crack propagating

through the bottom flange at the base of the unit and approximately 60 mm out from the support beam ledge. Figure 10c shows the state of the floor once drift to +1.0% had been sustained. At this stage, the crack width at the soffit was approximately 4 mm (0.3 times the diameter of the prestressing strand) and the vertical dislocation of the floor was approximately 4 mm. The authors consider that both the crack width at the prestressing strands and the vertical dislocation were representative of a crack that no longer has reliable means to transfer shear forces. The positive rotational deformation applied to the connection was then increased +2.0%. It was deemed that subjecting the connection to this increased positive rotation would provide more insight to the behaviour of the floor; specifically, the widening of the critical crack at the unit soffit that would result in the prestressing strands being unable to transfer shear forces to the support connection. Figure 10d shows the state of the floor at +2.0% drift and it can be seen that the crack width at the unit soffit had increased to approximately 7 mm with vertical support for the floor being retained as a result of shear transfer provided by dowel action of the prestressing strands combined with that provided by the floor bearing on plugs of concrete within the filled cells spanning across the crack. This is an unreliable load transfer mechanism. It should be noted that the application of pull-off deformations would have likely resulted in collapse of the floor prior to this stage in the test. Further cycles were applied to $\pm 2.0\%$ with the floor becoming increasingly susceptible to collapse as the crack opened and less shear transfer could be provided by the floor bearing on the filled cores. The mesh remained intact across the cracked interface and rather an additional crack formed in the topping with the topping becoming delaminated from the unit as shown in Figure 10e. Ultimately, the width of the crack became sufficiently large and the collapse of the floor occurred at -1.5% during the second cycle to -2.0%, as shown in Figure 10f.

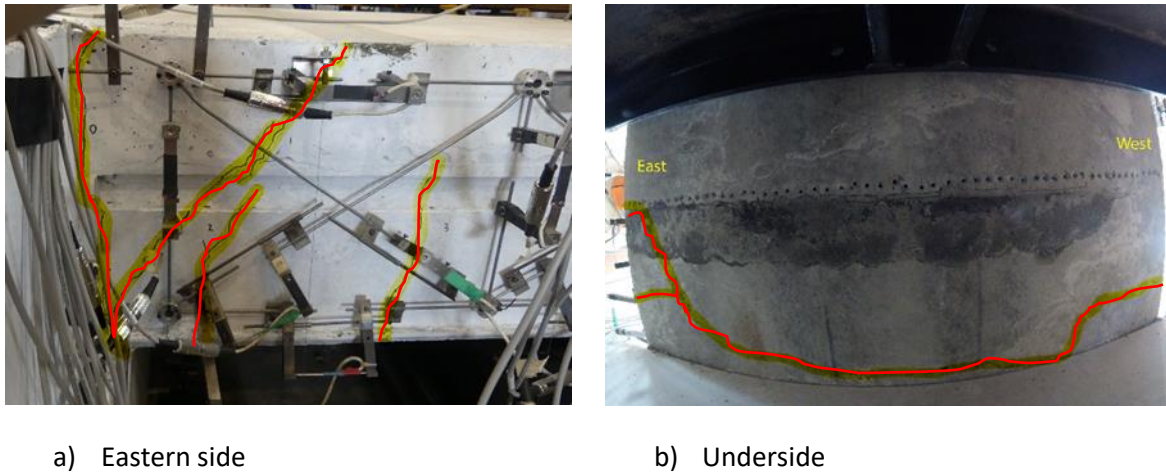
The intention for specimen HC2 was to induce a crack at the unit soffit approximately 300 mm from the support connection, similarly to those observed in some Wellington buildings (Brunsdon et al. 2017), and to investigate the subsequent behaviour of floors containing these cracks at a similar distance from the support. For this damage to be achieved, the setup shown in Figure 5a was established. However, in attempting to induce this damage it was found that the development of the prestressing strands at this section had been underestimated and the capacity required to crack the unit soffit was unable to be exceeded. Furthermore, the floor had cracked at the unit-to-beam interface during setup (see Figure 13a) thereby limiting the capacity of the connection to sustain positive moments. Figure 14 illustrates the bending profile of the floor and it can be seen that if the prestressing strands were close to full development, the gradient of the bending moment profile of the floor would need to be very sharp to generate sufficient demand at the targeted crack location to induce this soffit crack. For this sharp change in moment demand to be achieved, the loading beam was required to apply a load greatly in excess of the calculated floor shear capacity. For the

Figure 13. HC2 induced damage

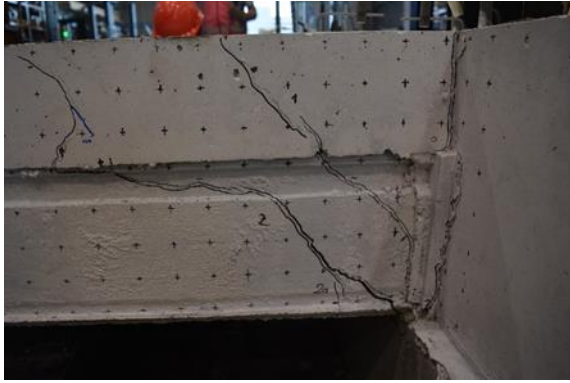
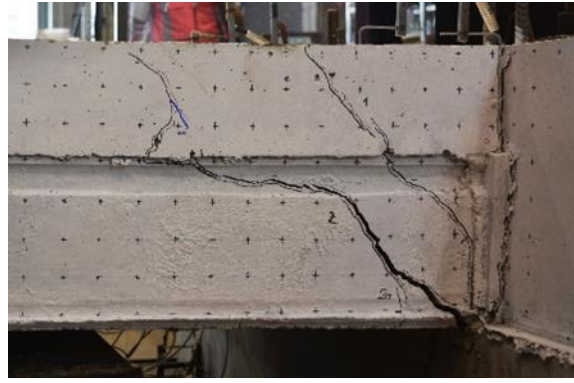
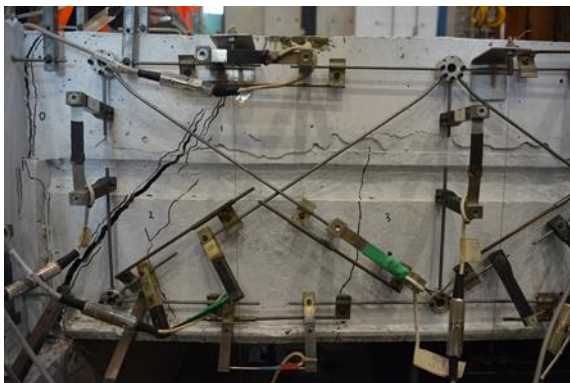
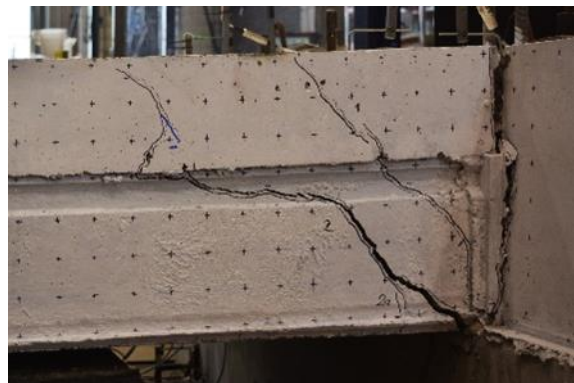
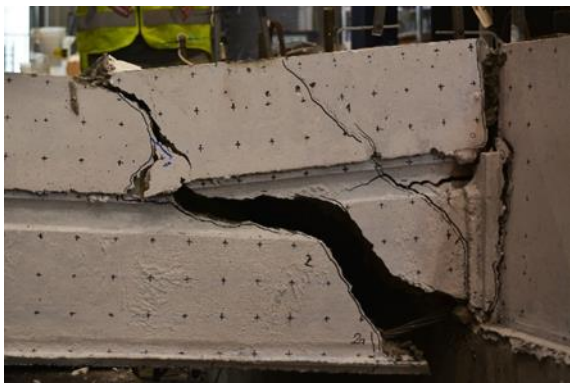
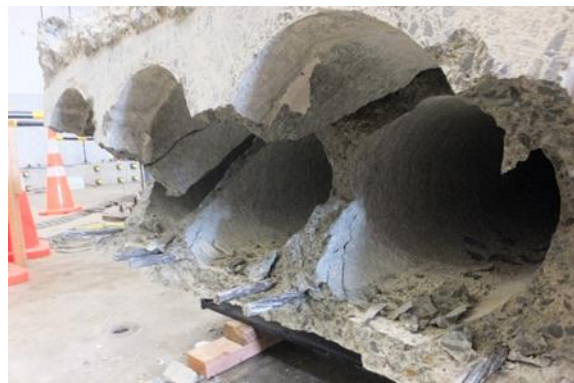
Figure 15. HC2 test progression photos

Seismic loading was subsequently applied to the connection and, similarly to the testing of specimen HC1, it was deemed that rotational deformation alone would be applied due to the expected susceptibility to failure at low levels of applied deformation for a floor with this connection detailing (cold-drawn mesh as continuity reinforcement) and the nature of the sustained damage. The progression of damage of the specimen through increasing cycles is shown in Figure 15. Positive rotations were accommodated by the growth of the diagonal crack at the unit soffit near the support ledge. This crack grew through successive cycles to 0.5%, 1.0% and 2.0% (see Figure 15) while the

crack 300 mm into the floor remained closed as anticipated due to the significant development of the prestressing strands at this location (see Figure 15c). Deformation during the negative loading cycles was concentrated in the topping at the floor-to-beam interface (see Figure 15d) with the top of the diagonal shear crack remaining closed. The mesh crossing the interface gradually fractured during successive cycles to -1.0% and the following cycle to -2.0% at crack widths ranging between 4 mm and 7 mm for these eight bars.

During the first cycle to +2.0% drift the width of the shear crack at the soffit resulted in sufficient dropping in the floor that the floor was deemed to have failed during this cycle with a maximum sustained drift of 1.0%. The width of the crack at this stage in the test was approximately half of the diameter of the prestressing strands. The maximum crack width that a floor is considered to be able to accommodate at this location is the equivalent to the strand diameter (with these units containing 12.9 mm strands). Following this point, the floor remained intact through loading to a second cycle to +2.0% and then a monotonic increase in positive loading with the floor ultimately collapsing at an applied drift of approximately 3.5% and a soffit crack width of approximately 1.5 strand diameters. It should be noted however that the bearing of the floor on the eastern side of the specimen (see Figure 15d) would have helped to enable support to be maintained to such a large deformation during this particular test. Furthermore, the application of pull-off deformations would have resulted in this critical crack width being sustained at a lower level of simulated drift. Figure 15f shows the state of the hollow-core unit with fractured webs following failure.

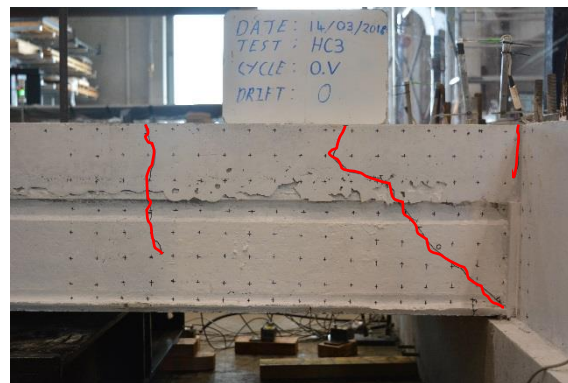
Due to the inability to induce a positive moment crack 300 mm away from the support during the testing of specimen HC2, specimen HC3 was altered to further help enable this targeted crack to form. The hollow-core soffit was cut to a depth of 20 mm at the intended crack location to reduce the cracking capacity and it was ensured during the setup of this specimen that the floor-to-beam interface remained uncracked. As a result of these factors, the difference in bending moment capacity of the two sections was reduced meaning that a lower shear force would be required to achieve the necessary bending moment profile in the floor. It was additionally considered that the shear capacity at the support would be greater due to the cores of this specimen being filled with concrete to a distance of 300 mm along the unit (see Table 1). However in attempting to induce this crack it was found that due to uneven bearing of the hollow-core unit on the support ledge, the shear capacity of this specimen was reduced in comparison to that of specimen HC2 and a diagonal crack was initiated on the western side of the connection, as shown in Figure 19. The moment able

Figure 19. HC3 induced and gravity load damage

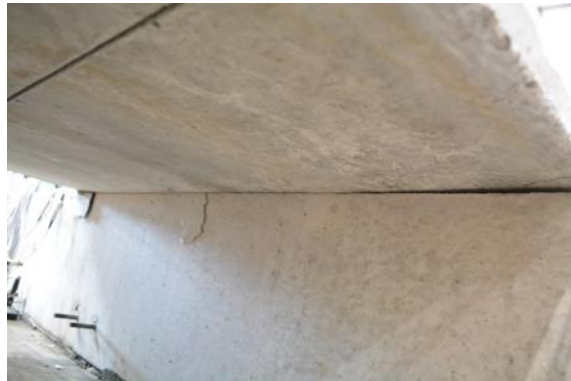
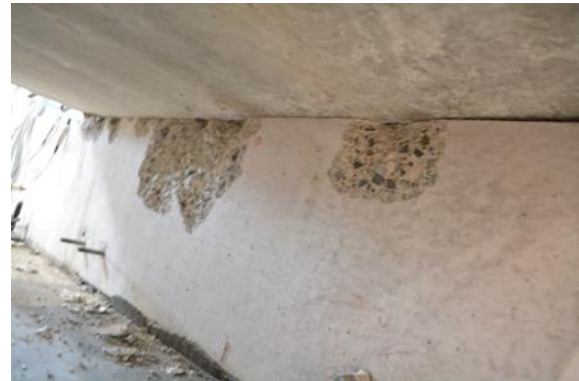
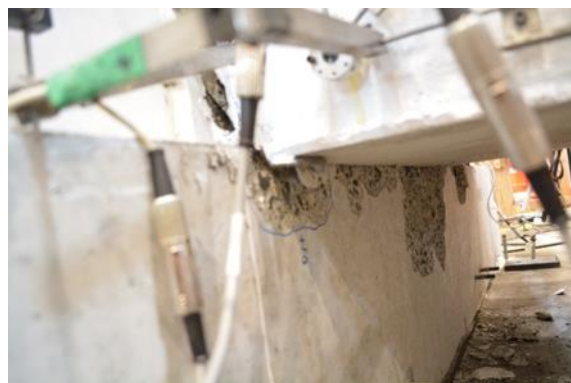
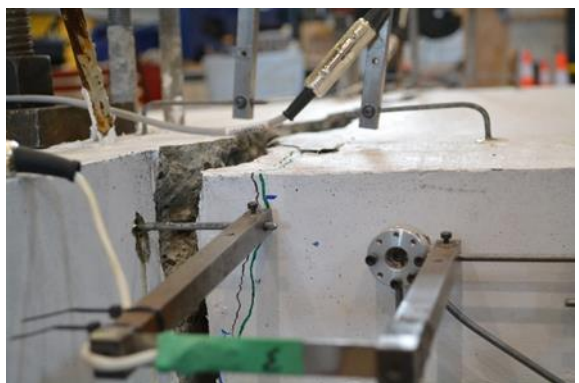
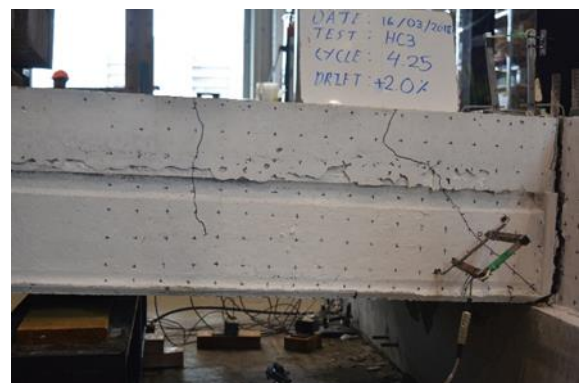
Figure 20. HC3 test progression photos

As deformation was concentrated at the floor-to-beam interface, this became a test to investigate loss of support failure for the floor with a typical gravity load on the floor and subsequently Figure 20a - Figure 20d show the spalling of the support ledge and vertical dislocation of the floor. Spalling damage increased during the test resulting in a significant drop in the floor on the eastern side of the

connection during the first cycle to -2.0% drift (see Figure 20c) and the floor was deemed to have lost support at this point. During the subsequent cycles the floor slipped further relative to the support ledge on the eastern side of the connection while a lack of spalling on the western side of the support ledge meant that seating for the unit on top of the ledge was maintained (see Figure 20d) and a significant twist was induced in the unit. The instability of the specimen due to this twist resulted in the need to end the test following the completion of the second cycle to $\pm 2.0\%$ drift, at which point the floor had dropped 33 mm relative to the support beam on the eastern side, as measured by gauge D1 (see Figure 8b). Vertical support for the floor was provided by the kinking of the D12 starter bars which remained intact during these final cycles.

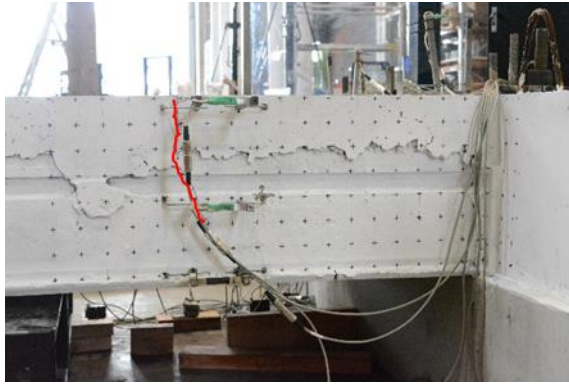
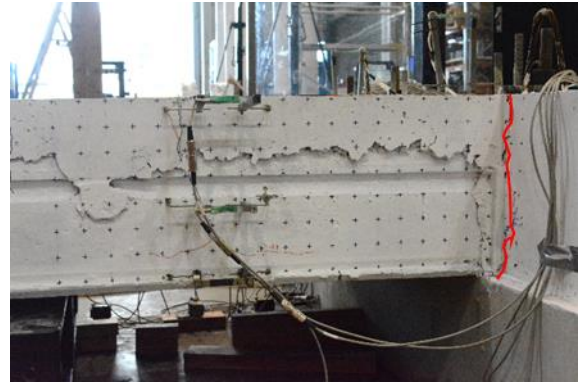
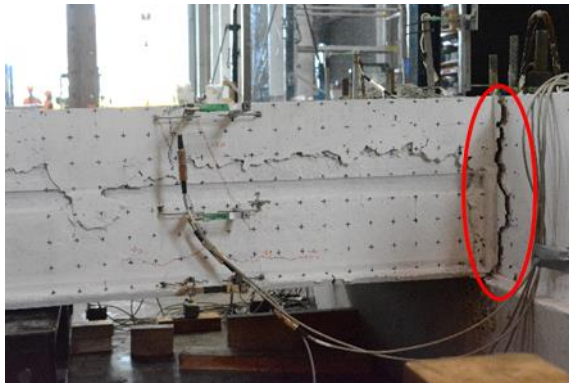
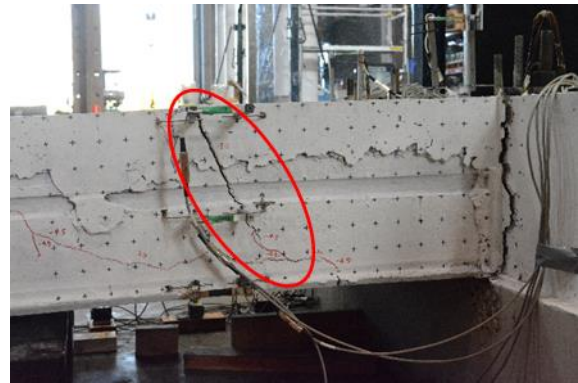
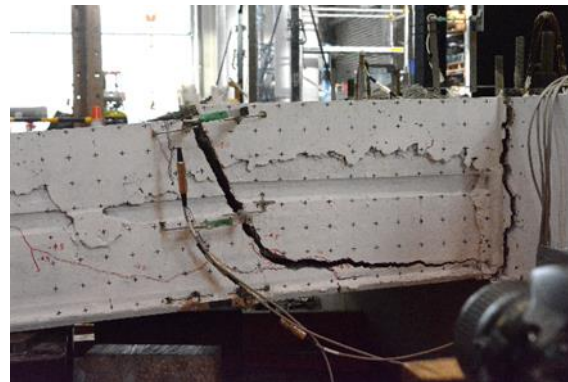
Figure 24. HC4 test progression photos

During the subsequent negative loading cycles to -2.0% and -3.0% , the drop in capacity of the cracked floor-to-beam interface resulted in most of the applied deformation being concentrated at this location and plastic straining of the starter bars (see Figure 24c). It was not until the loading cycle to -4.5% , at which point the starter bars were close to reaching their ultimate capacity, that the demand at the end of the starter bars was sufficient to induce inelastic strains in the mesh, resulting in the onset of fracturing of these bars. The subsequent drop in capacity at the end of the starter bars meant that further deformation was solely concentrated at this location and no further strain was sustained by the starter bars at the floor-to-beam interface. Figure 24d shows the state of the floor following the completion of the cycle to -4.5% . Following this cycle, the negative rotational deformation was increased until the remaining mesh bars fractured, resulting in collapse of the floor as shown in Figure 24e. The mesh bars were measured by gauge 11 (see Figure 8a) to fracture once the crack at the end of the starter bars reached a width of between 3 mm and 5 mm, indicating the non-ductile nature of this failure mode if stronger starter bars or an uncracked section had prevented such significant strains from being sustained at the floor-to-beam interface prior to this negative moment failure.
