NHRP Kaikōura Earthquake Short-Term Project

**Co-seismic and ongoing land deformation
at Mt Lyford Village, North Canterbury**

Leader: Robert Langridge

Organisation: GNS Science

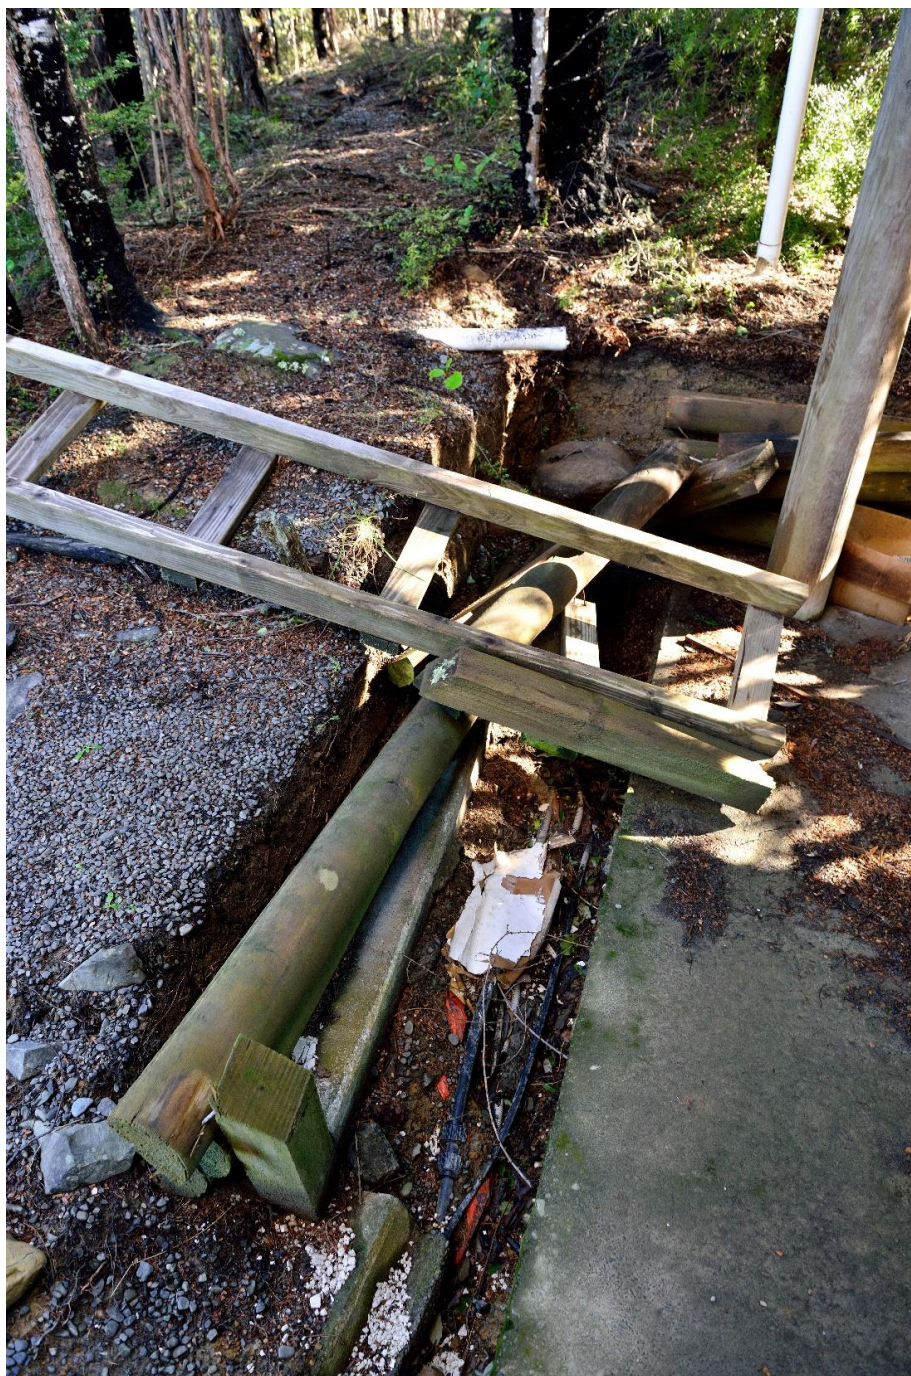
Figure 2.1 Typical foundation settling adjacent to a split-level log house at Mt Lyford Village. Note the subsidence of the ground and ground cracking extending away from the house (concrete pad).

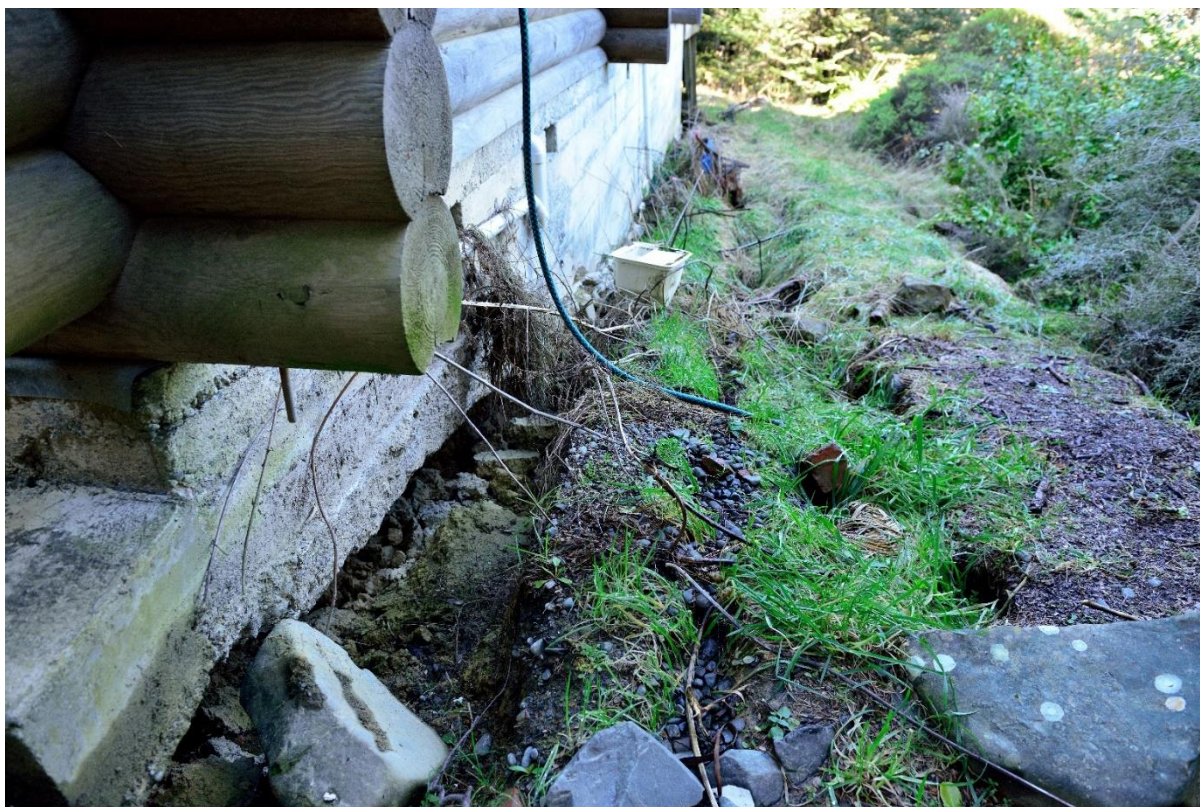
Figure 2.2 Typical ground extension observed at the downhill-facing edge of a log cabin at Mt Lyford Village.

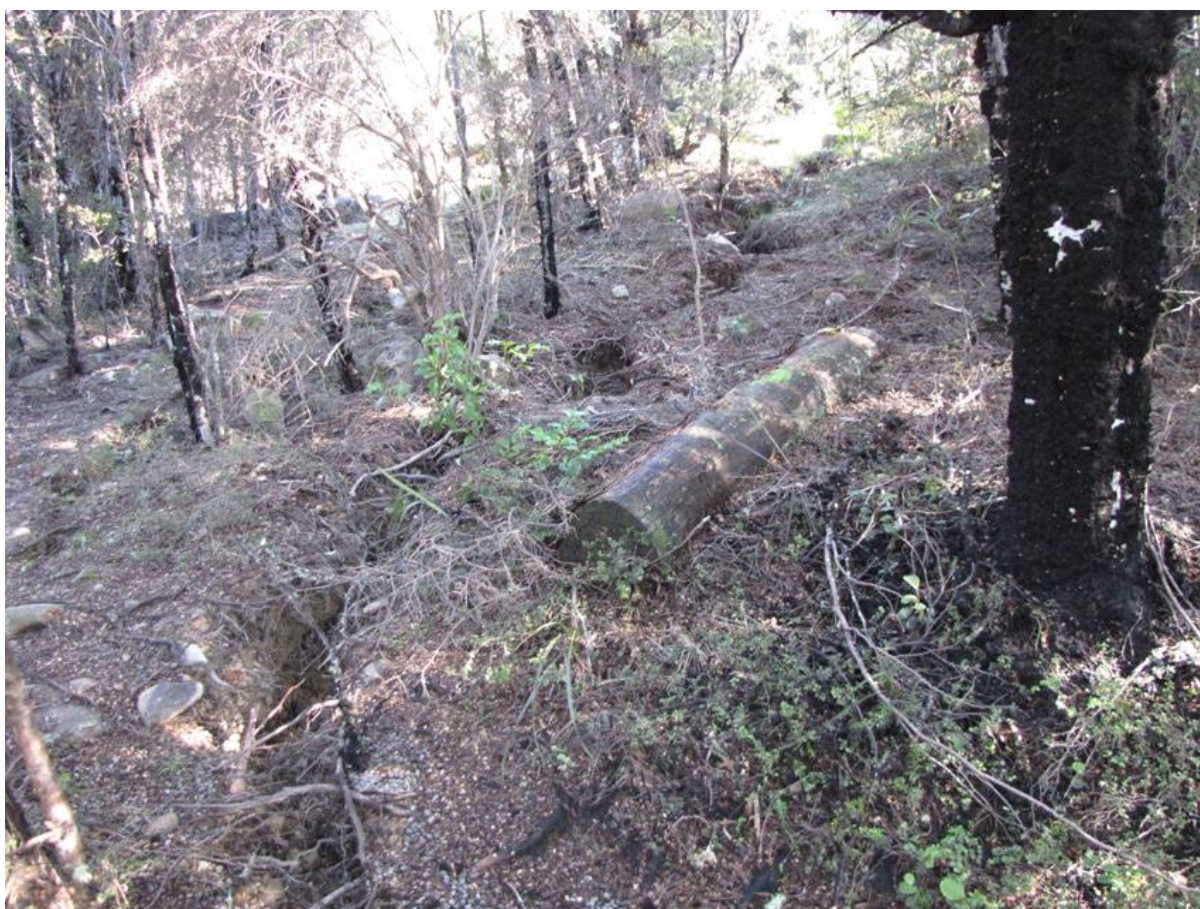
Figure 2.3 Arcuate ground cracking related to slope extension within scrub above 'unnamed' stream.

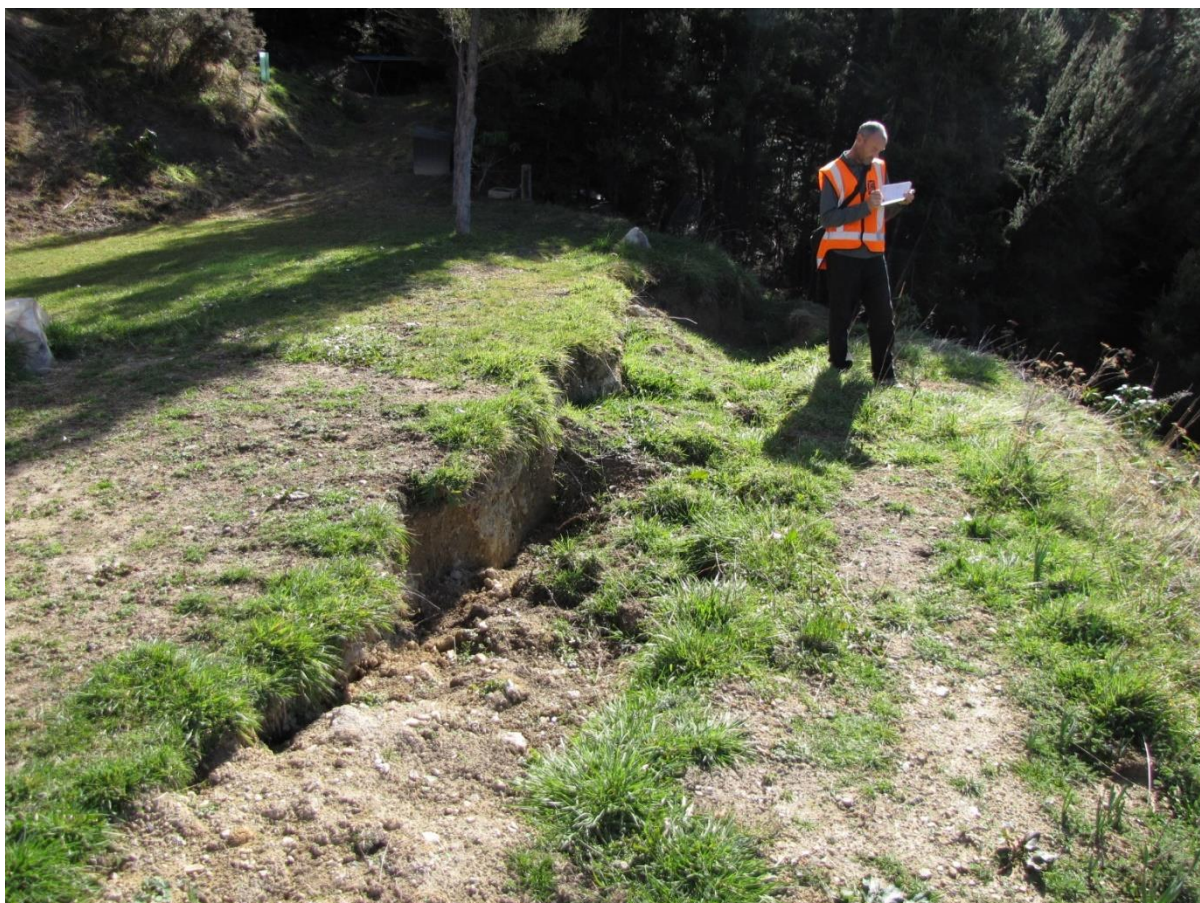
Figure 2.4 Ground cracking and extension causing subsidence in a yard at a property on Lulus Lane, adjacent to a steep cut bank edge.

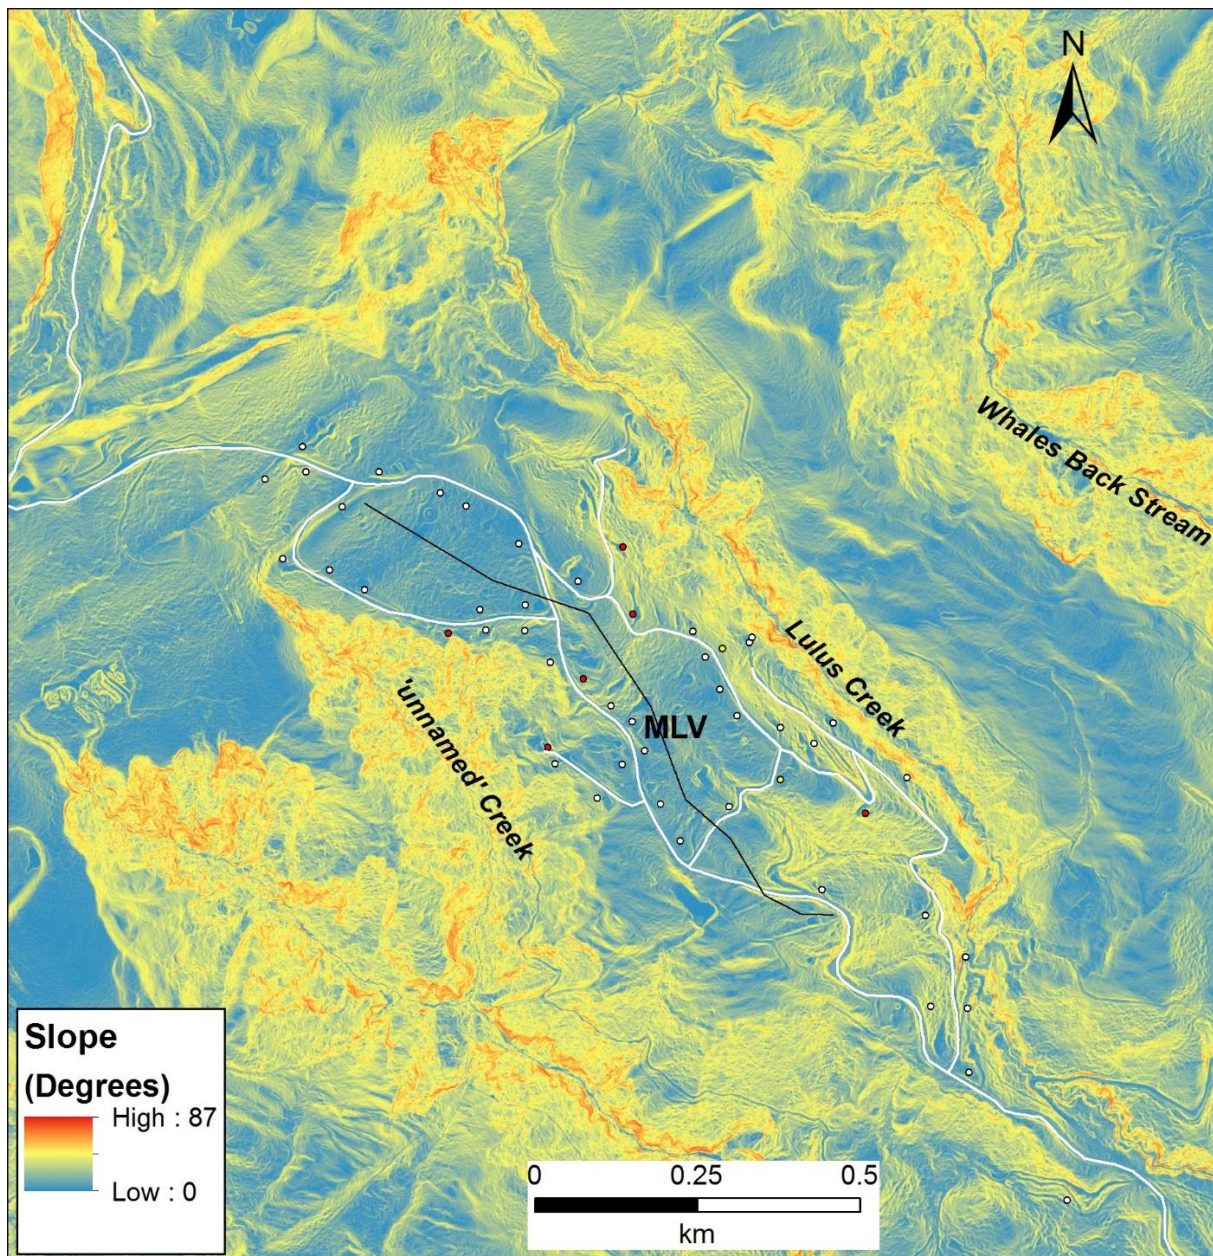
Figure 2.5 A digital Slope map of the wider Mt Lyford Village area derived from post-earthquake airborne LiDAR data. Slopes in bluish colours are between c. 0 and 20°, while slopes in yellow and orange are c. >25°. The village road network is shown in white and post-earthquake response placards are shown as coloured dots.

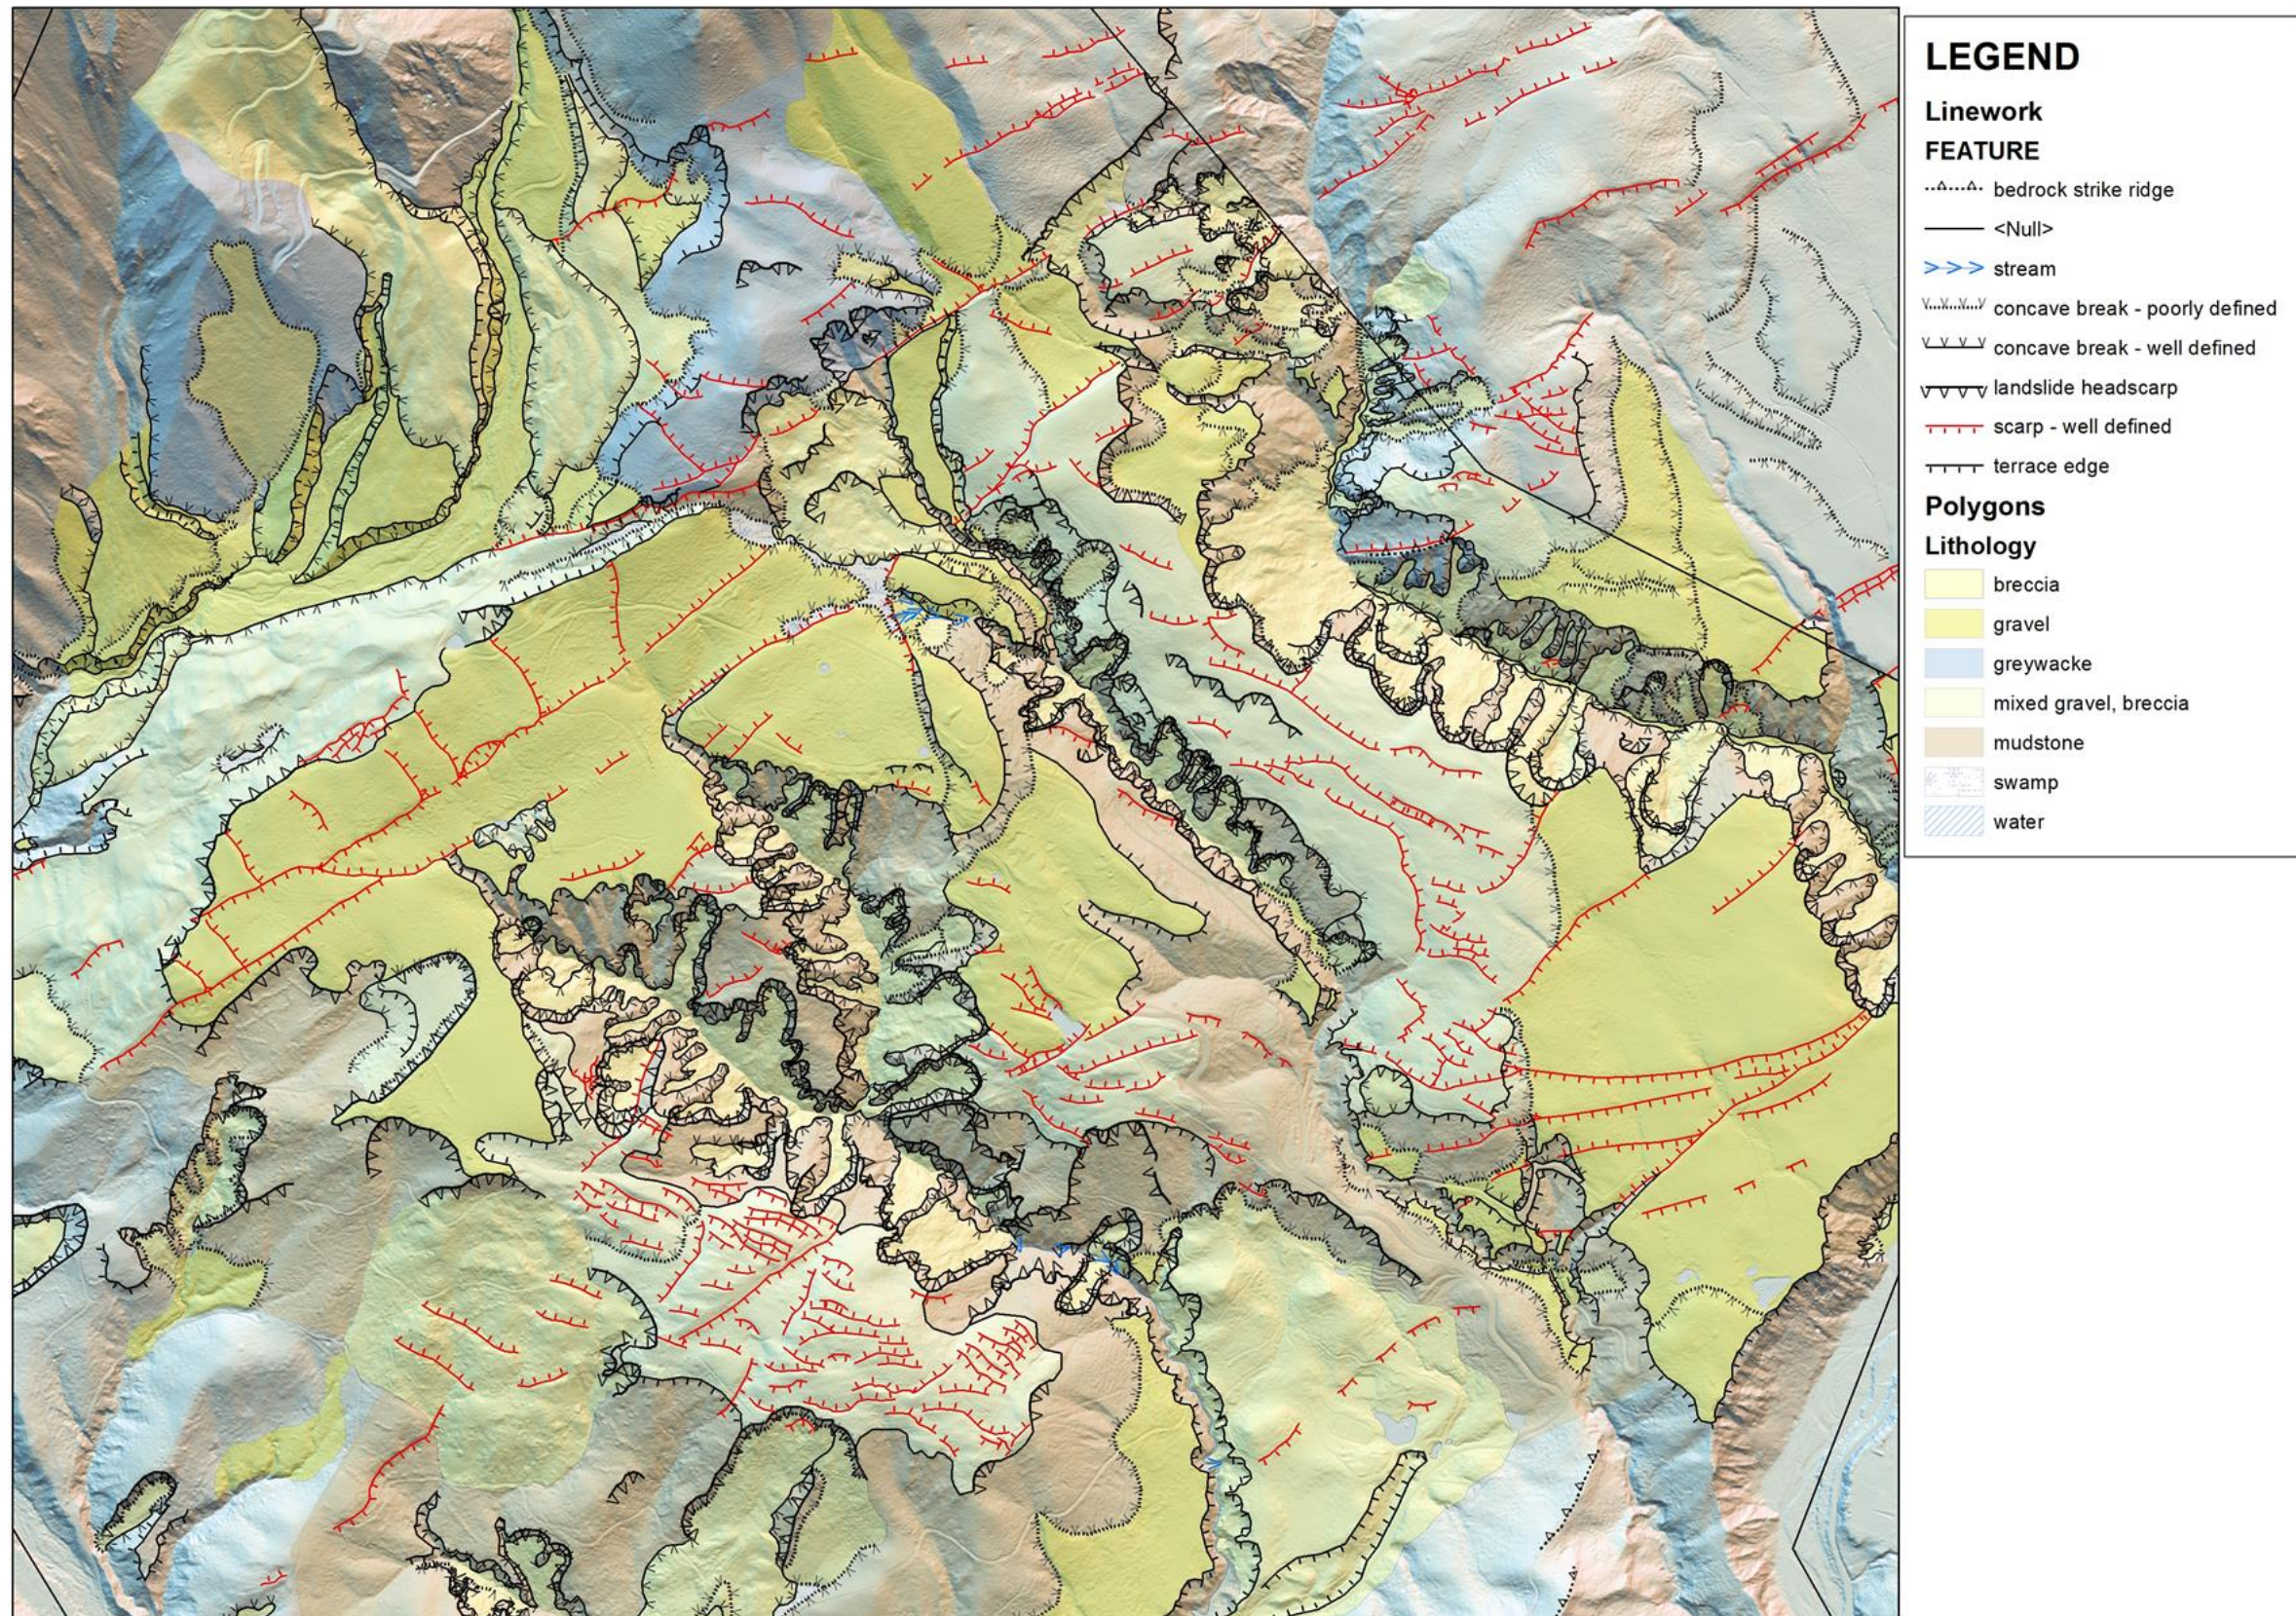
Figure 2.6 Geomorphic map of the Mt Lyford area. The map extends between the Wandle and Mason Rivers (top left to bottom right), and from the Hope Fault to the Inland Road. The geomorphic map identifies mainly: hill terrain – high (blue – mostly greywacke); hill terrain – low (orange – mostly mudstone); high terraces (dark yellow – constructional piedmont), mid-level terraces (yellow) and valley floor alluvium (pale yellow); hillslopes and hummocky ground (colluvium and landslide debris). Lines depict erosional processes such as breaks in slope (black), and tectonic and gravitational scarps (red lines). The rangefront spur on which most of the village is built is at centre.

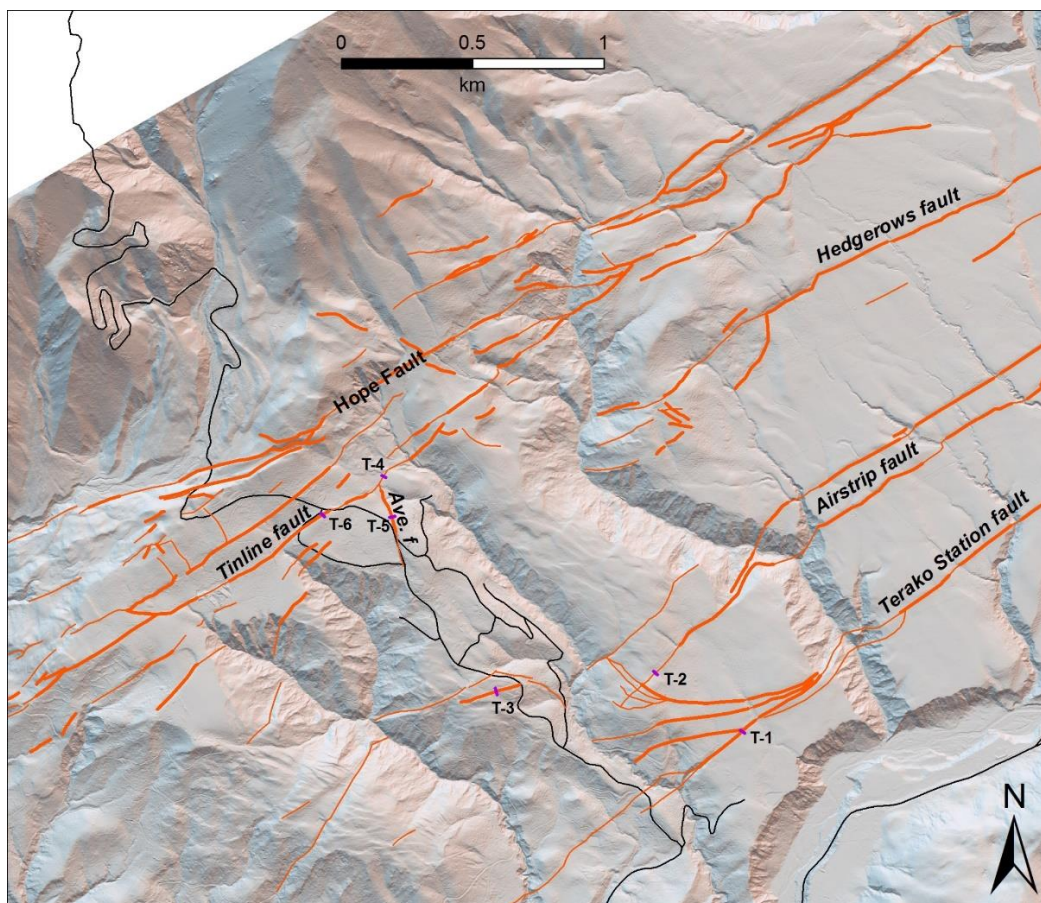
The LiDAR data was also used to map active faults traces throughout the village. Active fault mapping (Figure 2.7) and the development of Fault Avoidance Zones as part of this project supersedes previous active fault mapping and Fault Awareness Areas in the Mt Lyford area (Hancox et al. 2006; Barrell and Townsend 2012). In addition to new active fault mapping, the Langridge et al. (2018) report provided new recurrence interval data based on: radiocarbon dates from two trenches excavated in 2006; and geologic slip rates defined from the geomorphic mapping combined with estimated ages from local alluvial surfaces.

Figure 2.7 Updated active fault map for the Mt Lyford Village area. The Hope Fault is a distributed fault zone of up to 0.5 km width, and could be extended to include informally named faults (those in *italics*) such as the Tinline Fault. The accuracy of fault location is shown by the thickness of lines (accurate = thickest). The trenches excavated in 2006 are shown by purple dashes across faults and labels T-1, T-2 etc.

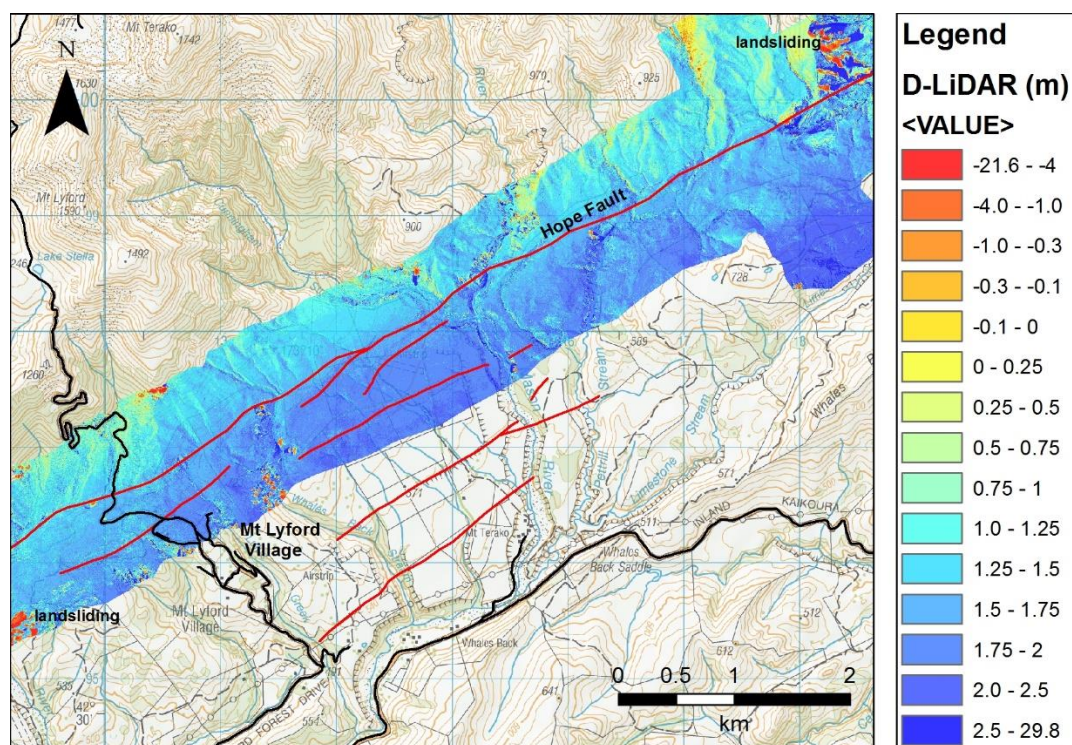
Post-earthquake LiDAR was re-processed alongside pre-earthquake LiDAR acquired in 2012 to develop a differential elevation model (Figure 2.8; Langridge et al., 2018). Such a differential or D-LiDAR model can display the amount of change in the landscape due to tectonic activity, landsliding and alluvial processes. A D-LiDAR model of the range front of the Amuri Range

along which the Hope fault runs, shows that there was significant (metre-scale) uplift of the land to the north and south of the Hope Fault. Uplift was higher to the south of the Hope Fault, in proximity to the Leader and Conway-Charwell faults that ruptured in the 2016 Kaikōura earthquake (Litchfield et al., 2018; Nicol et al., 2018). This result matches well with reoccupations of LINZ trig stations following the Kaikōura earthquake, which also show metre-scale vertical uplift and translation of trig monuments to the north-northeast compared with before the earthquake (Langridge et al. 2018).

Figure 2.8 Map showing differential LiDAR coverage along the rangefront of the Amuri Range near Mt Lyford Village. The legend indicates the vertical change between the 2012 and 2016 acquisitions.

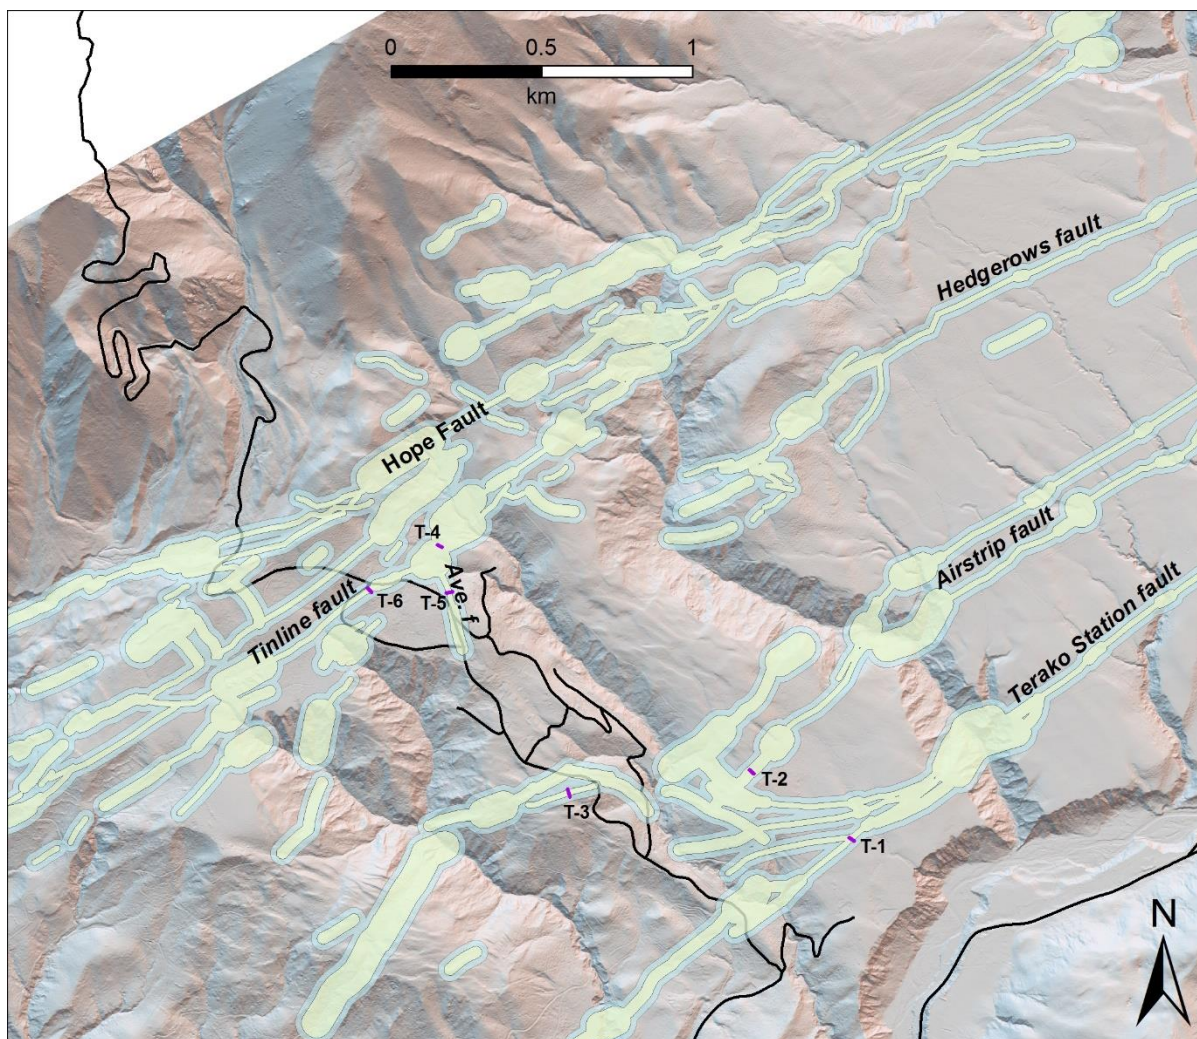
Active faults have been mapped and Fault Avoidance Zones have been developed following methods outlined in the 'Ministry for the Environment Guidelines for building on or adjacent to active faults' (Kerr et al., 2003). Active fault mapping is attributed with the accuracy terms: accurate, approximate and uncertain, depending on the level to which a fault trace can be recognised and mapped (Figure 2.7). Fault Avoidance Zones are developed by establishing setback zones based on the accuracy terms. Fault recurrence intervals have been derived from paleoseismic trench data (including new radiocarbon dates) and from estimated slip rate data (Figure 3.1).

Due to the village's proximity to the Hope Fault, many of the active faults mapped in the upper part of the village have been designated as Recurrence Interval Class I (RI <2000 years). Faults in the lower part of the village (e.g., Airstrip and Terako Station faults) have been designated as Recurrence Interval Class II (RI <2000-3500 years).

Figure 3.1 Fault Avoidance Zone (FAZ) map for Mt Lyford Village (from Langridge et al., 2018). FAZ 'sausages', based on accuracy of fault mapping, are shown with their associated active faults as labelled. Fault line data is intentionally left off this map to focus on the avoidance zones.
