# LESSONS LEARNT FROM 2011 CHRISTCHURCH EARTHQUAKES: ANALYSIS AND ASSESSMENT OF BRIDGES

## SUMMARY

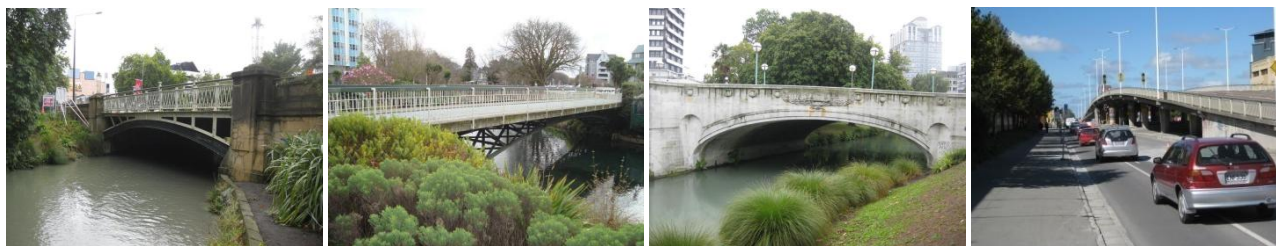
**Figure 4:** Selection of damaged bridges in the CBD area. From left to right: Colombo Street Bridge; Bridge of Remembrance; Antigua Street Footbridge; Moorhouse Avenue Overpass.

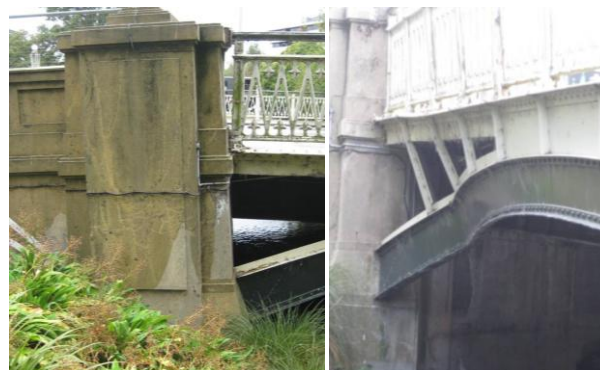
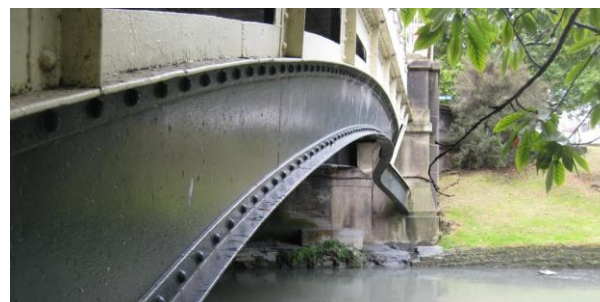
The lateral displacement of the banks behind the abutment contributed to the large cracks observed in the abutments and their back-rotation. Abutment wall rotation was observed on both sides of the bridge, but was more pronounced at the north abutment (Figure 5a). It appears that the abutment wall is restrained at the top by the bridge superstructure and may have rotated outwards at the bottom due to earthquake earth pressures or lateral displacement towards the river. The north abutment pilasters also rotated outwards as a result of the lateral spreading pressures on the wingwalls, with vertical cracks in the abutment wall.

Significant damage identified following the Christchurch earthquake involved severe buckling of the arched edge

girders both on the upstream and downstream sides of the bridge (Figure 5b-c). Moreover, the cast iron handrail attached to the top of the arched edge girders became unstable. Connection of the pilasters to the rest of the abutment may be questioned, but irrespectively, even if the pilasters were well connected to the rest of the abutments, abutment rotations produced a larger horizontal displacement at their base than at their top, resulting in buckling of the arches. Because of additional movements and damage resulting from the June 2011 earthquakes, the bridge was still closed at the time of writing (September 2011).

**Figure 5:** Colombo Street Bridge (a) Rotation of the abutment [Courtesy of Opus]; (b) Buckling of steel arch [Photo by M. Yashinsky]; (c) Close up view of the steel arch [Courtesy of Opus].

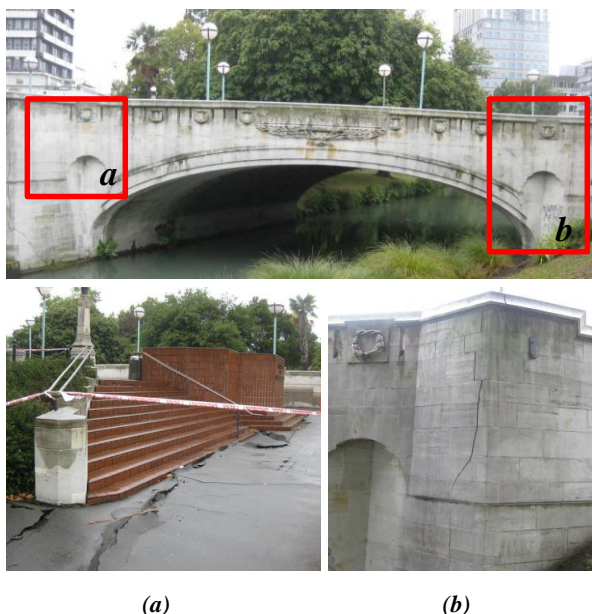
**Figure 6:** *Bridge of Remembrance (a) Damage to steps on western approach [Courtesy of Opus]; (b) Damage to north-eastern wingwall [Courtesy of Opus].*

This bridge suffered moderate superficial damage as a result of the 2011 Christchurch earthquake. However, the Triumphal Arch over the bridge sustained more significant structural damage. In terms of the bridge, reported damage included paving damage at the approaches (Figure 6a), large vertical cracks to all wingwalls (Figure 6b) and widespread cracks near the base of arch, along the full length at base of both parapets and through the buttress of the arch above the east abutment. The width of some of these cracks increased after the 13 June 2011 aftershocks.

The majority of the damage has resulted from settlement of the approach fill, lateral spreading soil pressures resulting in deflection and rotation of the wingwalls and possibly the abutments. Minor rotation of all four wingwalls caused cracking of the stone facades. The concrete sections behind the cracked stonework are also likely to have been cracked. This is not considered a major concern at present, as the wingwalls are independent from the main bridge structure and are founded on concrete pads.

Cracking of the parapets may indicate some deflection and hogging of the main arch of the Bridge of Remembrance. Hogging damage to the crown of the arch is unlikely to have a significant effect on the live load capacity of the bridge, given that it only carries pedestrian loads. Hogging of the bridge may result in a slight reduction in the residual seismic capacity of the structure. However, collapse of this robust structure under earthquake induce soil loading/lateral spreading is highly unlikely.

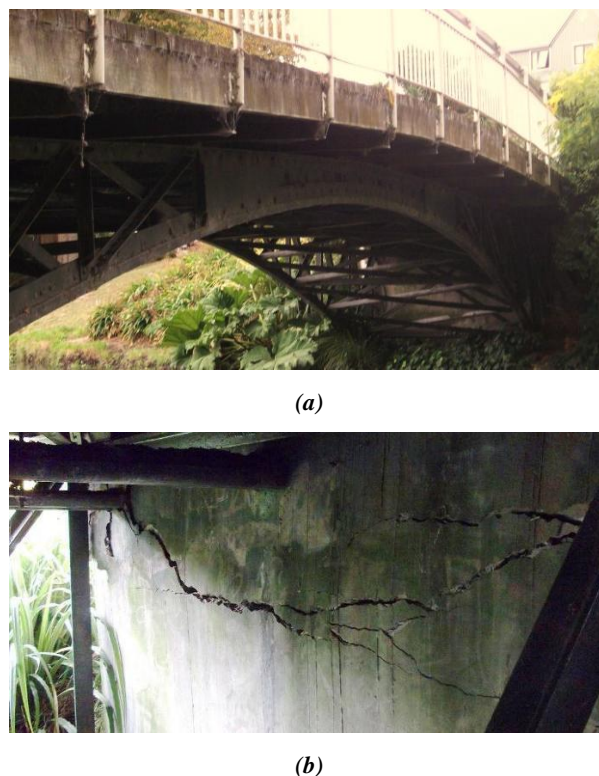
The bridge was closed at the time of writing (September 2011), and additional damage was observed after the 13 June aftershocks. The hog in the longitudinal profile of the bridge was approximately 450 mm at the centre of the span. Both abutments have back-rotated between 1-1.5°, (Figure 7a), and displaced towards the river, with the truss arch compressing. The vertical and diagonal truss members adjacent to the north-eastern abutment have disconnected due to rotation of a low level concrete retaining wall, causing the riveted connection to fail.

The majority of the observed damage resulted from localized liquefaction and/lateral spreading pressures. The lack of piles and lack of reinforcement in the abutments can be considered a critical structural weakness for this bridge. These have resulted in shear failure of the concrete abutments and wingwalls, with the top of the abutment wall being restrained by the bridge superstructure. While this has reduced the capacity of the abutments, they are likely to have some residual shear capacity due to the aggregate interlock of the concrete at the cracked sections.

**Figure 7:** *Antigua Street Footbridge (a) View underneath showing hogging [Courtesy of Opus]; (b) Damaged north-eastern abutment [Courtesy of Opus].*

The abutment displacement and rotation caused the vertical deflection and hogging of the steel arch truss (Figure 7a). This hogging meant some cross bracing members failed adjacent to more rigid, corroded joints (Figure 8b). The shear failure of the concrete wingwalls has caused the supports to the timber footbridge beams to fail (Figure 8a). These supports had very little anchorage into the concrete wingwalls, and would not have required much movement to cause them to fail. The failure of these supports is not a major concern, as they only support a very small section of the footway, which is currently supported by the rigid handrail.

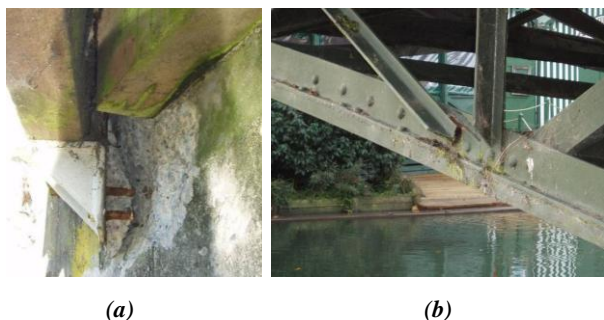
**Figure 8:** *Antigua Street Footbridge (a) Typical failure of end support of timber footway beams [Courtesy of Opus]; (b) Typical failure of cross bracing member adjacent to corroded joint [Courtesy of Opus]*

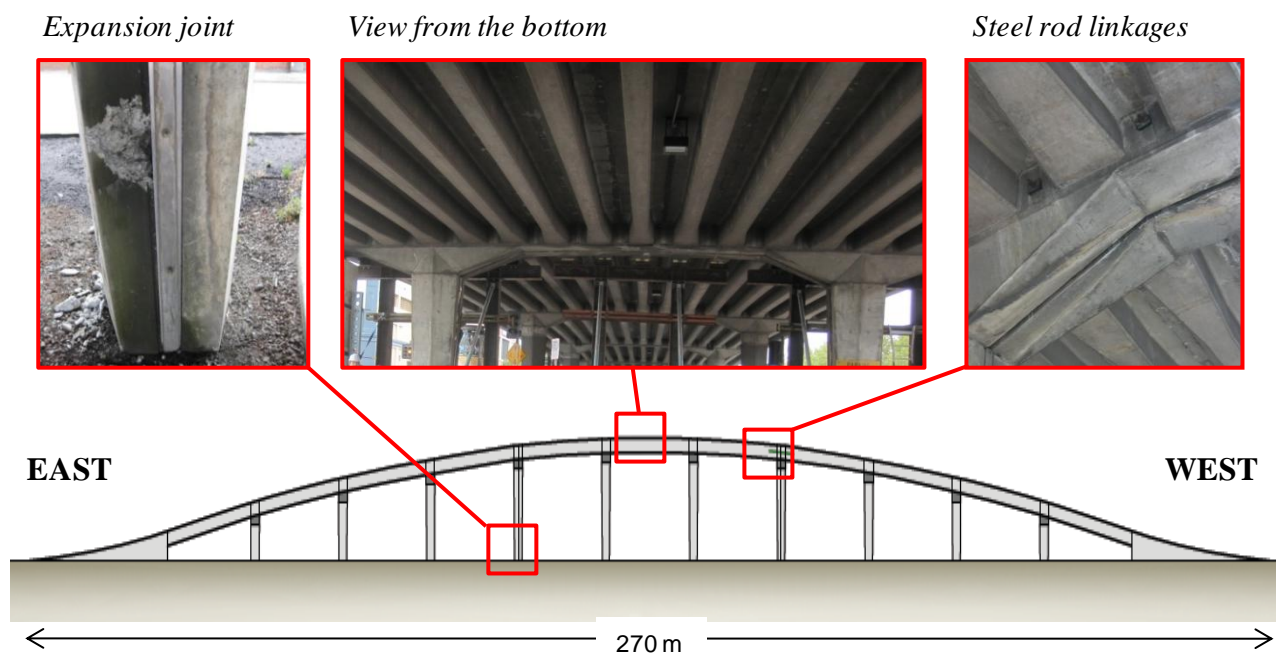
The bridge sustained damage to one column near the north-east approach where a deck expansion joint was located. The insertion of steel rod linkages in the deck at the expansion joint at only one side of the bridge induced irregularity in the structures transverse response. In fact, with the west and central part of the bridge linked, the bridge pier at the eastern expansion joint suffered extensive displacement demand. The slenderness of the pier affected the vertical load carrying capacity of the structure along with its lateral capacity. The columns also had widely spaced transverse reinforcement, making the structure susceptible to shear failure, a brittle failure mechanism (Figure 10a). Observations after the 2011 Christchurch earthquake indicated that the damaged columns had started to buckle (Figure 10b) putting the central span at risk of collapse. In this instance, damage was induced by extensive ground shaking; large transverse horizontal accelerations may have caused a flexural-buckling failure mechanism in the columns.

**Figure 9:** *Moorhouse Avenue Overpass. Sketch of the bridge elevation with locations of the expansion joints and steel rod linkages (Taken from [5]).*

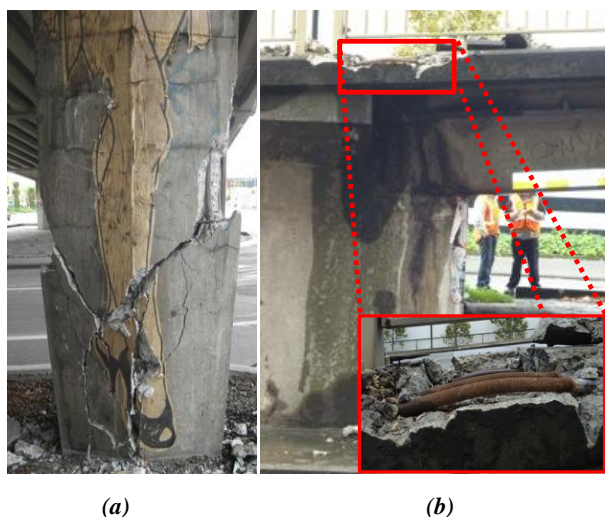
Due to the higher displacement demand in the west-central part of the bridge, the deck pounded against the south-west abutment of the bridge causing extensive spalling and bar buckling. Ground shaking in the longitudinal direction caused the deck to pull away from the abutment, developing vertical cracks and yielding the reinforcing steel. When put back into compression, the concrete kerb spalled and the reinforcing bars buckled. This has occurred as the abutment is also taking some of the longitudinal lateral load of the centre section due to the placement of steel ties.

**Figure 10:** *Moorhouse Avenue Overpass. (a) Shear failure mechanism of the pier at the expansion joint [Photo by A. Palermo]; (b) Concrete spalling and bar buckling at south-west side abutment [Photo by A. Kivell] (Taken from [5]).*

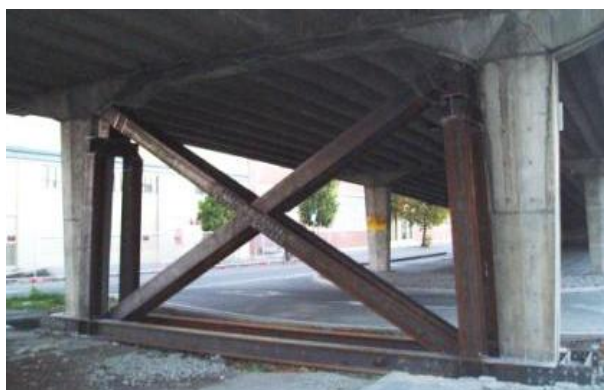
**Figure 11:** *Moorhouse Avenue Overpass. Temporary propping [Photo by G. Whüla].*

Initially temporary strengthening works were erected around the failed pier. These consisted of two columns built-up from square concrete blocks with timber blocking between to prop the bridge while further work was undertaken. A multi-span structural steel frame was designed and constructed soon after the earthquake spanning between the two failed columns. This led to the bearing of the tapered deck beams on the steel portal to be on a smaller cross-section and was meant only as a temporary solution to prevent collapse of the damaged section. This solution did not provide any additional lateral stability and so the over bridge was not reopened to vehicle traffic until the final temporary solution was implemented.

To improve the transverse capacity of the damaged structure Opus (consulting engineers) elected to construct dual cross-bracing units at each of the piers. These straddled between the piers and used doubled up steel sections to act as a diagonal bracing system as shown in Figure 11.

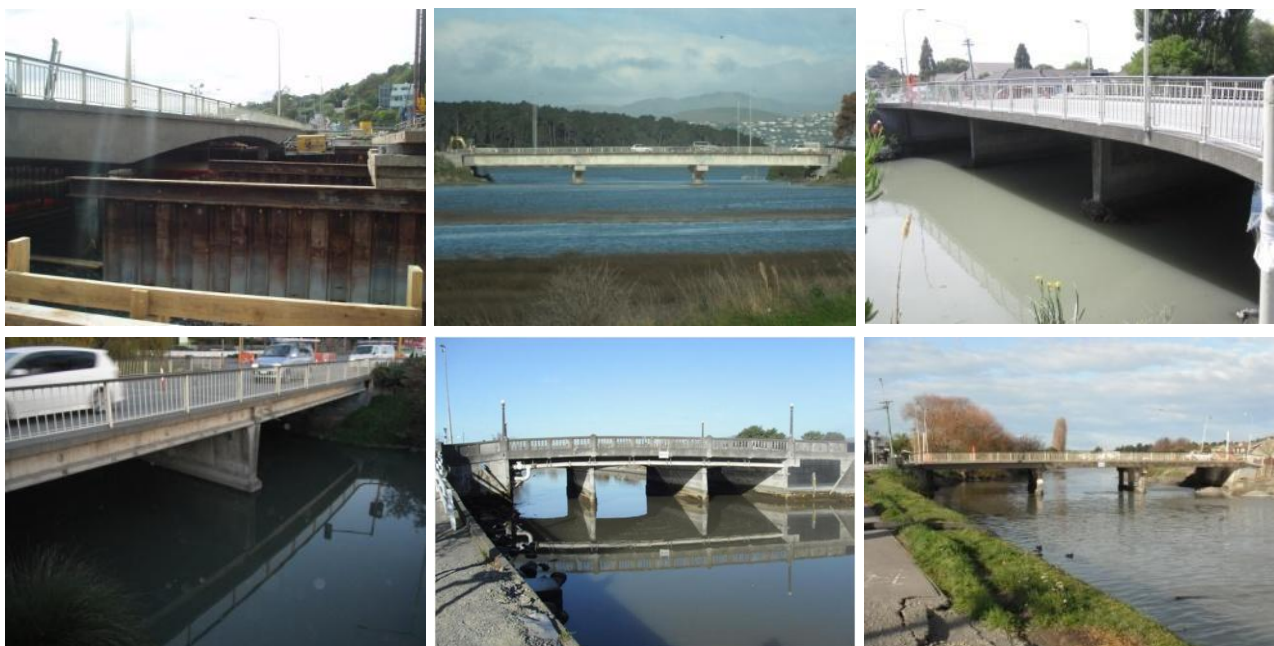
**Figure 12:** Selection of damaged road bridges. Clockwise from top left: Ferrymead Bridge; Bridge Street Bridge; Gayhurst Road Bridge; Avondale Road Bridge; Pages Road Bridge; Fitzgerald Avenue Bridge.

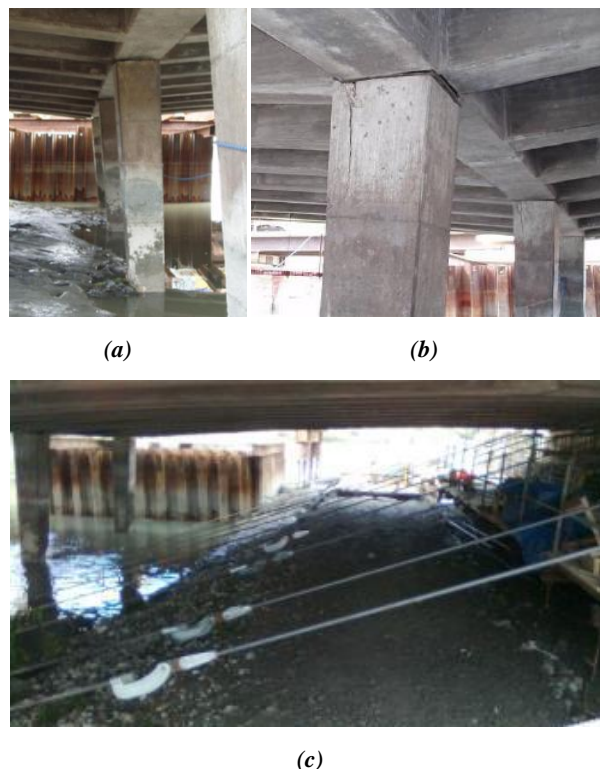
The Ferrymead Bridge was the only bridge along the Heathcote River to suffer significant damage. Lateral spreading caused significant damage to the new abutment components and temporary construction platforms. The existing structure also sustained damage due to lateral spreading, with permanent rotation and cracking of a number of the piers situated in the estuary (Figure 13a).

**Figure 13:** Ferrymead Bridge (a) Tilted piers [Courtesy of Opus]; (b) Close-up view of flexural cracks at the top of the piers [Courtesy of Opus]; (c) Securing works of Ferrymead Bridge [Courtesy of Opus].

The bridge was temporarily repaired with prestressed rods connecting the bottom of the piers to the abutments (Figure 13b). This limited further movements of piers inwards

towards the river/estuary which could compromise the overall stability of the bridge. Due to the earthquake damage, heavy vehicle restrictions had been placed on the bridge following the 2011 Christchurch earthquake.

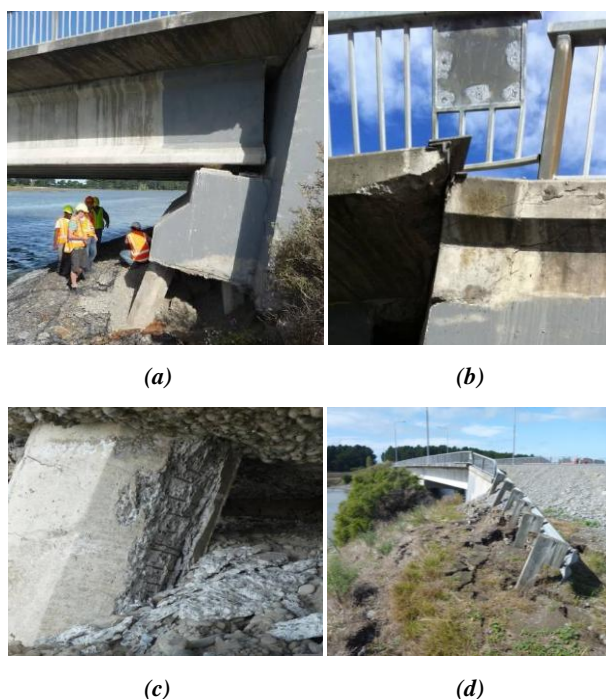
The primary cause of damage was from lateral spreading of the reclaimed embankment soil on which the abutments are located. Situated in an estuary, the underlying soils were heavily prone to liquefaction and after the onset of shaking, loss of soil stability caused failure and spreading throughout the approach to the bridge (Figure 14a). Flow of soil against the wingwall, abutment and through the piles resulted in abutment back-rotation due to the restraint provided at the top of the abutments by the superstructure. Transverse translation of the skewed abutments relative to the bridge deck was a result of lateral spreading perpendicular to the bridge axis, and some pounding between the deck and abutments (Figure 14b).

Flexural hinging, cracking and spalling was observed in the abutment piles at their connection to the pile cap caused by both the rotation and the translation of the abutments (Figure 14a). Slumping of soil around the abutments due to lateral spreading exposed the tops of the abutment piles. Hinging at the top of the piles was accompanied by flexural cracking and

spalling in the exposed sections of the piles under both abutments. The crack patterns observed on the piles indicate that the piles were subjected to bi-directional bending during the earthquake due to the rotation of the abutments and the transverse translation (Figure 14c). Crack widths on the west piles were greater than on the east piles suggesting larger deformations. Uncertainty remains with regards to potential plastic hinging below the ground surface.

**Figure 14:** *Bridge Street Bridge (a) Back-rotated abutments [Photo by M. Bruneau]; (b) Pounding of the deck on the abutment [Photo by A. Kivell]; (c) Plastic hinging in abutment piles of Bridge Street Bridge [Photo by M. Bruneau]; (d) West approach settlement and temporary repair [Photo by S. White].*

Major cracking and settlement of the approach pavement and embankments impeded vehicle access to the bridge (Figure 14d). Non-structural components such as guard rails and handrails founded in slumping soil were heavily damaged. The amount of approach settlement at the west end of the bridge was significantly more than observed at the east end, with large amounts of aggregate required to build up the approach road level to that of the bridge before it could return to service. The deck was largely undamaged with damage limited to spalling at the ends due to pounding against the abutments.

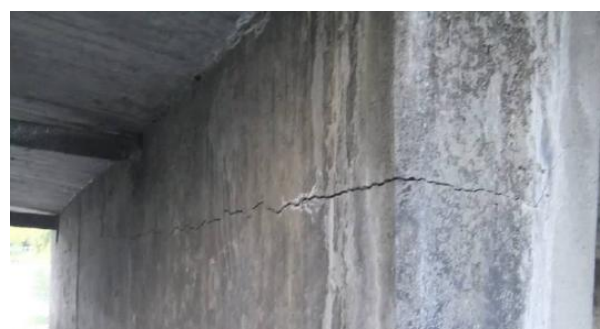
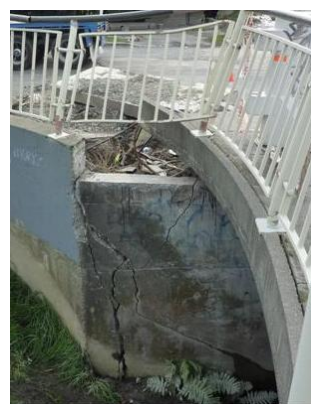
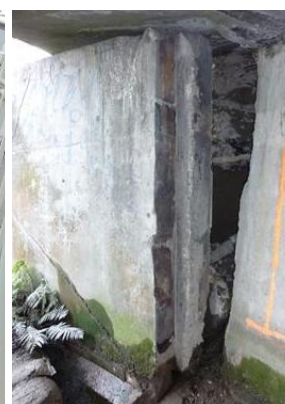
Lateral spreading resulted in rotation and displacement of the northern abutment backwall and wingwalls (Figure 15b). Wingwalls displaced towards the river and rotated in plan with their outer, more poorly restrained, edges moving towards the river causing the development of flexural cracks in both abutment-to-wingwalls and abutment-to-deck connections. The top of the wingwalls on both sides of the northern abutment displaced 900 mm towards the river relative to the edge of the bridge deck, with lateral movement of 100-150 mm at their base. This rotation/translation of the structural element resulted in high flexural stresses in the abutment and eventually cracking, as shown in Figure 15b. The differential settlement of the soil beneath the abutment and the ground shaking may also have contributed to the formation of cracks. A worsening of the cracking was evident after the 13 June aftershocks, resulting in a total displacement of the top of the wingwalls of 1,300 mm towards the river relative to the backwall. The rotation and translation of the wingwalls meant they completely detached and moved in front of the backwall (Figure 15c). Conversely, there was little indication of damage to the southern abutment, with no significant displacement or rotation accompanying minor cracking.

Lateral spreading exerted a lateral force on the pier base, causing a large moment at the stiff pier-deck interface, inducing cracking of the pier. A single horizontal crack along one face of a pier, approximately one metre from the deck soffit, developed during the 2010 Darfield earthquake and increased after 2011 Christchurch earthquake (Figure 15a). Liquefaction would have reduced the lateral stiffness of the pier foundation system, allowing rotation of the bottom of the pier towards the centre of the river.

**Figure 15:** *Gayhurst Road Bridge (a) Damaged pier with flexural cracking [Photo by L. Hogan]; (b) Flexural cracks at the north-western wingwall [Photo by L. Wotherspoon]; (c) Displacement of north-western wingwall [Photo by L. Wotherspoon].*

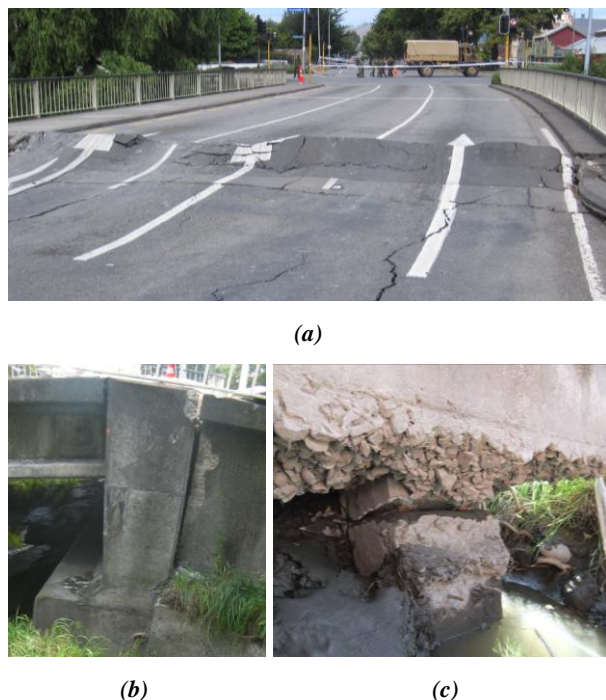
**Figure 16:** *Fitzgerald Avenue Bridge (a) Damage at the approach of the eastern bridge [Photo by A. Kivell]; (b) Back-rotated abutments [Courtesy of Opus]; (c) Flexural cracks on the piles [Photo by L. Hogan].*

Following the 2011 Christchurch earthquake the Fitzgerald Avenue Bridges were closed to traffic for several weeks. Closure was necessary because of severe spreading of the road north of the bridges which developed large fissures (Figure 16a), and Christchurch City Council's decision to place an emergency cordon around the 'four avenues' of the Christchurch CBD, of which Fitzgerald Avenue is one. Large amounts of settlement occurred at the bridge approaches primarily on the northern bank; this was accompanied by two directional lateral spreading. The combination of these factors resulted in the back-rotation of the northern bridge abutments (Figure 16b). Moderate pounding damage was observed at the

ends of the simply supported deck beams, exposing reinforcing steel in some regions. Services housed within the bridge were damaged due to lateral spreading.

Rotation of abutments placed high demands on the northern abutment piles. Figure 16c shows the damage to the eastern-most pile of the eastern bridge. Failure occurred in tension with a 30 mm crack opening up across the entire section. In some cases, heavy cracking and spalling due to hinging of the piles at their connection with the pile cap occurred resulting in exposure of prestressing tendons. Cracks ranging from 0.1 mm to 1.5 mm were present on the river side of all the piles. Below ground pile performance was unable to be determined but it would be expected that differential movements between liquefied and non-liquefied layers caused damage in addition to that at the pile to pile cap connection.

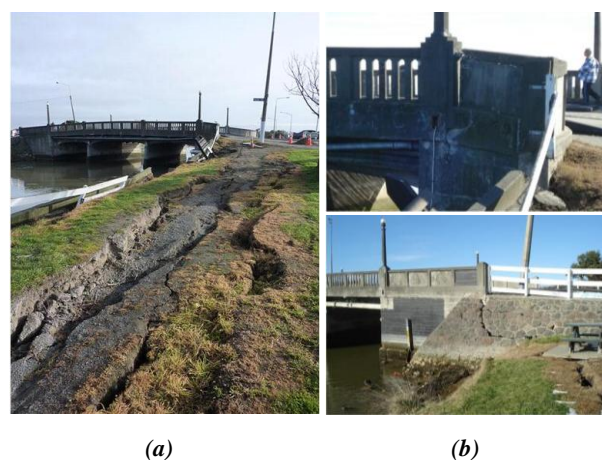
**Figure 17:** *Pages Road Bridge. (a) Lateral spreading to the south of the eastern abutment following the June 13 aftershocks; (b) Rotation and cracking of the south-east wingwall (top) and cracking of rock facing and lateral spread crack at north-west corner following June 13 aftershocks (bottom) [Photos by L. Wotherspoon].*

latter region. Cracking and settlement of the approaches developed at both abutments as a result of lateral spreading, with movements perpendicular to the river on the west approach, and movements towards the south-west on the east approach. There was a large volume of ejecta and flooding around the western abutment. The region to the north-east of the bridge suffered less liquefaction induced damage compared to the other areas. Following the 13 June aftershocks, there was further minor settlement of the approaches and additional lateral spreading. A large lateral spread immediately to the south of the eastern abutment is shown in Figure 17a.

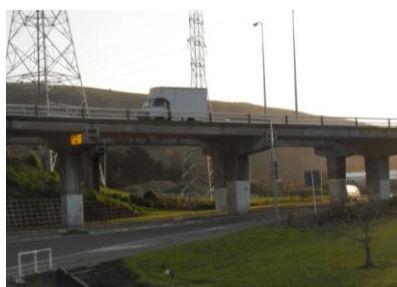
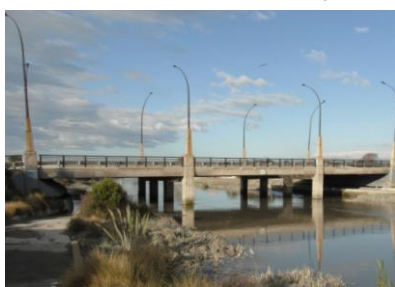
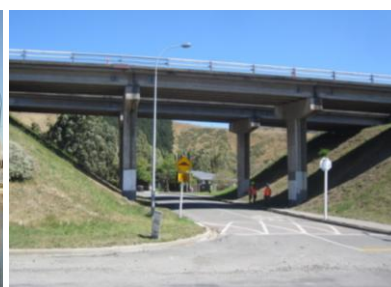
**Figure 18:** Selection of damaged State Highway bridges after February 22, 2011. From left to right: Anzac Drive Bridge [Photo by E. Camnasio]; Horotane Overbridge [Courtesy of Opus]; Port Hills Overbridge [Courtesy of Opus].

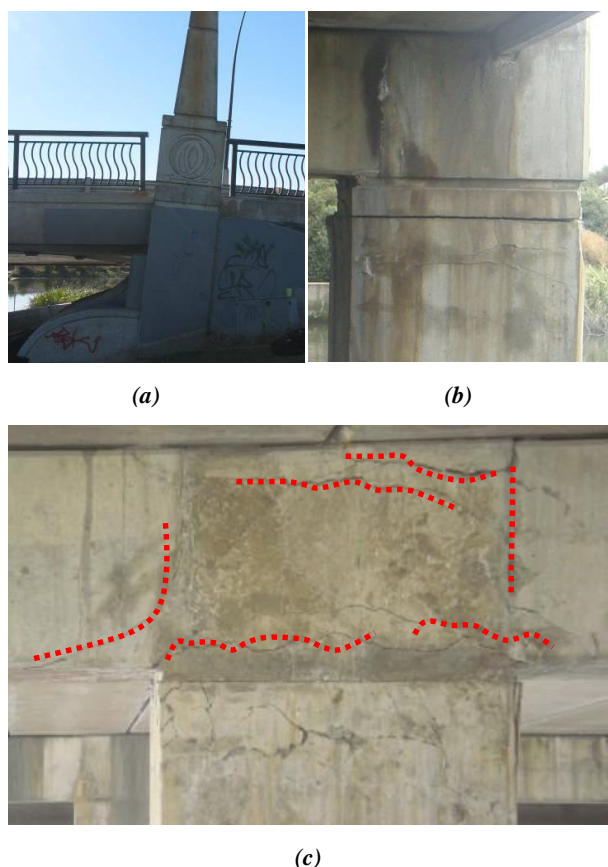
Significant structural damage was observed following the strong shaking in the 2011 Christchurch earthquake. Lateral spreading of the approaches caused the abutment piles and beam seatings to rotate about 8° (Figure 19a). Cracking and spalling was observed at the beam-column joints in the piers and some of the pier columns rotated up to 2° (Figure 19b). Damage was more pronounced at the outer of the three columns in each pier. There was also significant lateral spreading and settlement of the approach pavements and embankments. Concrete walkway structures under each end of the bridge moved towards the river about 300 mm and 500 mm at the north and south ends respectively. No significant additional structural damage was reported following the 13 June 2011 aftershocks.

**Figure 19:** *Anzac Drive Bridge (a) Back-rotation of southern abutment [Photo by A. Palermo]; (b) Flexural cracks at the central pier [Photo by N. Chow]; (c) Plastic hinging at pier cap [Photo by N. Chow].*

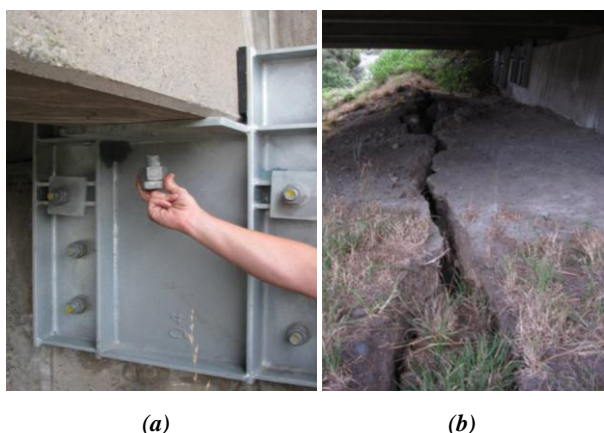
Minor structural damage to the bridges had been observed following the 2010 Darfield Earthquake. The most significant damage was the loosening of all the abutment linkage rods on both bridges with the slackness under the washers varying between 5 and 10 mm.

**Figure 20:** *Horotane Overbridge (a) Sheared bolt at the abutment retrofit [Photo by J. Allen]; (b) Slope failure at the abutments [Photo by J. Wood].*

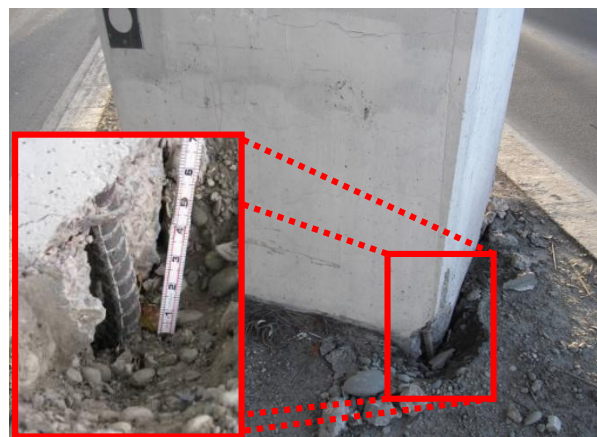
Down slope soil movement on the abutment slopes under the bridge resulted in wide cracks in the soil and at the contact between the soil and abutment face under the south-east abutments. Wide cracks running parallel to the roadway at the top of the approach embankment developed in the soil on the east side at the south-east end of the bridges. There was also minor settlement and displacement of the approach pavement and back-fill at the abutments.

**Figure 21:** Port Hills Overbridge. Buckling of reinforcing steel at the base of the piers [Courtesy of Opus].

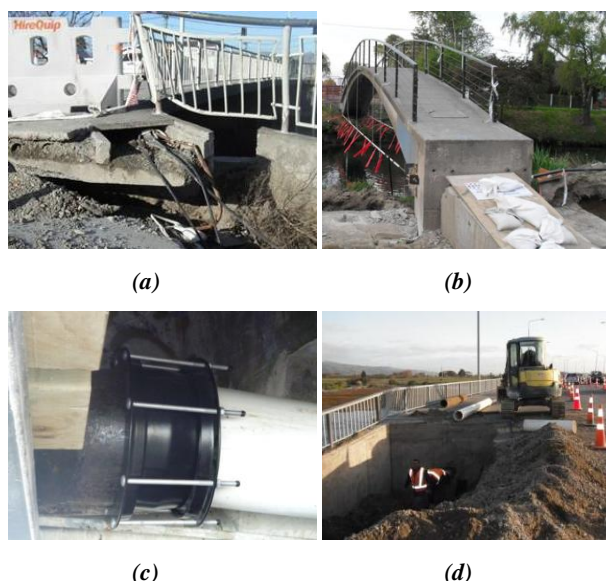
An example of important services carried on a bridge is the Dallington Pedestrian Bridge, where lateral spreading created extensive cracking parallel to the bridge and perpendicular to the alignment of the road and buried pipes, potentially leading to damage to sewer pipes in the road. This bridge has two 66 kW power cables placed under the bridge deck, providing electricity to 20,000 inhabitants, making this modest pedestrian bridge a structure with strategic importance. Some moderate to extensive damage was observed at many road bridges where pipes were distorted and/or leaking in the proximity of the connections from deck-to-abutment, and abutment-to-approaches. The main issues arose with stiff pipes, such as sewage and water pipes, as they are fully fixed to the deck and usually run through the abutments. On the other hand, the flexibility of power and/or telephone cables were able to accommodate larger displacement demands.

**Figure 22:** (a) *Gayhurst Road Bridge, damage to lifelines [Photo by A. Palermo]; (b) Dallington Pedestrian Footbridge, damage to electrical services to the Dallington area [Photo by M. Le Heux]; (c) Repair to water pipe at Bridge Street Bridge [Photos by A. Campbell]; (d) Repairing works at Bridge Street Bridge [Photo by A. Palermo].*
