SEISMIC PERFORMANCE OF REINFORCED CONCRETE BUILDINGS IN THE 22 FEBRUARY CHRISTCHURCH (LYTTELTON) EARTHQUAKE

Weng Y. Kam¹, Stefano Pampanin², Ken Elwood³

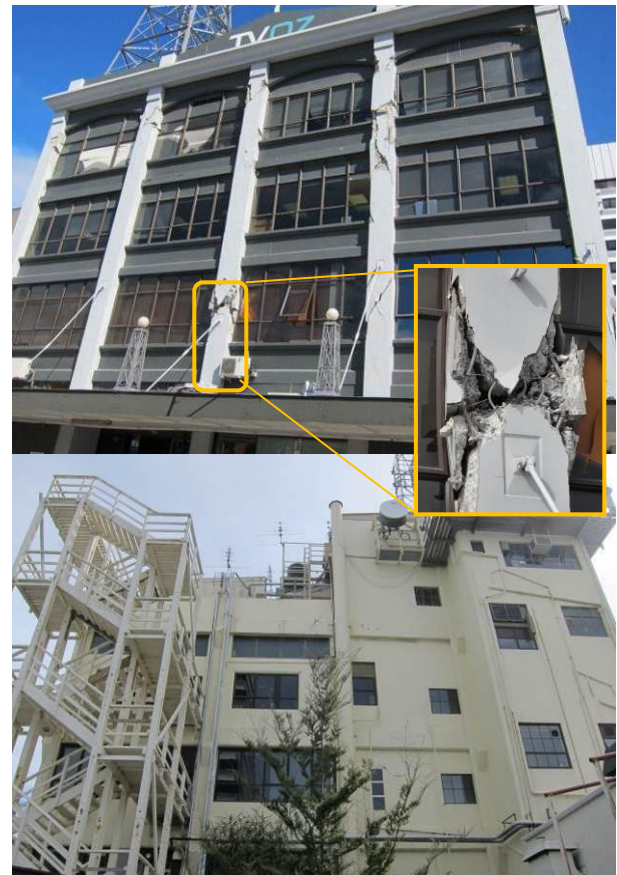
Plan irregularity and column shear failure: Figure 9 and Figure 10 show a 4-storey 1950s RC frame-wall building with severe columns damage on the Northern frame. The building is reinforced with plain round bars. As seen in Figure 10, the columns, which failed in shear, have almost negligible transverse reinforcement.

Figure 10: Severe column shear failures of the front (North) façade frame of a 4-storey RC frame-wall building.

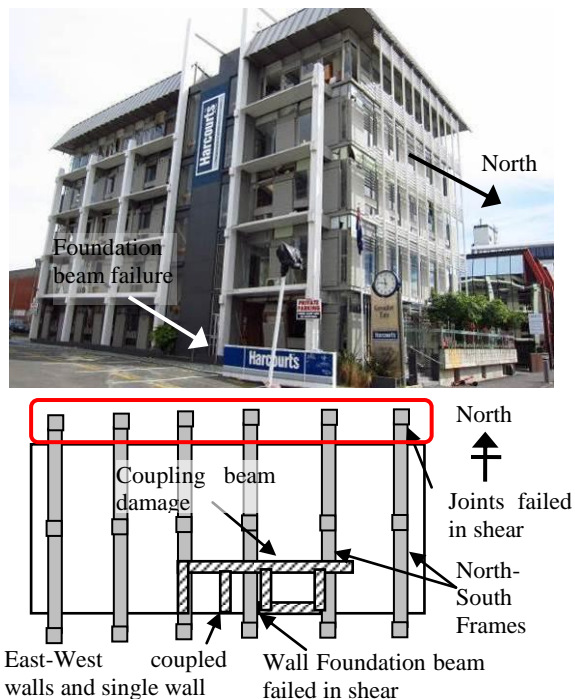
Foundation beam, coupling wall and joint shear failure: Figure 11 and Figure 12 show a 5-storey RC frame-wall building with multiple elements failing in brittle behaviour. It comprises six one-way RC frames in the North-South direction and several coupled- and single RC walls acting predominantly in the East-West direction.

Figure 11: *Pre-1970s RC frames-walls building with multiple elements experiencing a brittle failure mode.*

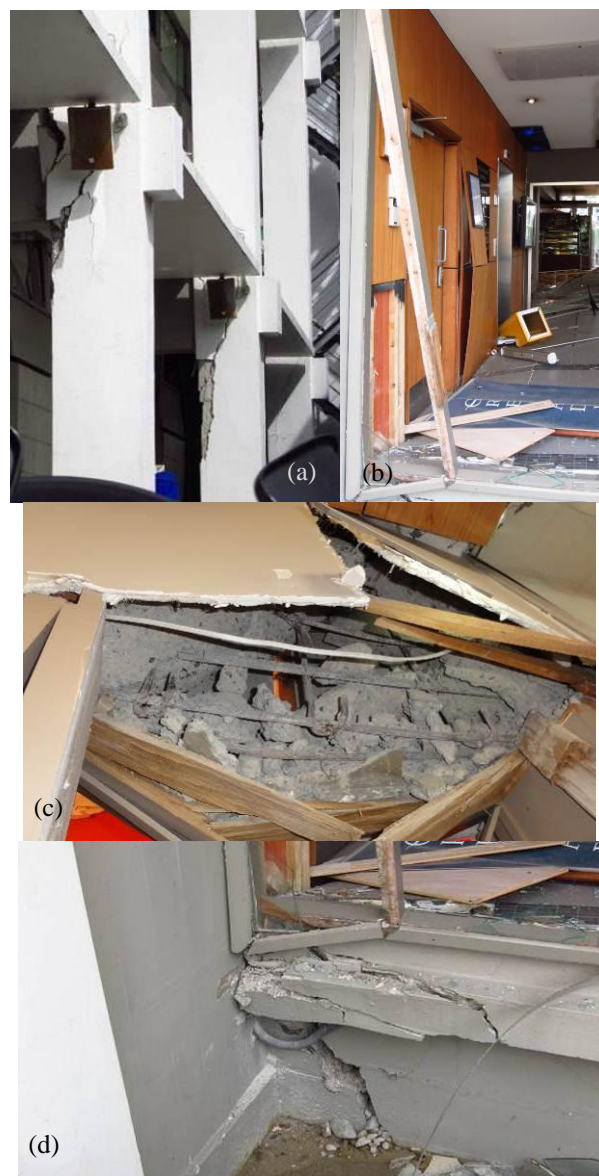
The lateral resisting system in the East-West direction appears to be severely damaged. The coupled walls in the internal grid line had severe damage on its coupling beams at the lower three storeys (Figure 12c). The coupling beams are lightly-reinforced with plain round bars. The foundation underneath the core walls around the lift-shaft appears to have failed and dropped approximately 400 mm (Figure 12b). One of the foundation ground beams was observed to have failed in shear with evidence of liquefaction observed in the vicinity of the foundation beams (Figure 12d).

It is likely that the RC frames resisted a significant portion of the lateral load in the North-South direction and torsional load from the East-West shaking. The failure of the walls system and foundation beam in the East-West direction and the vertical drop of these core walls also ‘dragged’ the RC frames inward, resulted in shear-failure of the beam-column joints as the frames deformed inwards. The unreinforced beam-column joints developed the highly brittle shear-wedge mechanism.

Figure 12: *Pre-1970s RC frame-wall building: a) Exterior joint shear failure ; b) Approximate 400mm drop of the RC walls; c) Coupling beam failure; d) Shear failure of the foundation beam.*

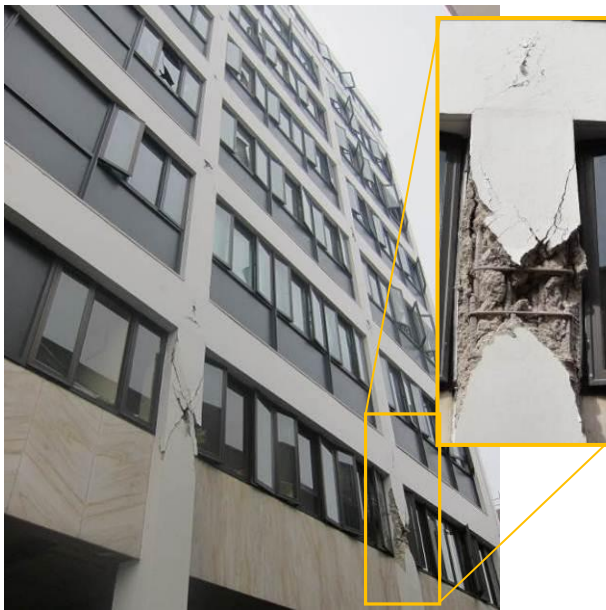
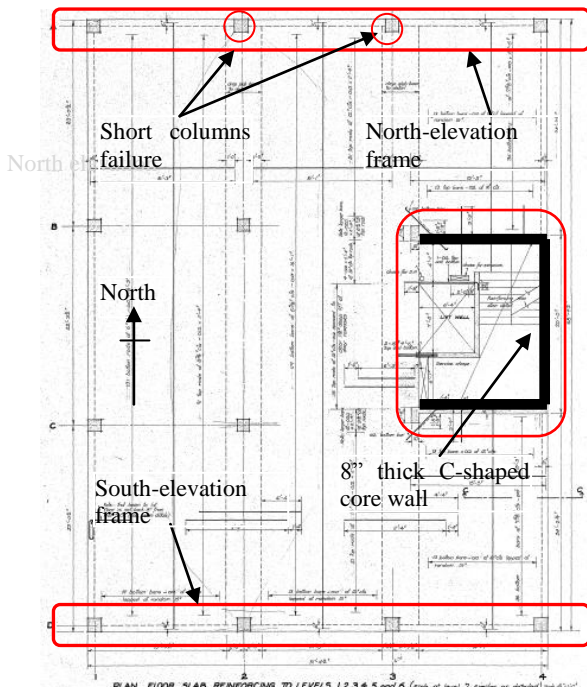
Short column and joint shear damage of an early 1970s building: Figure 13 shows an 8-storey 1973 building of two-way RC frames with a C-shaped core-wall structural system. Typical 457 mm square columns are reinforced with 12 distributed D28 (28 mm diameter deformed) longitudinal bars and D10 stirrups at 230 mm centres. The beam-column joints are reinforced with 1-2 stirrups. The C-shape wall is

The first floor columns on the North elevation failed in shear with the upturned spandrel beam creating a short-column effect. In both Northern and Southern elevation frames, the beam-column joints were cracked with limited spalling. No apparent damage of the shear-core wall was observed.

By most accounts, this early 1970s RC building has performed reasonably well despite the onset of the brittle failure mode in the columns. The redundancy provided by the dual frame-wall systems ensures the building remains standing despite the onset of brittle failure of the East-West perimeter frames.

The core wall did not seem to resist a significant amount of the seismic inertial forces. Relative minor cracks were observed within the core walls. The diaphragm area (~4.5 m x 2 lengths) tied into the core wall is limited by the voids within the core and the location of the walls.

Figure 13: An 8-storey building with two-way RC frames system had a mix of column and beam-column joint shear failures.

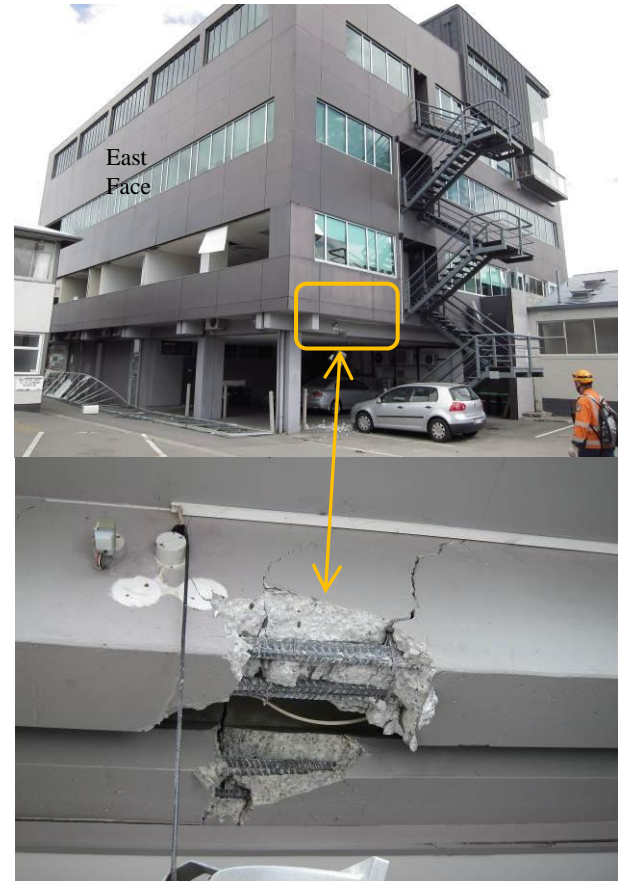
Beam lap-splice failure: Figure 14 illustrates the typical damage sustained by a 5-storey 1967 RC frame building (plan view shown in Figure 15). The building comprises six two-bay RC frames in the East-West direction and three five-bay RC frames in the North-South direction.

Figure 14: Ground floor beam lap-splice failure.

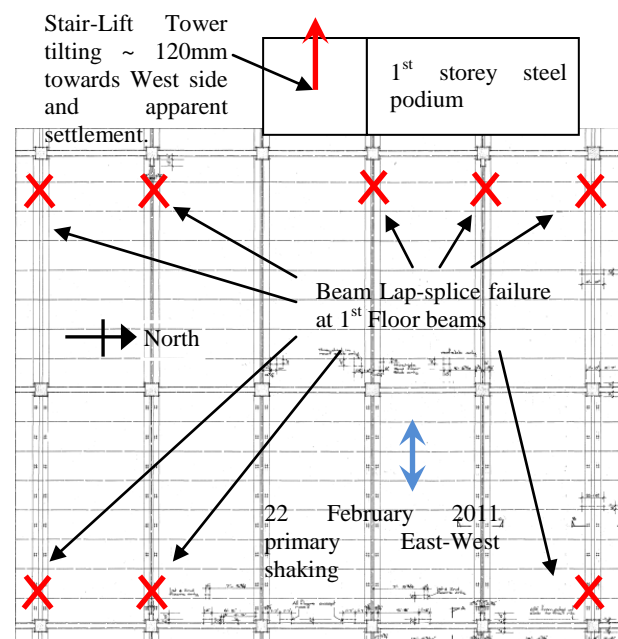
The tower structure on the West side, seismically isolated from the frame building, was tilting 120 mm east due to ground failure.

Figure 15: 5-storey RC frame building built in 1967 with beam lap-splice failure.

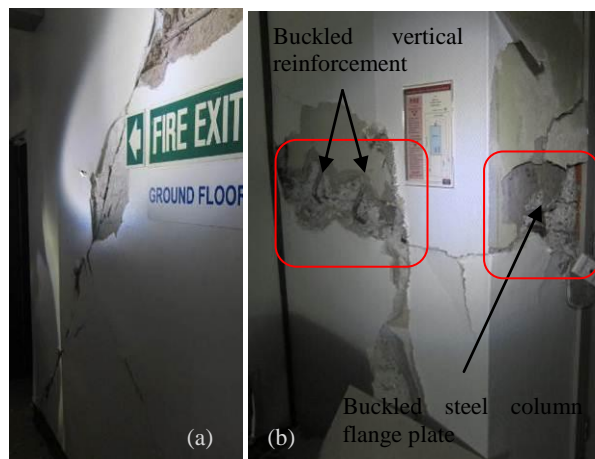
Figure 16: Typical shear and flexural failure of RC walls in buildings built prior to the 1970s.

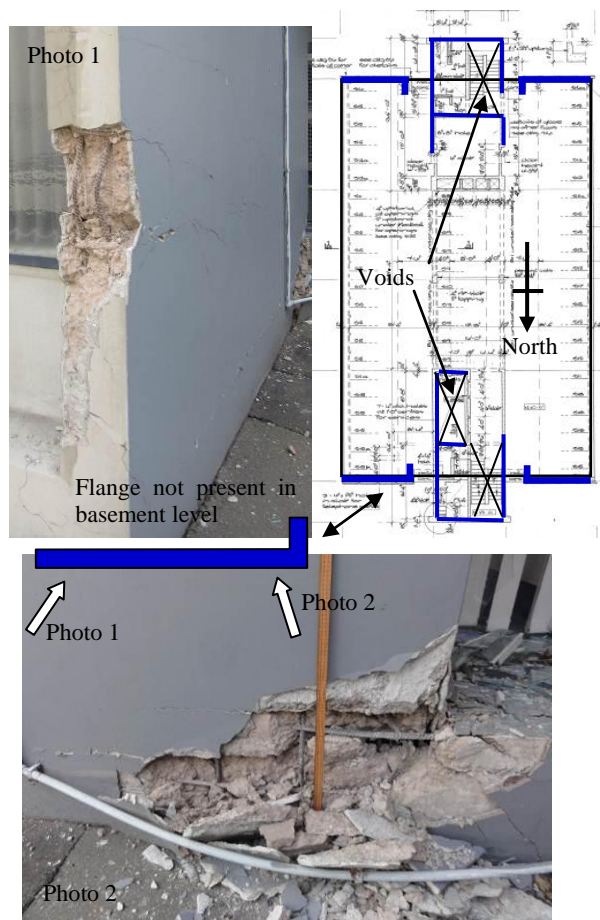
Figure 17: Wall boundary compression zone crushing and buckling failure.

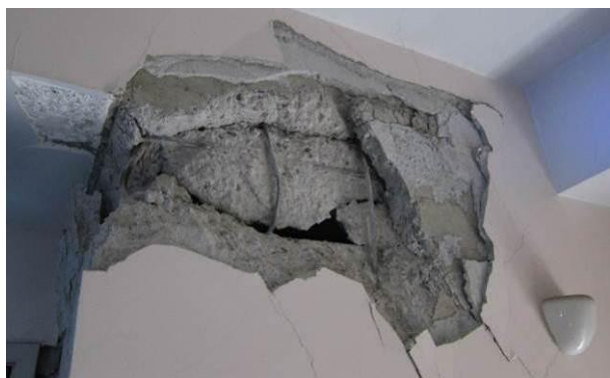
Figure 18: *Compression zone failure of pre-1970s RC walls. Photo is taken from the ground floor wall of an early 1960s 9-storey RC building.*

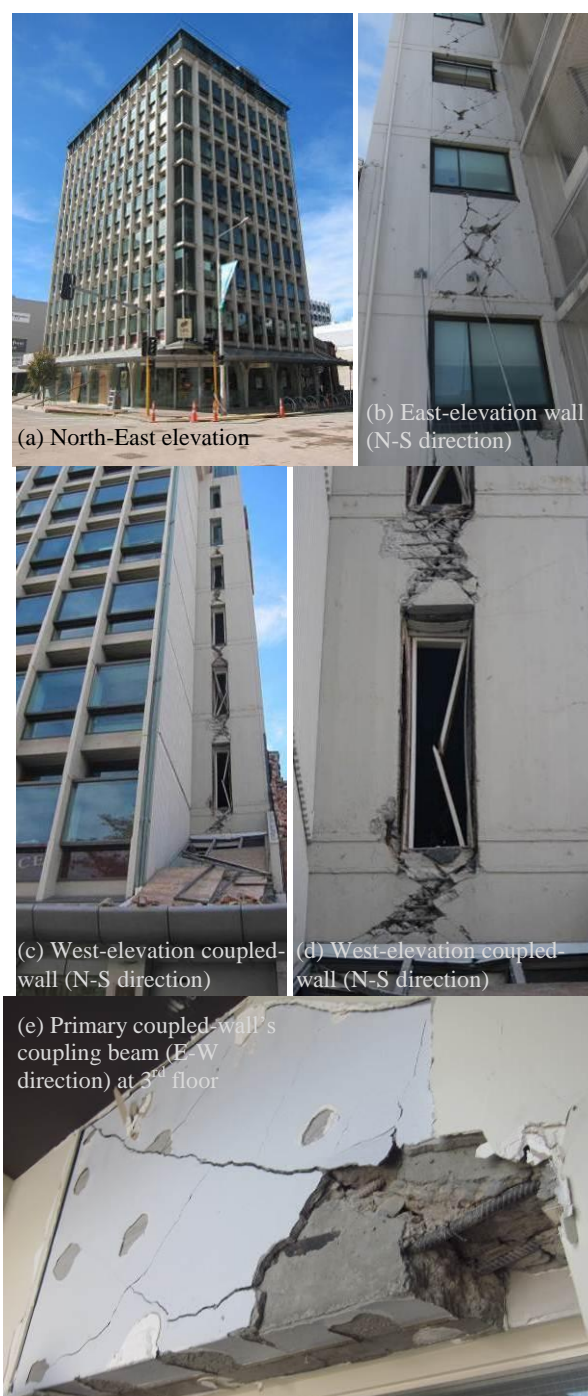
Figure 19: *a) Seven-storey 1960s coupled-RC walls building with significant damage on the coupling beams. b) Shear walls damaged at East elevation; c-d) Coupled-wall damage at the West elevation; e) Damaged coupling beam at the internal coupled-walls (East-West direction).*

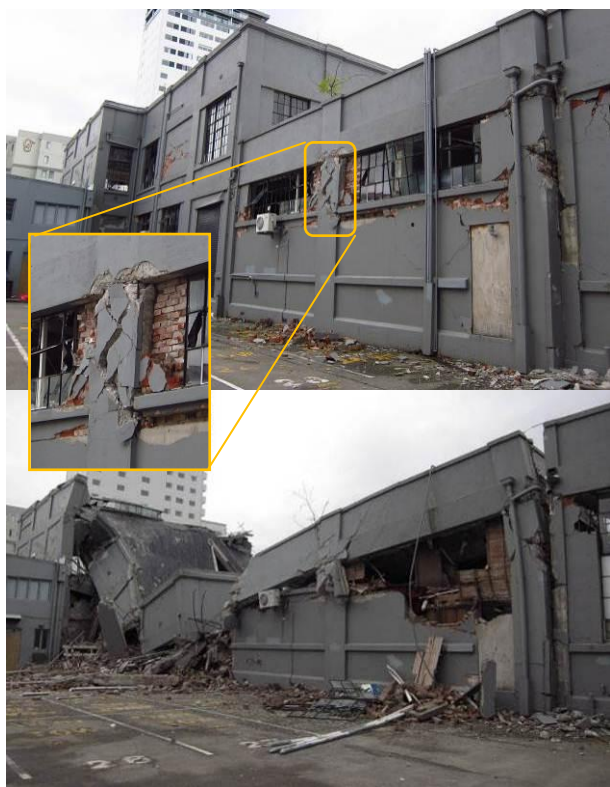
Figure 20: Reinforced concrete frame buildings collapse/damage patterns: Pre-1930s three-storey RC frame with masonry infill a) Survived the 22 February 2011 M_w 6.2 earthquake; b) Collapsed after the 13th June M_w 6.0 aftershock; insert: short column failure.

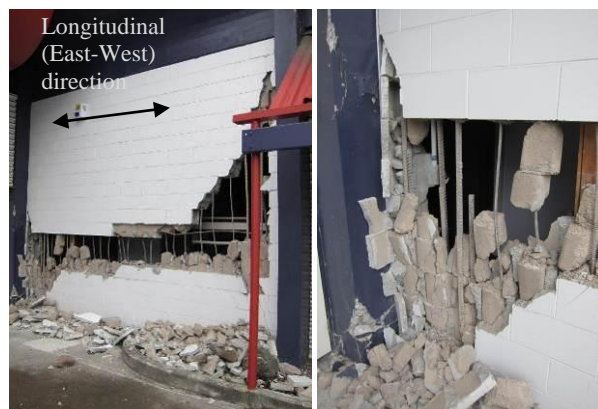
Figure 21: Flexural-shear damage of a RC masonry infill wall within two-storey RC frames.

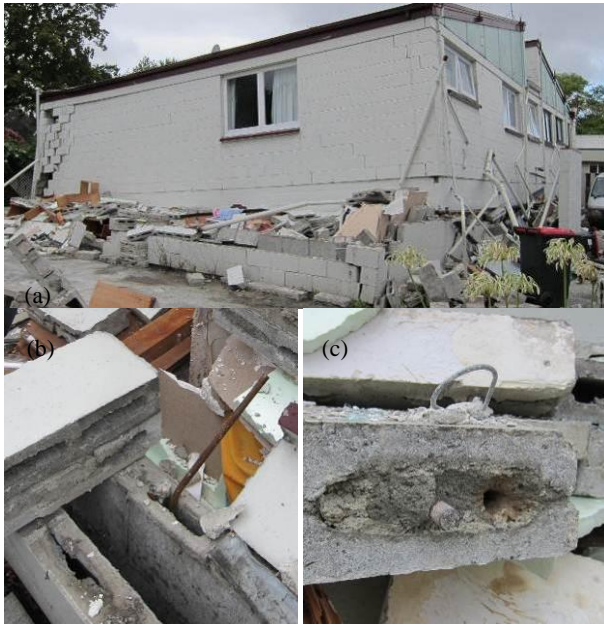
Figure 23: a) Soft-storey collapse of a 2-storey residential RCM building. (b-c) Anchorage pull-out failure of the lapped vertical reinforcement.

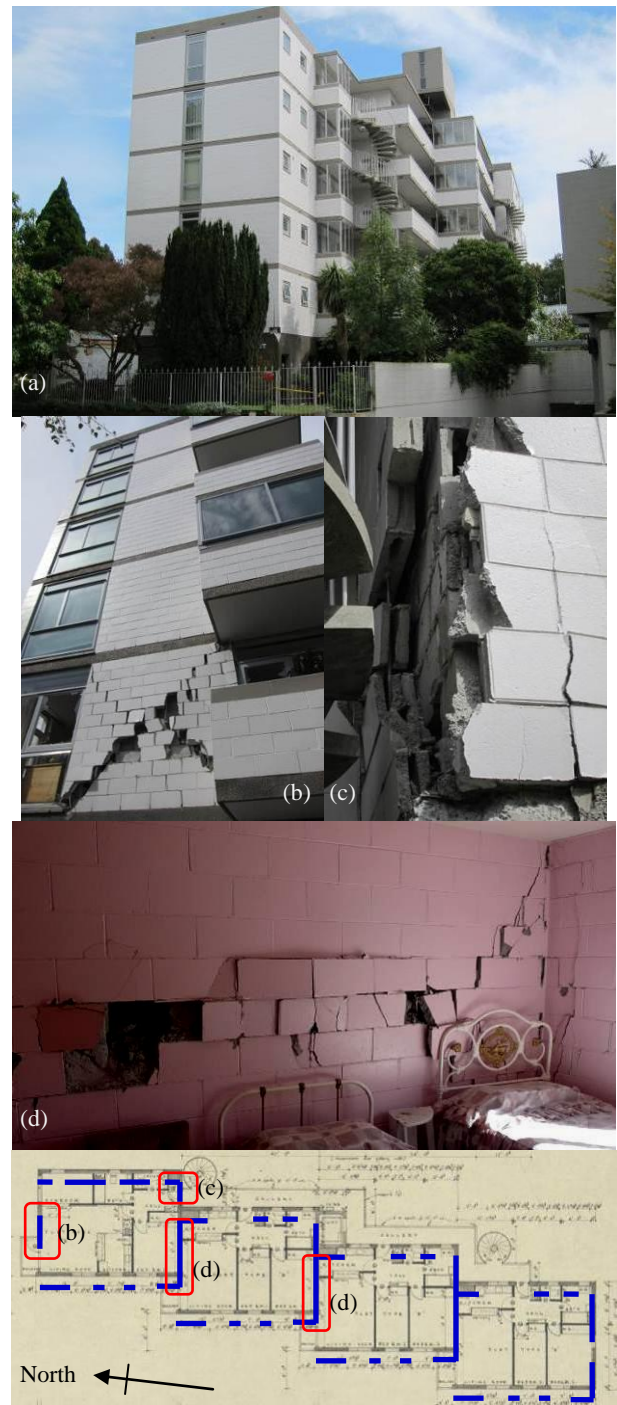
Figure 24: Typical shear and compressive failure of reinforced concrete masonry walls construction.

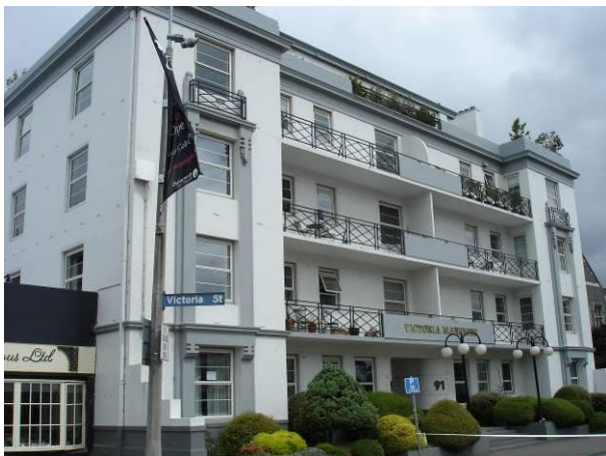
Figure 25: a) 4-storey Victoria Mansion (1935), with RC walls or possibly RC frame with infill walls, had limited structural damage; (b) 4-storey RC frame/wall National Bank / Isaac House (1926) showed limited cracking and damage from preliminary inspection.

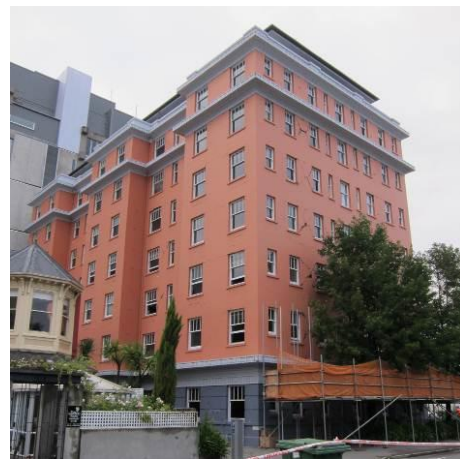
Figure 26: The 8-storey St Elmo Courts (1935) suffered heavy masonry infill walls damage.

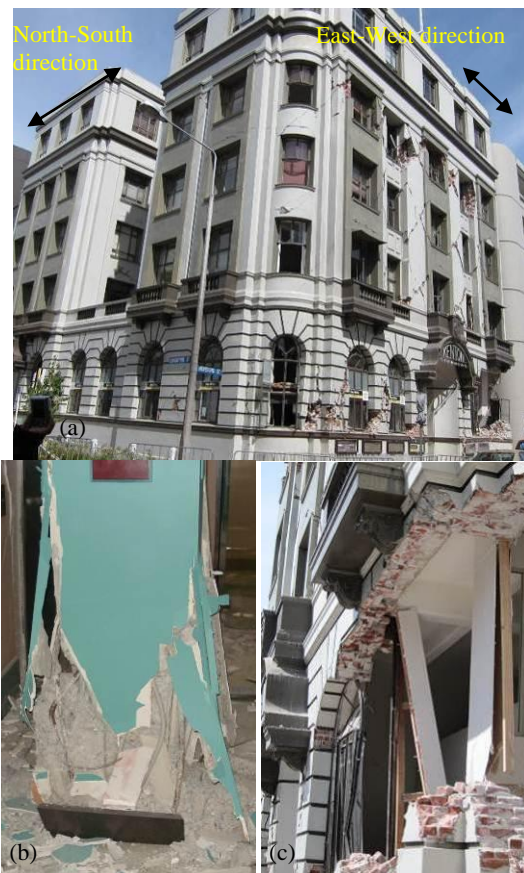
Figure 27: The 6-storey Kenton Chambers (1929) with perimeter URM walls and interior RC frames.

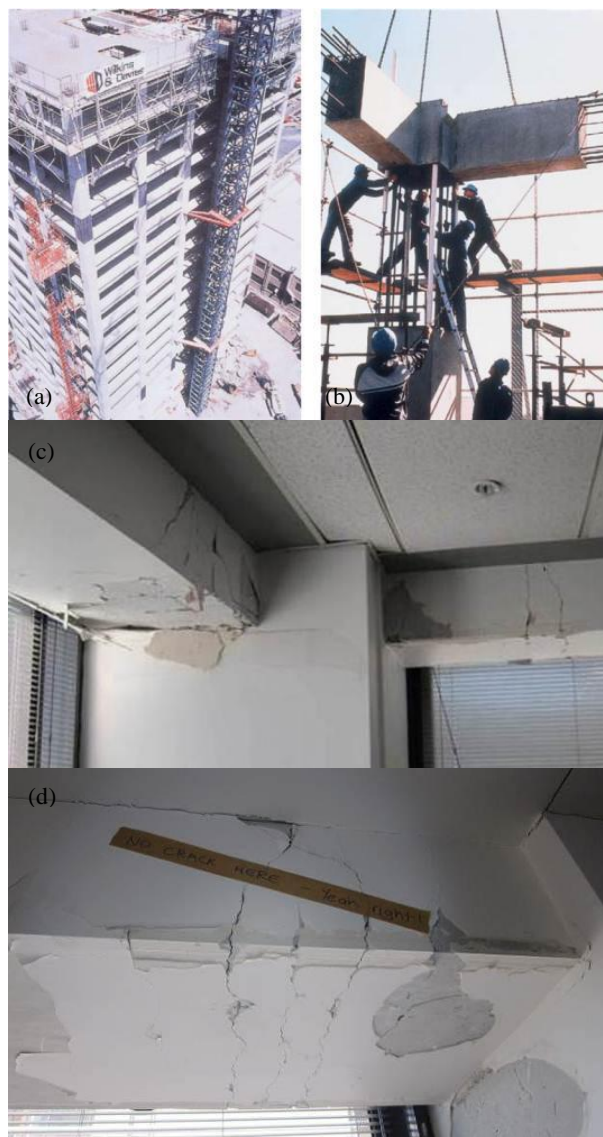
Figure 28: Post-1970s RC moment-resisting frame buildings collapse/damage patterns: a-b) 22-storeys precast concrete frame building under construction; c) Two-way plastic hinging on 5th floor of a 22-storeys office tower; d) Beam plastic hinge mechanism occurred in both the 4 September and 22 February earthquakes.

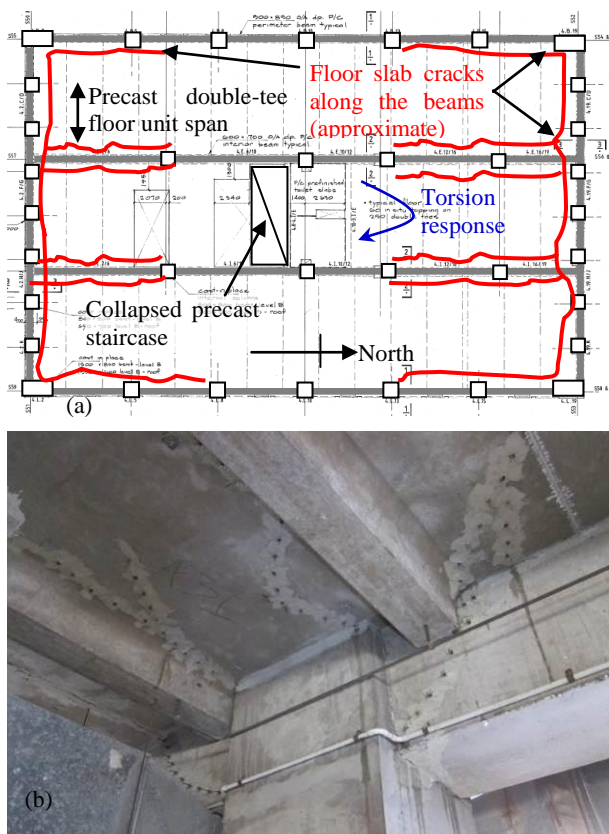
Figure 29: Ductile RC perimeter frames building with beams hinging, floor slab damage and collapsed precast staircase at upper levels (8th to 11th floor). Photo (b) is showing the crack repair done after the 4 September earthquake.

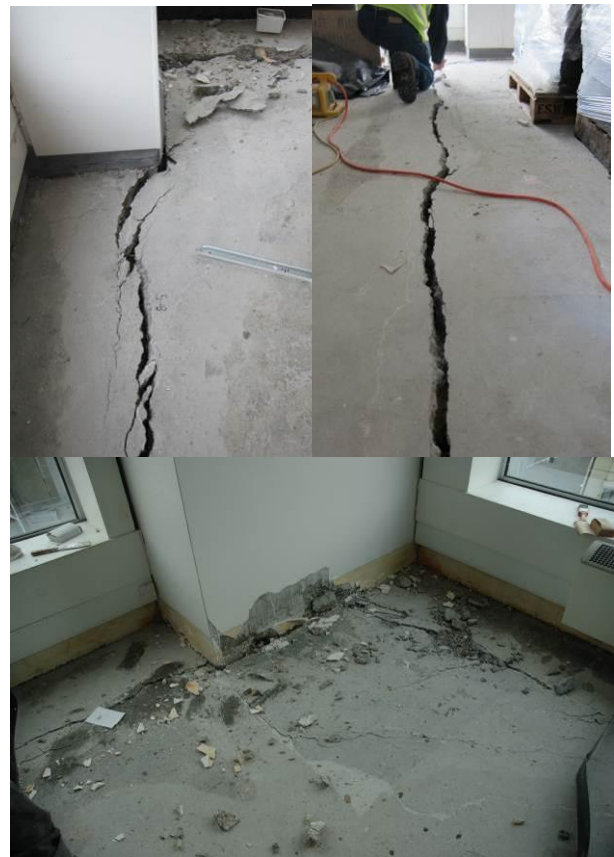
Figure 30: Extensive damage of floor diaphragm and loss of floor support for building in Figure 29 due to the beam-elongation effects of concrete frame inelastic response.

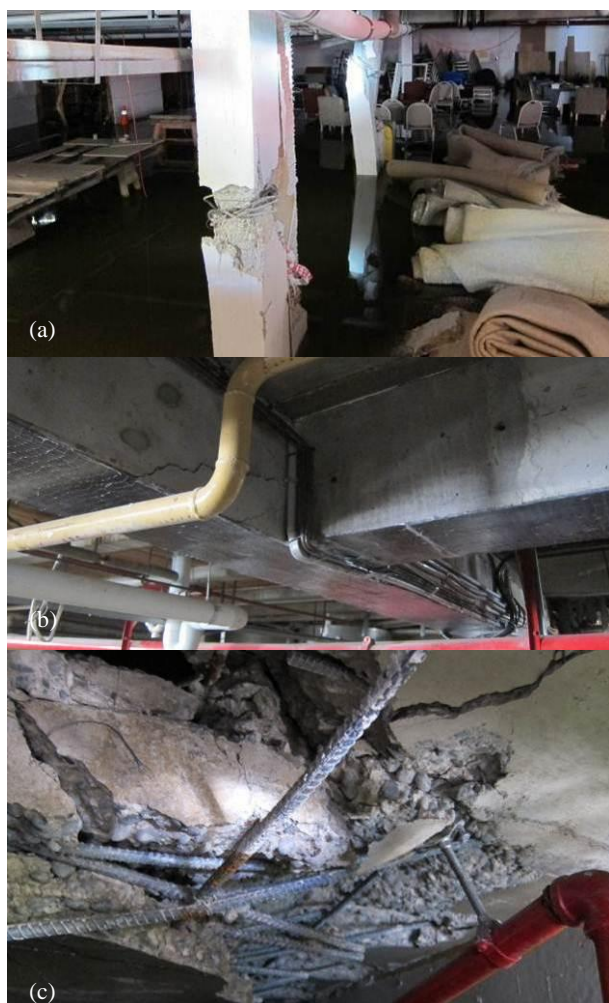
Figure 32: Vertical irregularity resulting in (a) severe basement columns shear-axial failure; (b) transfer beam repair and damage; c) Ground floor transfer slab failure.

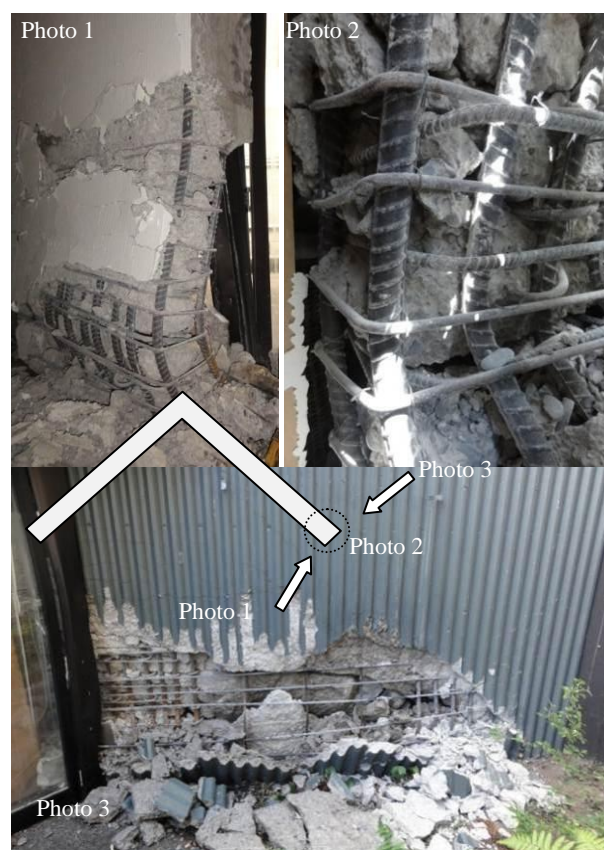
Figure 33: Seven-storey 1980s office block with significant compression failure of the V-shaped RC shear wall.

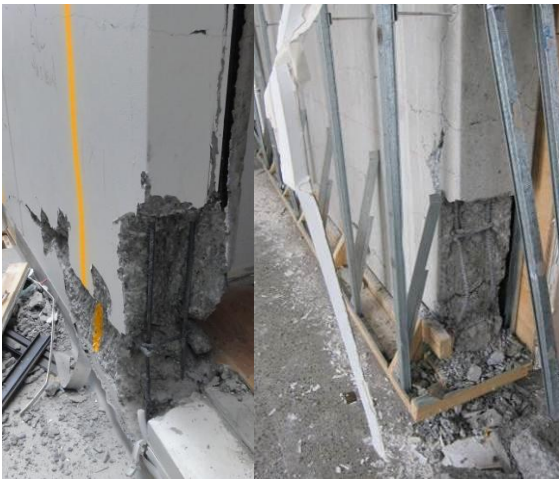
Figure 34: Bar buckled and fractured in lightly reinforced slender RC shear wall: a) North-South Wall; b) East-West Wall.

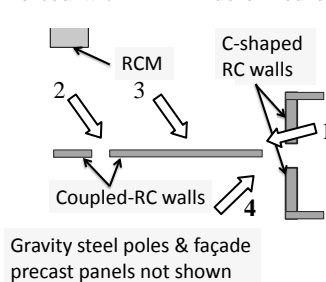
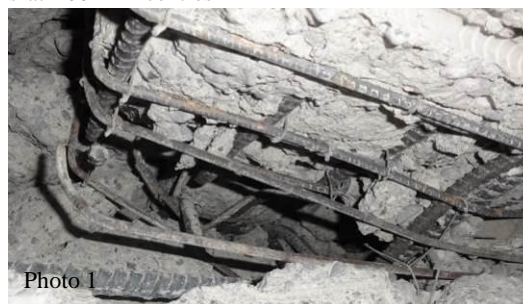
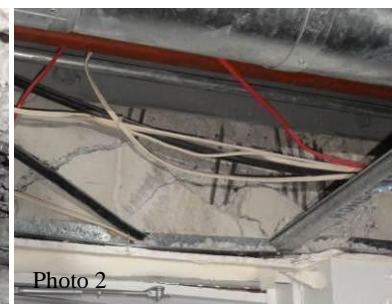
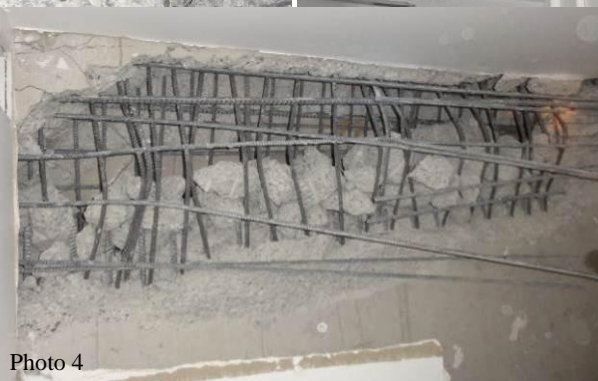
Figure 35: Boundary bar fracture and slender wall shear-axial failure in the Ground Floor of an 8-storey plus basement residential apartment building built in the 2000-2010.

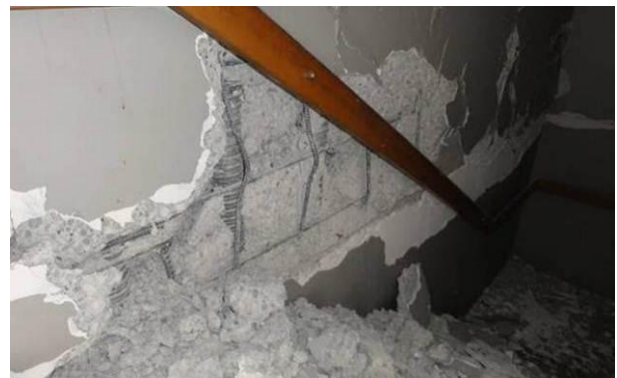
Figure 36: Failure of unconfined grouted duct splice for longitudinal bars of precast concrete walls.

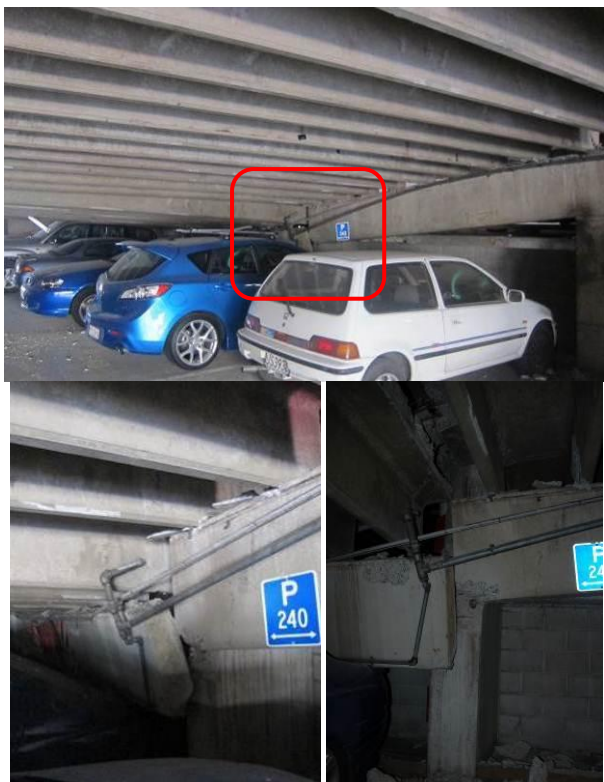
Figure 37: Localised collapse and loss of gravity support at the 1st floor at the 5-storey car park due to corbel failure.

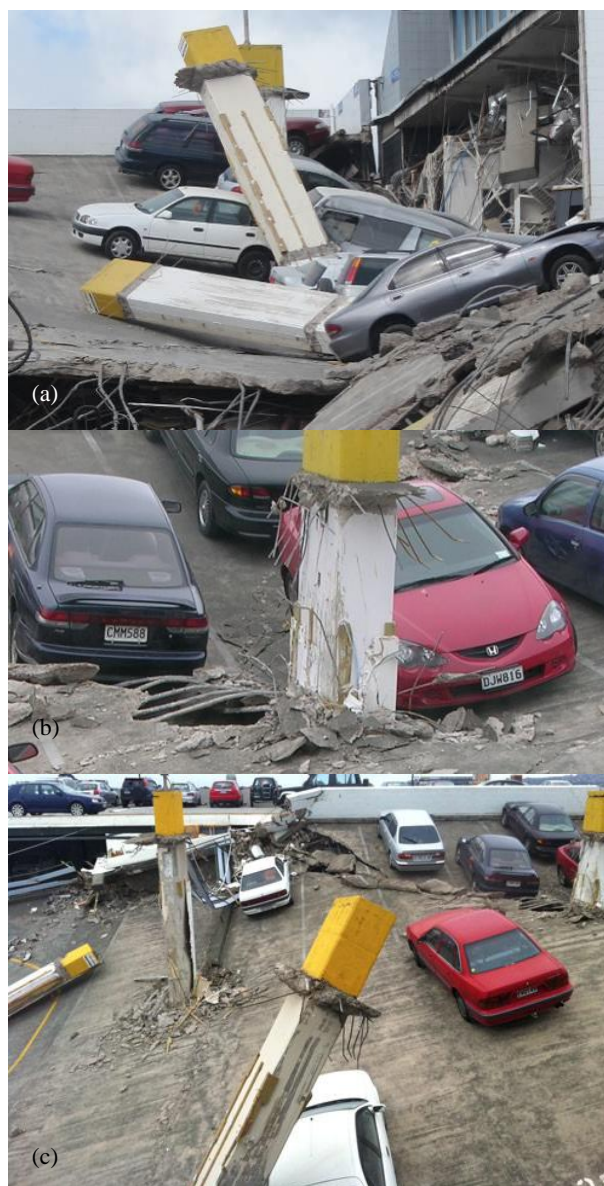
Figure 38: Punching shear failure of a 5-storey post-tensioned flat-slab and columns building. (Photograph (c) is courtesy of David Swanson).

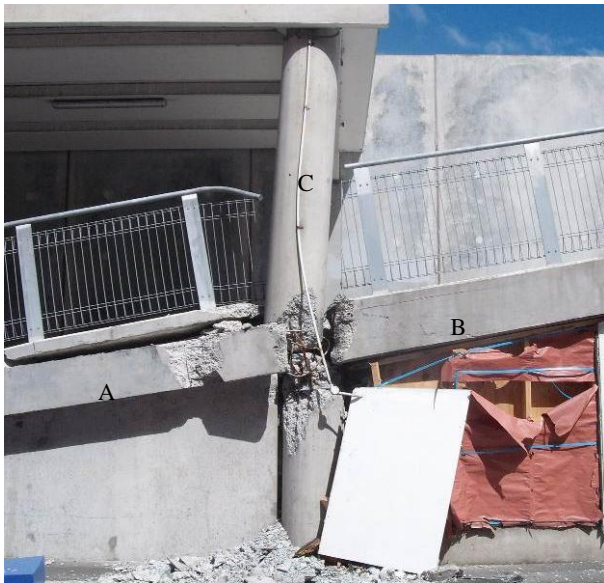
Figure 39: Lack of displacement allowance for ‘simply-supported’ elements such as car park ramp leading to a column shear failure.

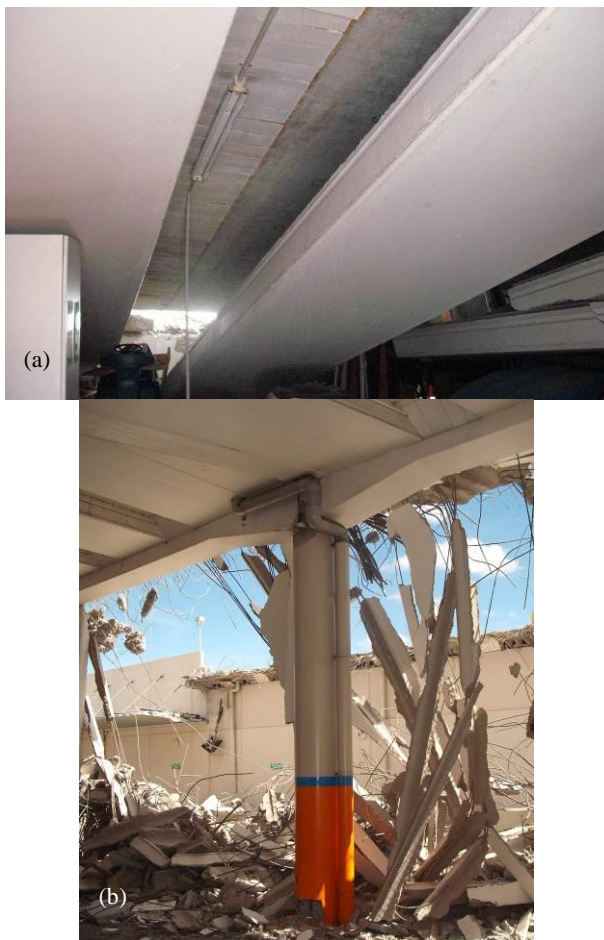
Figure 40: Lack of displacement allowance for ‘simply-supported’ elements leading to failure and collapse of car-park ramp: a) Unseating of hollow core unit at one-simply supported end; b) Collapse of one bay of ramp, possibly due to compressive buckling and pounding with the abutment. Photographs are courtesy of John Marshall [38].

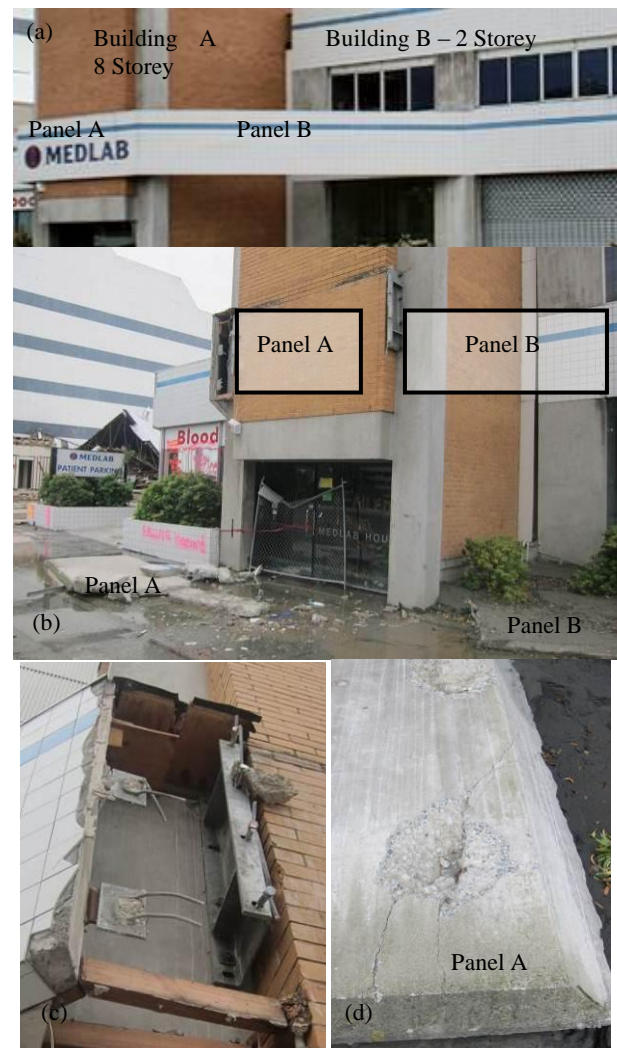
Figure 41: Failure of heavy precast concrete panel connections: a) Panels prior to the earthquake; b) collapse of the panel at the entrance; c) Close-up view of the two anchorage types; d) Pull-out concrete cone on the panel.

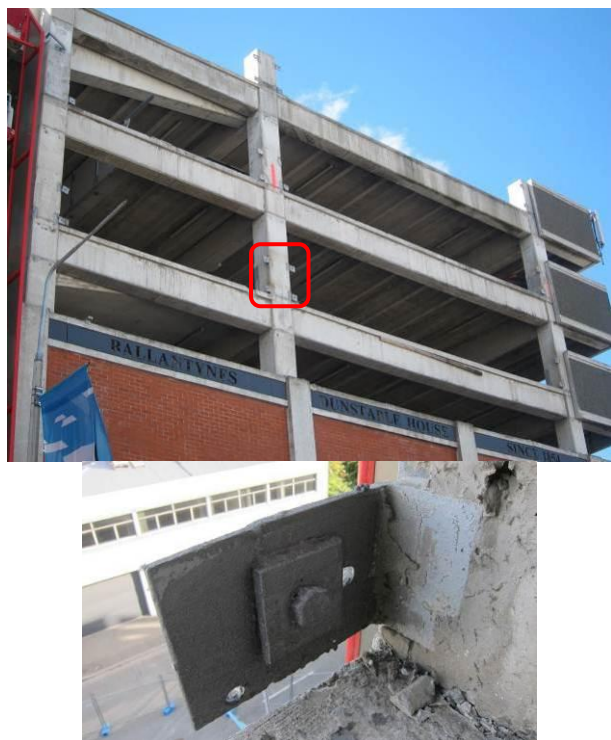
Figure 42: Failed precast concrete façade panels “welded and slotted-bolt” connection (construction error).

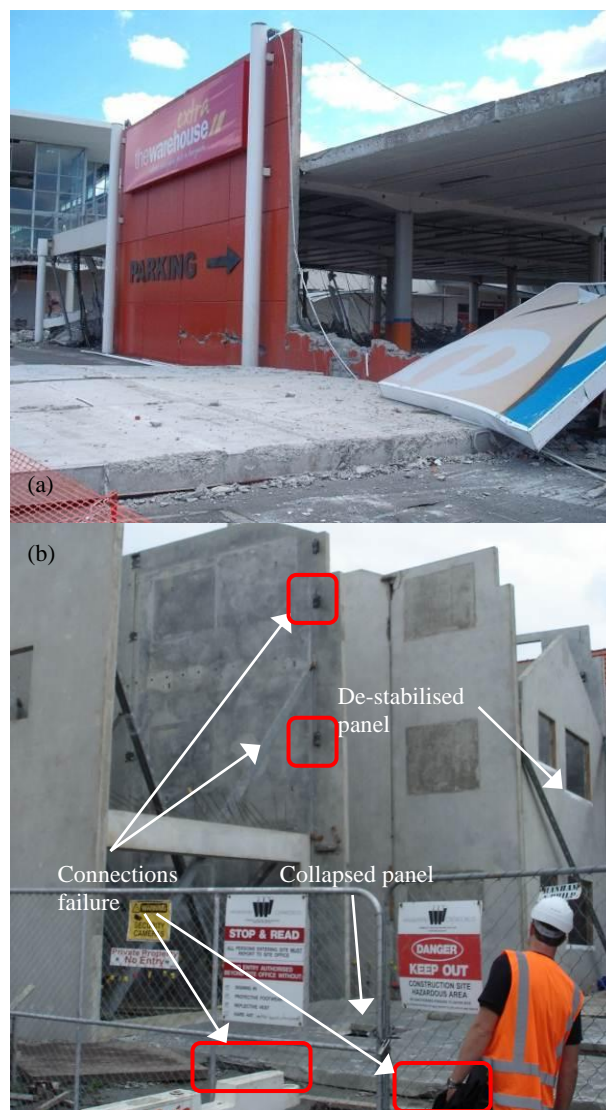
Figure 43: Collapse of precast concrete tilt-up structural walls: a) Localised flexural failure along the base of the wall panel; b) Destabilisation of tilt-up concrete wall under construction.

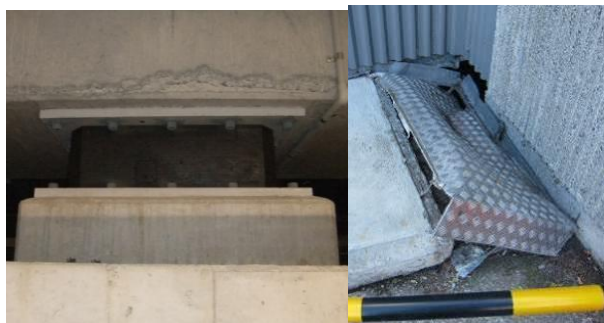
Figure 44: a) A Lead-Rubber-Bearing isolation device with near zero residual deformation (compared to 50mm after the 4 September earthquake); b) The seismic moat cover on the ground level indicates significant lateral movement during the earthquake.

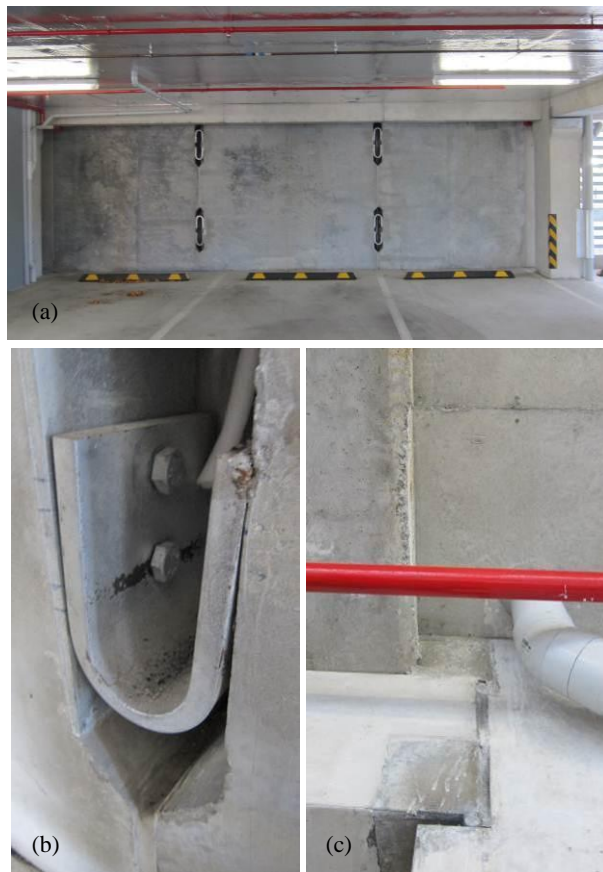
Figure 45: Self-centring precast concrete system implemented for a newly constructed private hospital facility: a) Coupled post-tensioned rocking walls; b) Yield lines observed in the U-shaped flexural plates coupling the post-tensioned rocking walls; c) No residual crack along the rocking interface at the beam-column connection.

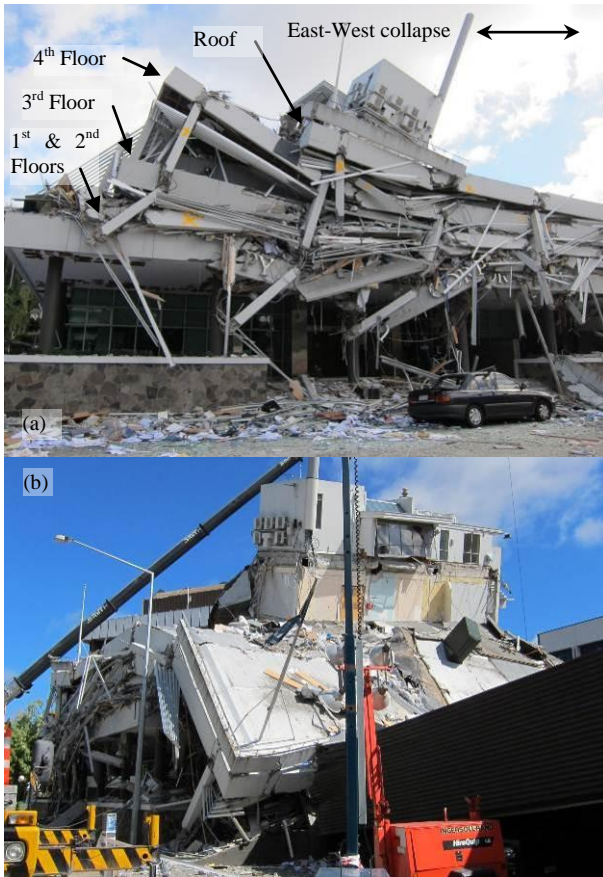
Figure 49: a) Southern elevation of the collapsed PGC building; b) South-Eastern elevation of the collapsed PGC building.

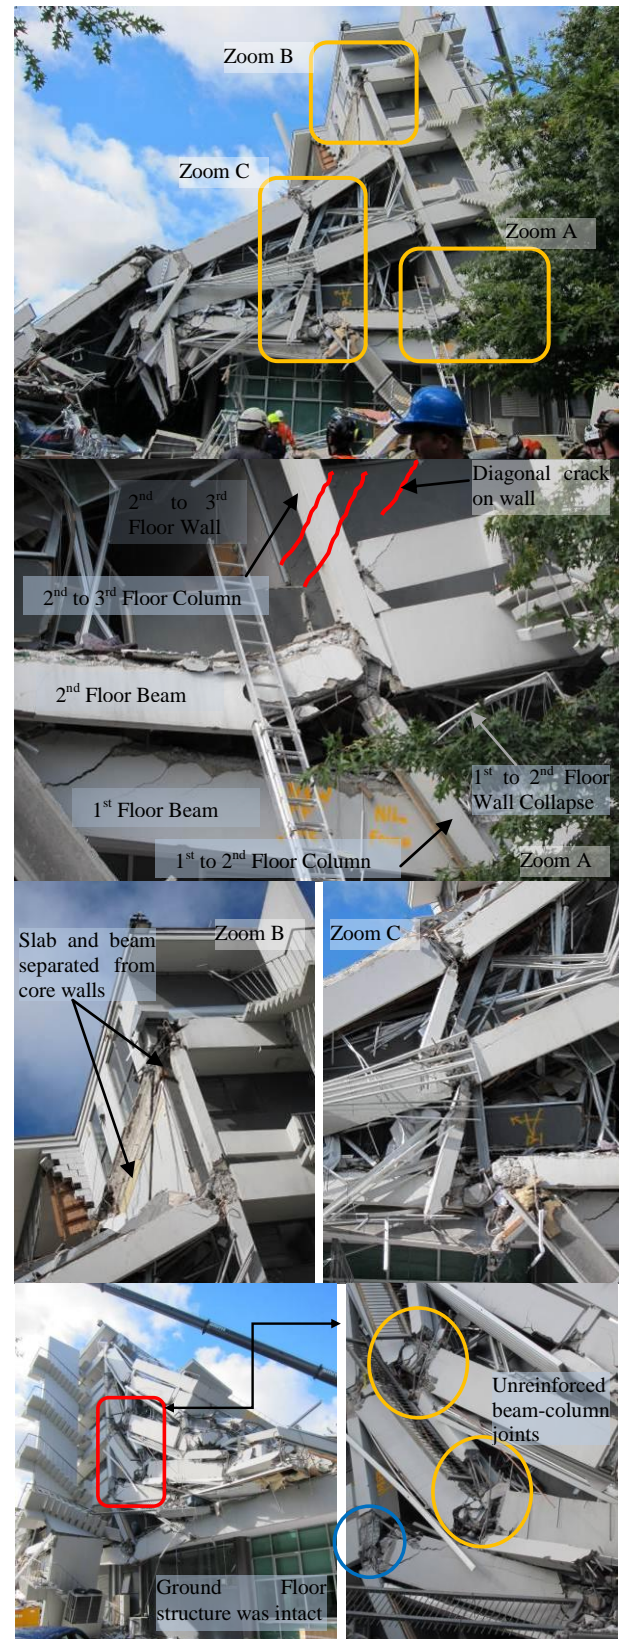
Figure 50: Various failure mechanisms observed on the Northern elevation of the collapsed PGC building.

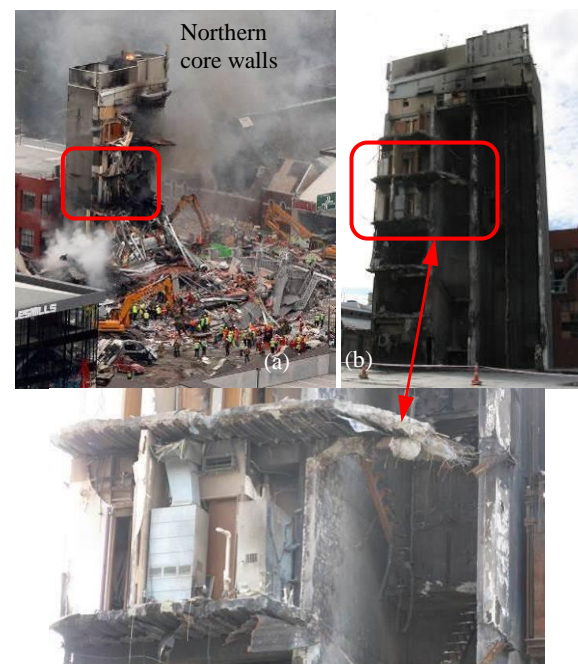
Figure 54: Northern RC core walls of the CTV Building. Photograph (a) is taken on the 23rd February 2011 by Mark Mitchell published in New Zealand Herald. Photograph (c) illustrates the remains of the Hi-Bond floor slab deck at 3rd and 4th Floors.

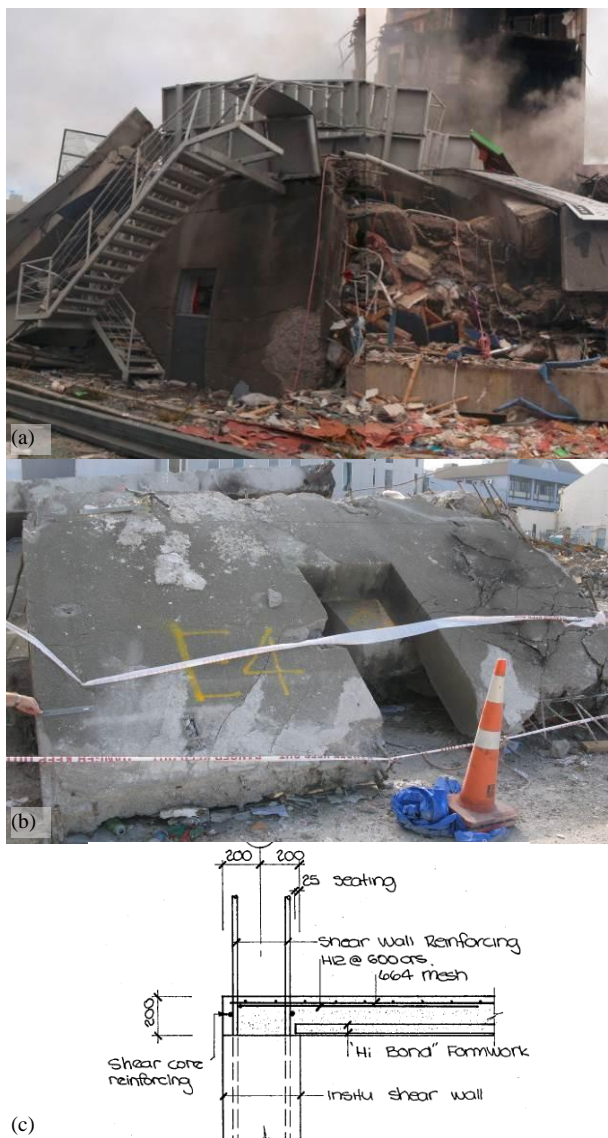
Figure 55: Coupled walls on the Southern side: a) the coupled walls remain intact on the Ground Floor with limited flexural or shear cracking; b) All six pairs of the coupled-walls were accounted for during a post-demolition inspection – limited damage was observed on these walls; c) the connection detail of slab-to-coupled walls.

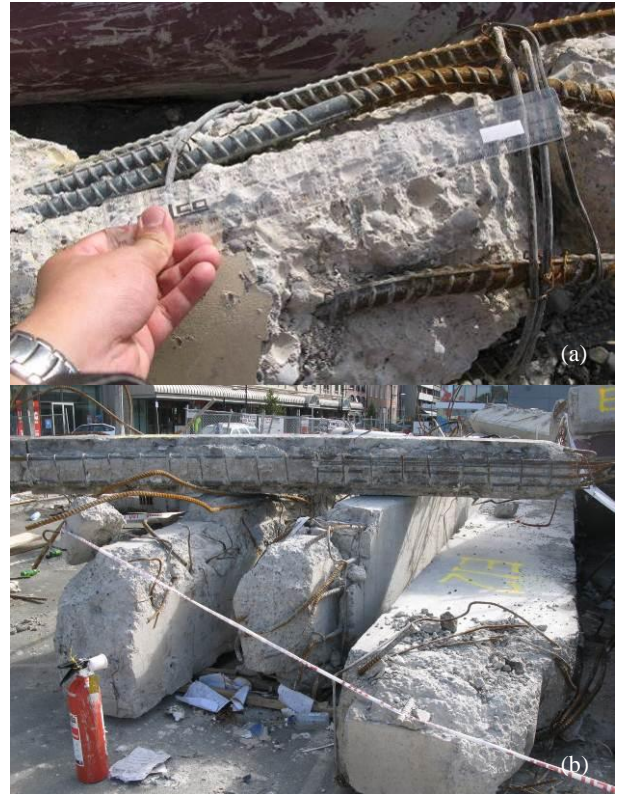
Figure 56: Post-demolition inspection of the RC frame elements: a) RC column with R6 spiral ties at 250 mm centre and six-HD20 longitudinal reinforcement.
