SEISMIC PERFORMANCE OF REINFORCED CONCRETE BUILDINGS IN THE 22 FEBRUARY CHRISTCHURCH (LYTTELTON) EARTHQUAKE

Weng Y. Kam¹, Stefano Pampanin², Ken Elwood³

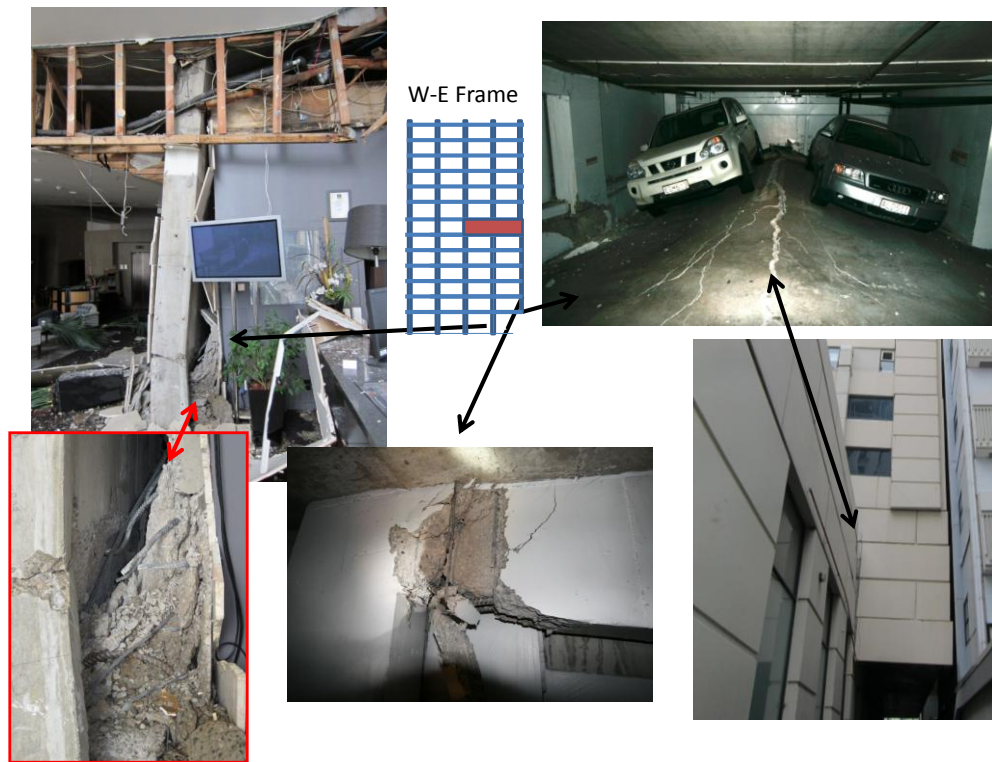
Figure 59: Grand Chancellor Hotel: The shear-axial failure of the RC wall D5-6 and the resulting damage pattern.

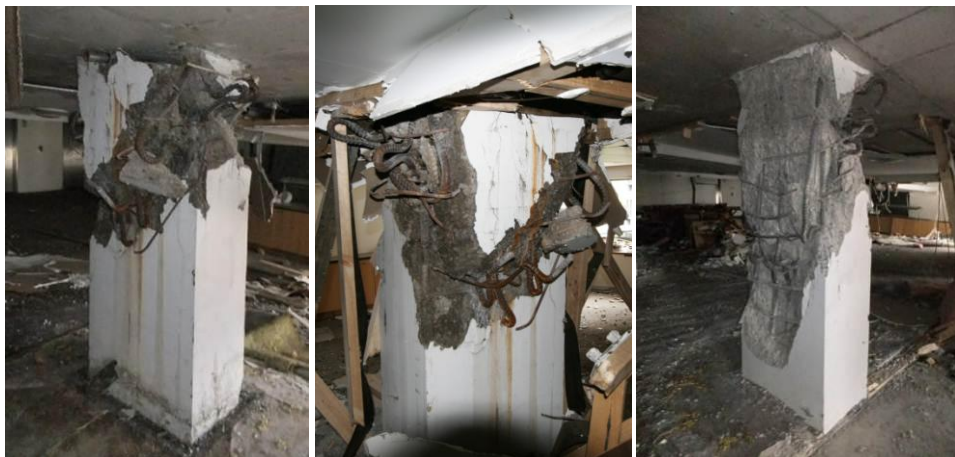
Figure 60: Grand Chancellor Hotel: The shear-axial failure of the RC columns below the transfer girders at Level 10 and 11.

Figure 67: Emergency stabilisation repair of the columns with axial-shear failure. See Figure 60 for the pre-repair condition of the columns.

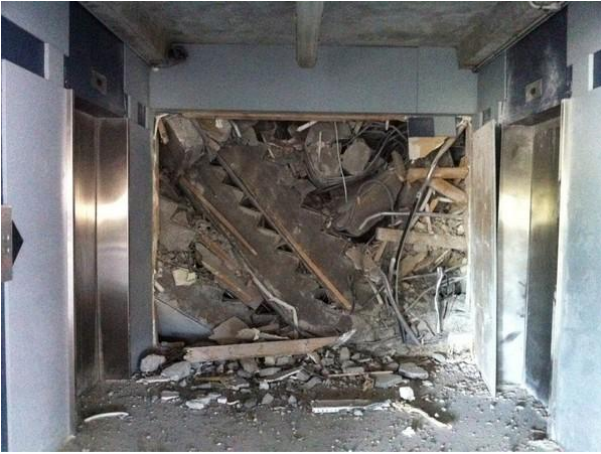
Figure 61: Collapse of precast concrete staircase in multi-storey buildings.

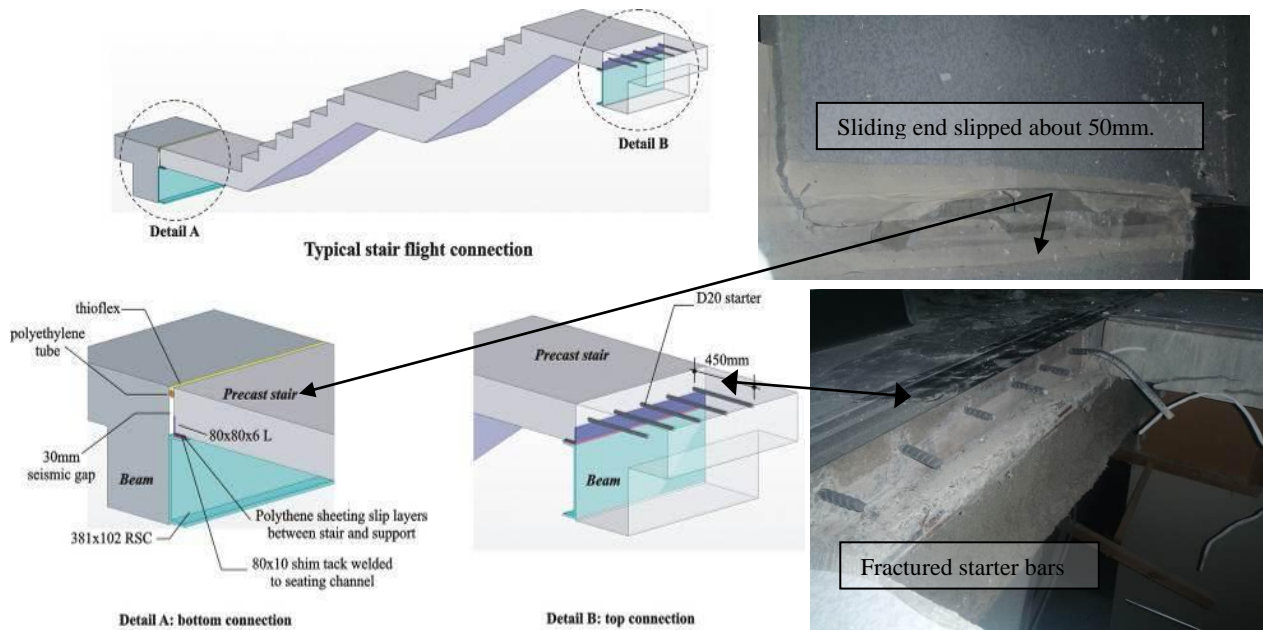
Figure 63: Typical detailing and damage of staircase with partially pinned-slide bottom connection; cast-in-situ connection at top with longitudinal starter bars lapped at landing. Image (left) is courtesy of Umut Akguzel and photographs (right) are from USAR engineers.

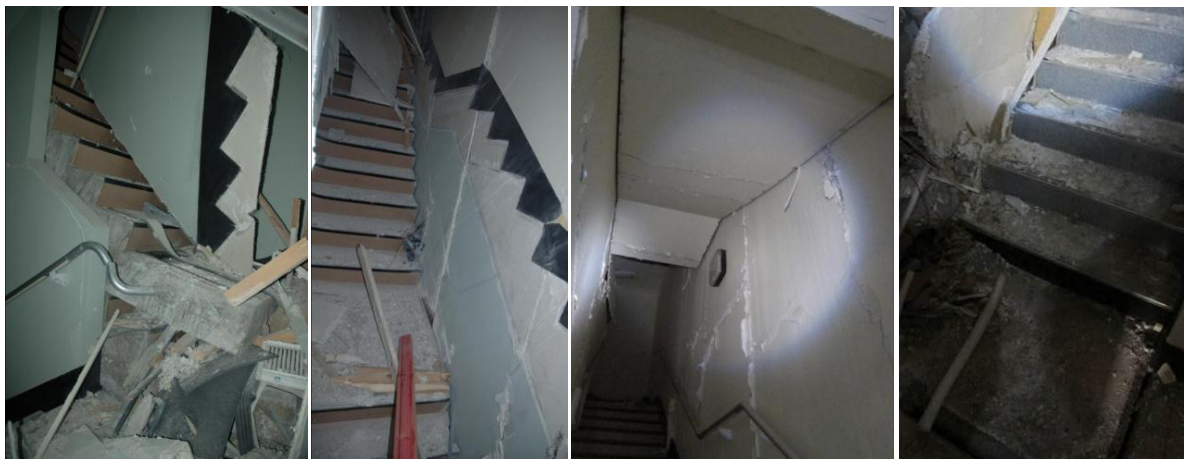
Figure 64: Collapse of one out of two internal scissor staircases in a multi-storey RC frame building. The staircase was under repair work for the damage sustained in the 4 September 2010 earthquake.

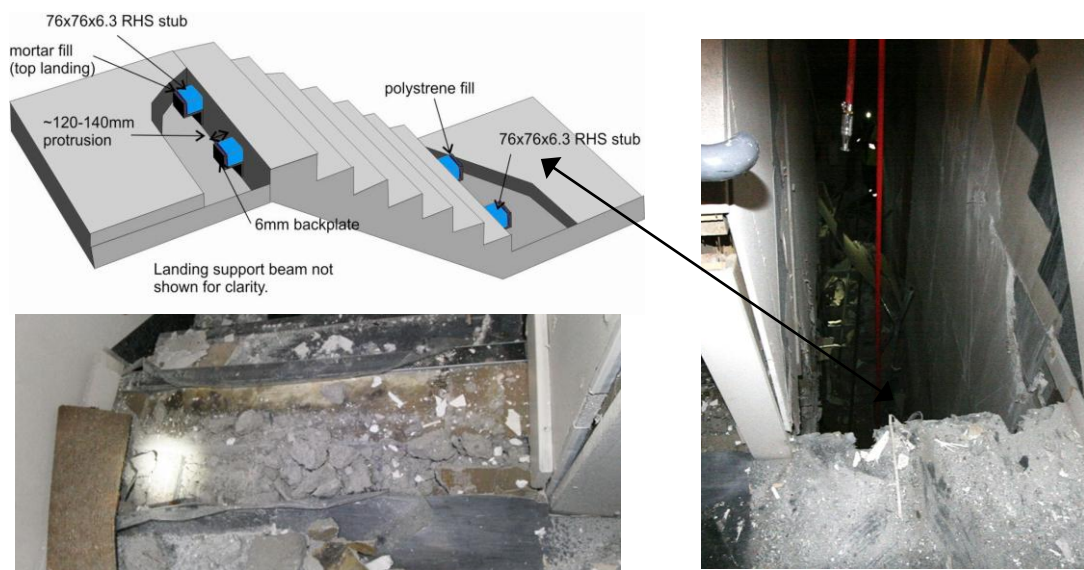
Figure 65: Alternative typical detailing of staircase- Type A - Pinned-slide connections with RHS shear keys on both ends and observed failures. (Damage photographs are courtesy of USAR engineers).

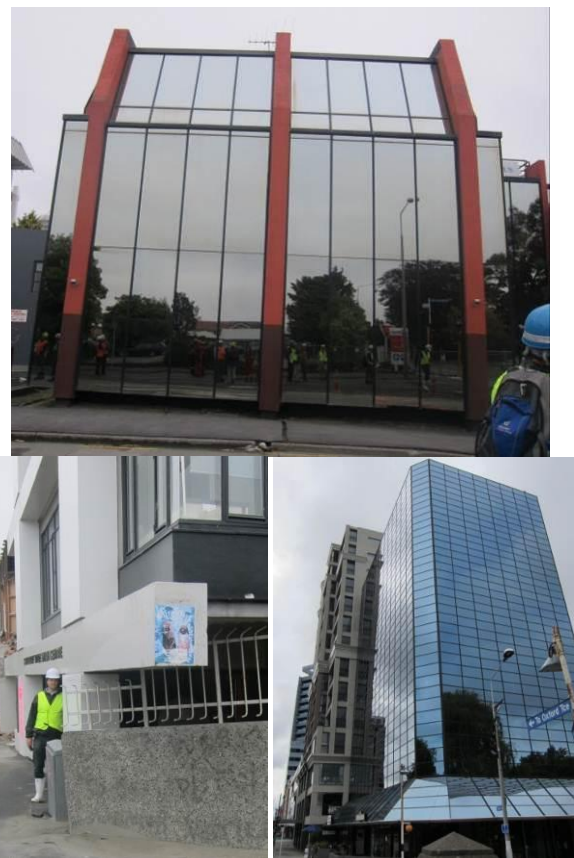
Figure 72: Liquefaction induced differential settlement resulting in significant tilting of mid- to high-rise buildings of various foundation and soil details: a) Four-storey with shallow foundation; b) Six-storey with shallow foundation; c) Two high-rise buildings with substantial differential settlement and tilting.
