Liquefaction Impacts on Pipe Networks

Short Term Recovery Project No. 6 Natural Hazards Research Platform

**Misko Cubrinovski¹⁾, Matthew Hughes¹⁾, Brendon Bradley¹⁾
Ian McCahon²⁾,
Yvonne McDonald³⁾, Howard Simpson⁴⁾, Rod Cameron⁴⁾,
Mark Christison⁴⁾, Bruce Henderson⁴⁾,
Rolando Orense⁵⁾ and Thomas O'Rourke⁶⁾**

December 2011

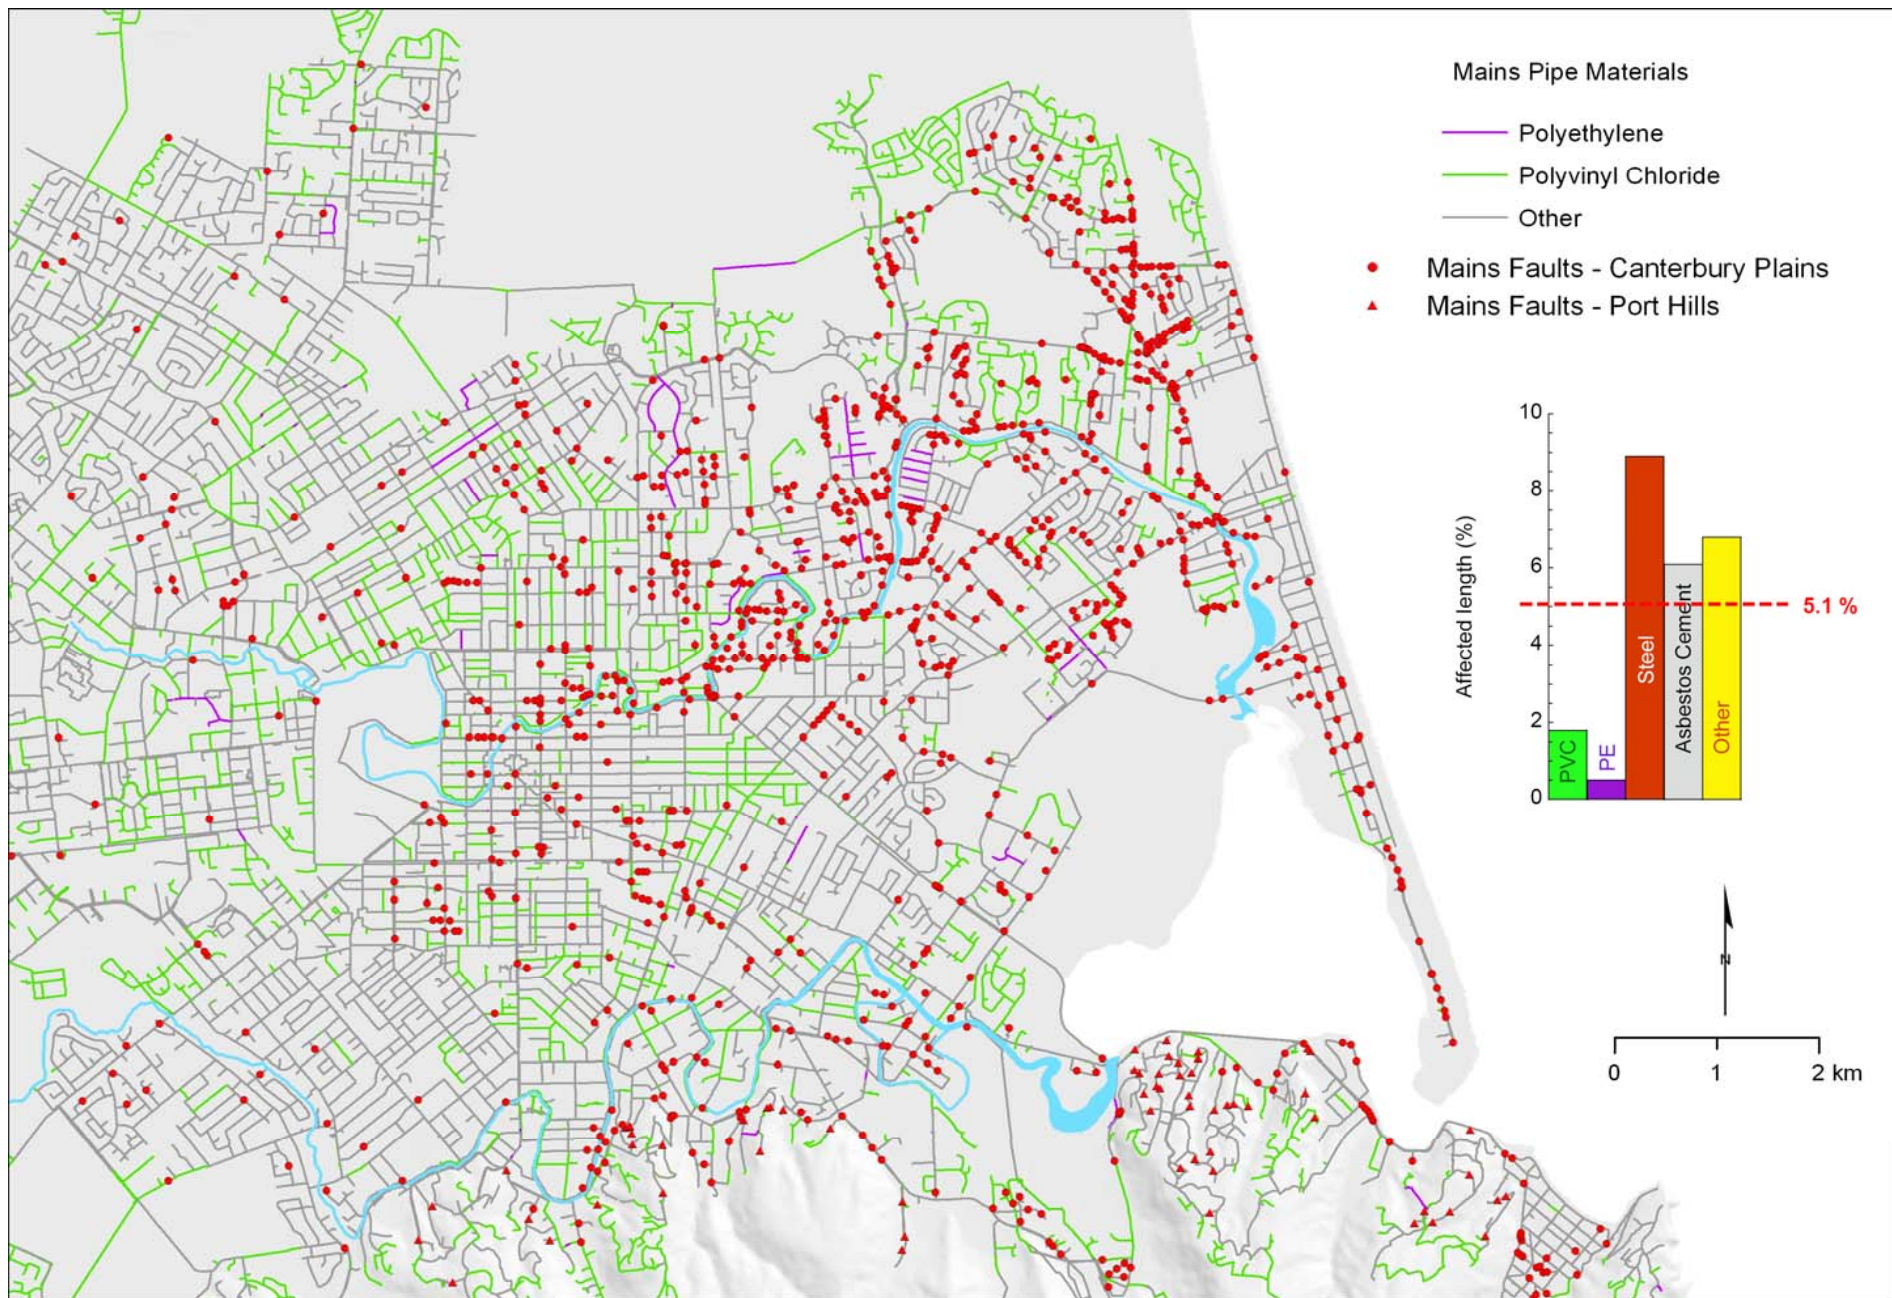
Figure 16 shows the location of repairs/faults on the watermains network following the 22 February 2011 earthquake. In the background GIS layer the pipe materials are indicated with different colours. In the inset of the figure, the performance of different pipe materials is summarized with a bar chart (for areas in the plains, excluding the hills). It shows that 5.1% of the total length of watermains was damaged, or 77.5 km out of 1511 km considered in the analysis. Steel pipes suffered the largest damage (8.9%), followed by AC pipes and other material pipes (6.1% and 6.8%, respectively), whereas much better performing were the PVC (1.8%) and PE (0.5%) pipes. The results of the analyses are summarized in Table 2. It is noted that the sample lengths of PE and S pipes are considered insufficient for a robust statistical analysis and hence the respective results should be treated with caution.

Figure 16. Locations of repairs/faults (indicated by red symbols) on the Christchurch watermains network following the 22 February 2011 earthquake

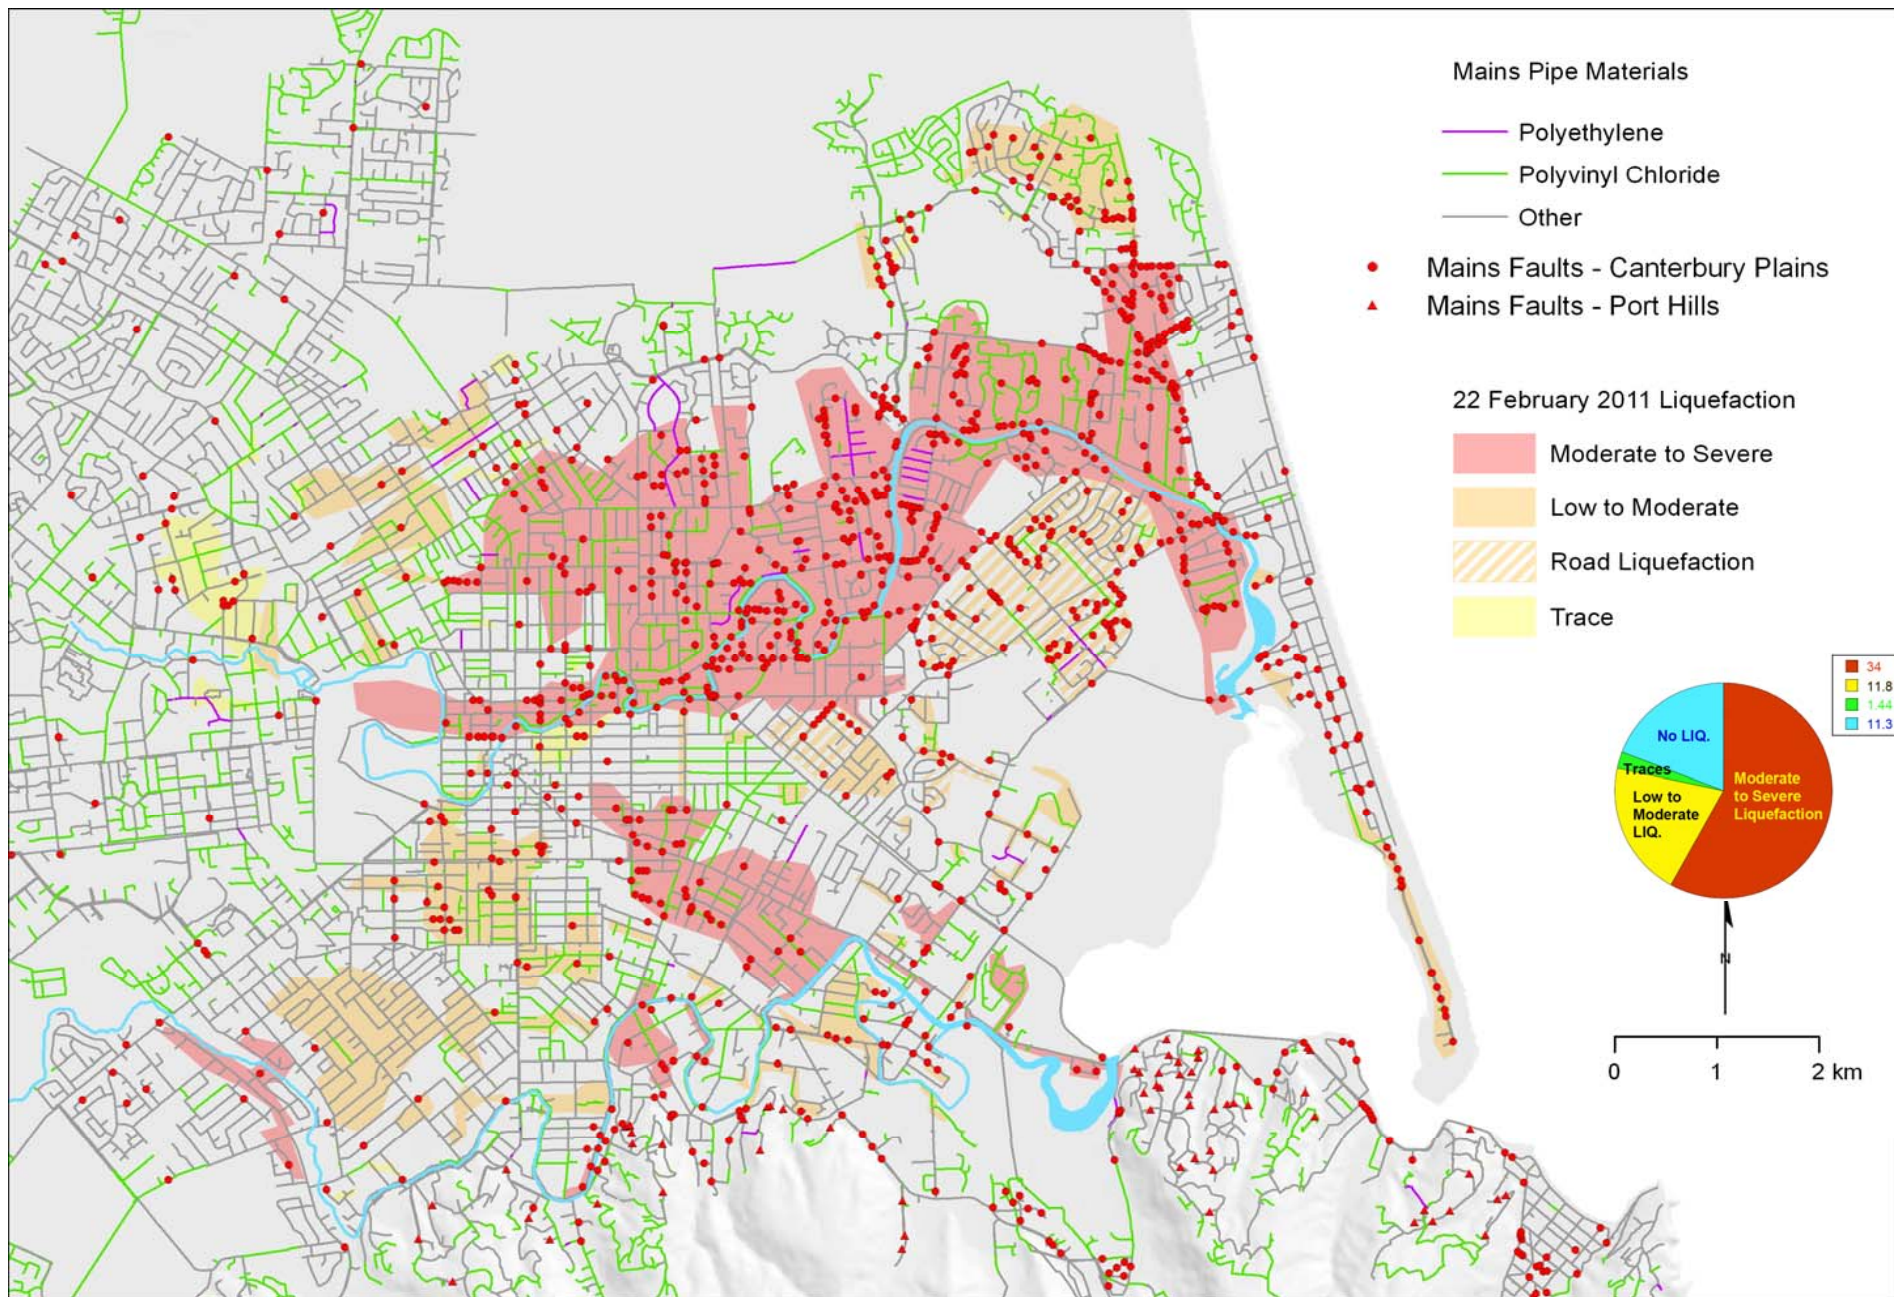
Figure 17 shows the same repairs/faults data for the watermains network and 22 February earthquake with the liquefaction map (Figure 6) shown in the background. Using this setup in the GIS framework, it was possible to calculate and correlate the pipe damage with the observed severity of liquefaction. The pie chart shown in the

inset of Figure 17 indicates that 34 km of the damaged pipes or 58% of the damaged length in the area covered by ground surveying (Figure 6) was in areas of moderate to severe liquefaction, 20.2% were in areas of low to moderate liquefaction, 2.5 % in areas where traces of liquefaction were observed and 19.3% in areas where no signs of liquefaction were observed. Hence, there is a clear link between liquefaction severity and damage to the pipe network. To further scrutinize the correlation between the damage to pipes and liquefaction severity, the results are summarized separately for different materials in Table 2 and with a series of bar charts shown in Figure 18. These results indicate the following:

Figure 17. Locations of repairs/faults (red symbols) on the Christchurch watermains network and areas of liquefaction following the 22 February 2011 earthquake

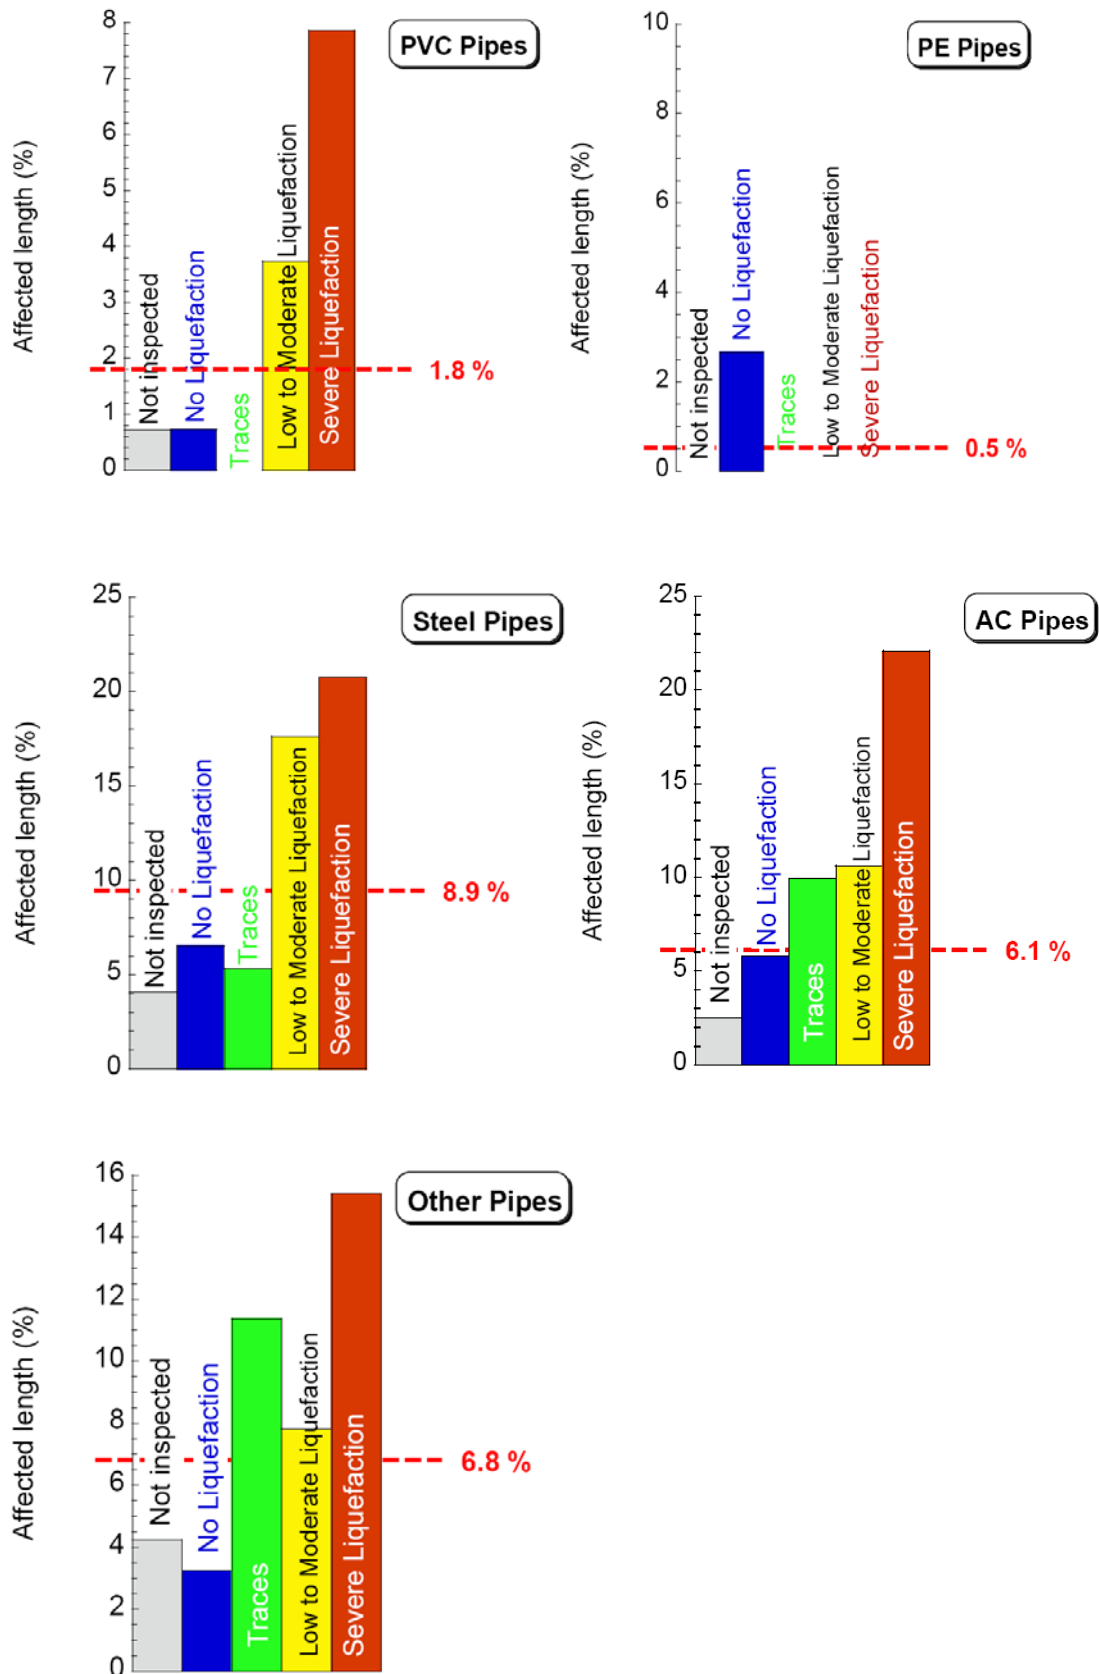
- For all pipe materials except PE pipes, there is a clear increase in the affected length (percentage of damage) with increasing liquefaction severity

Figure 18. Percentage of length damaged for water mains due to the 22 February earthquake, for different pipe materials and liquefaction severity (dashed red lines represent the average affected length across all ground damage levels).

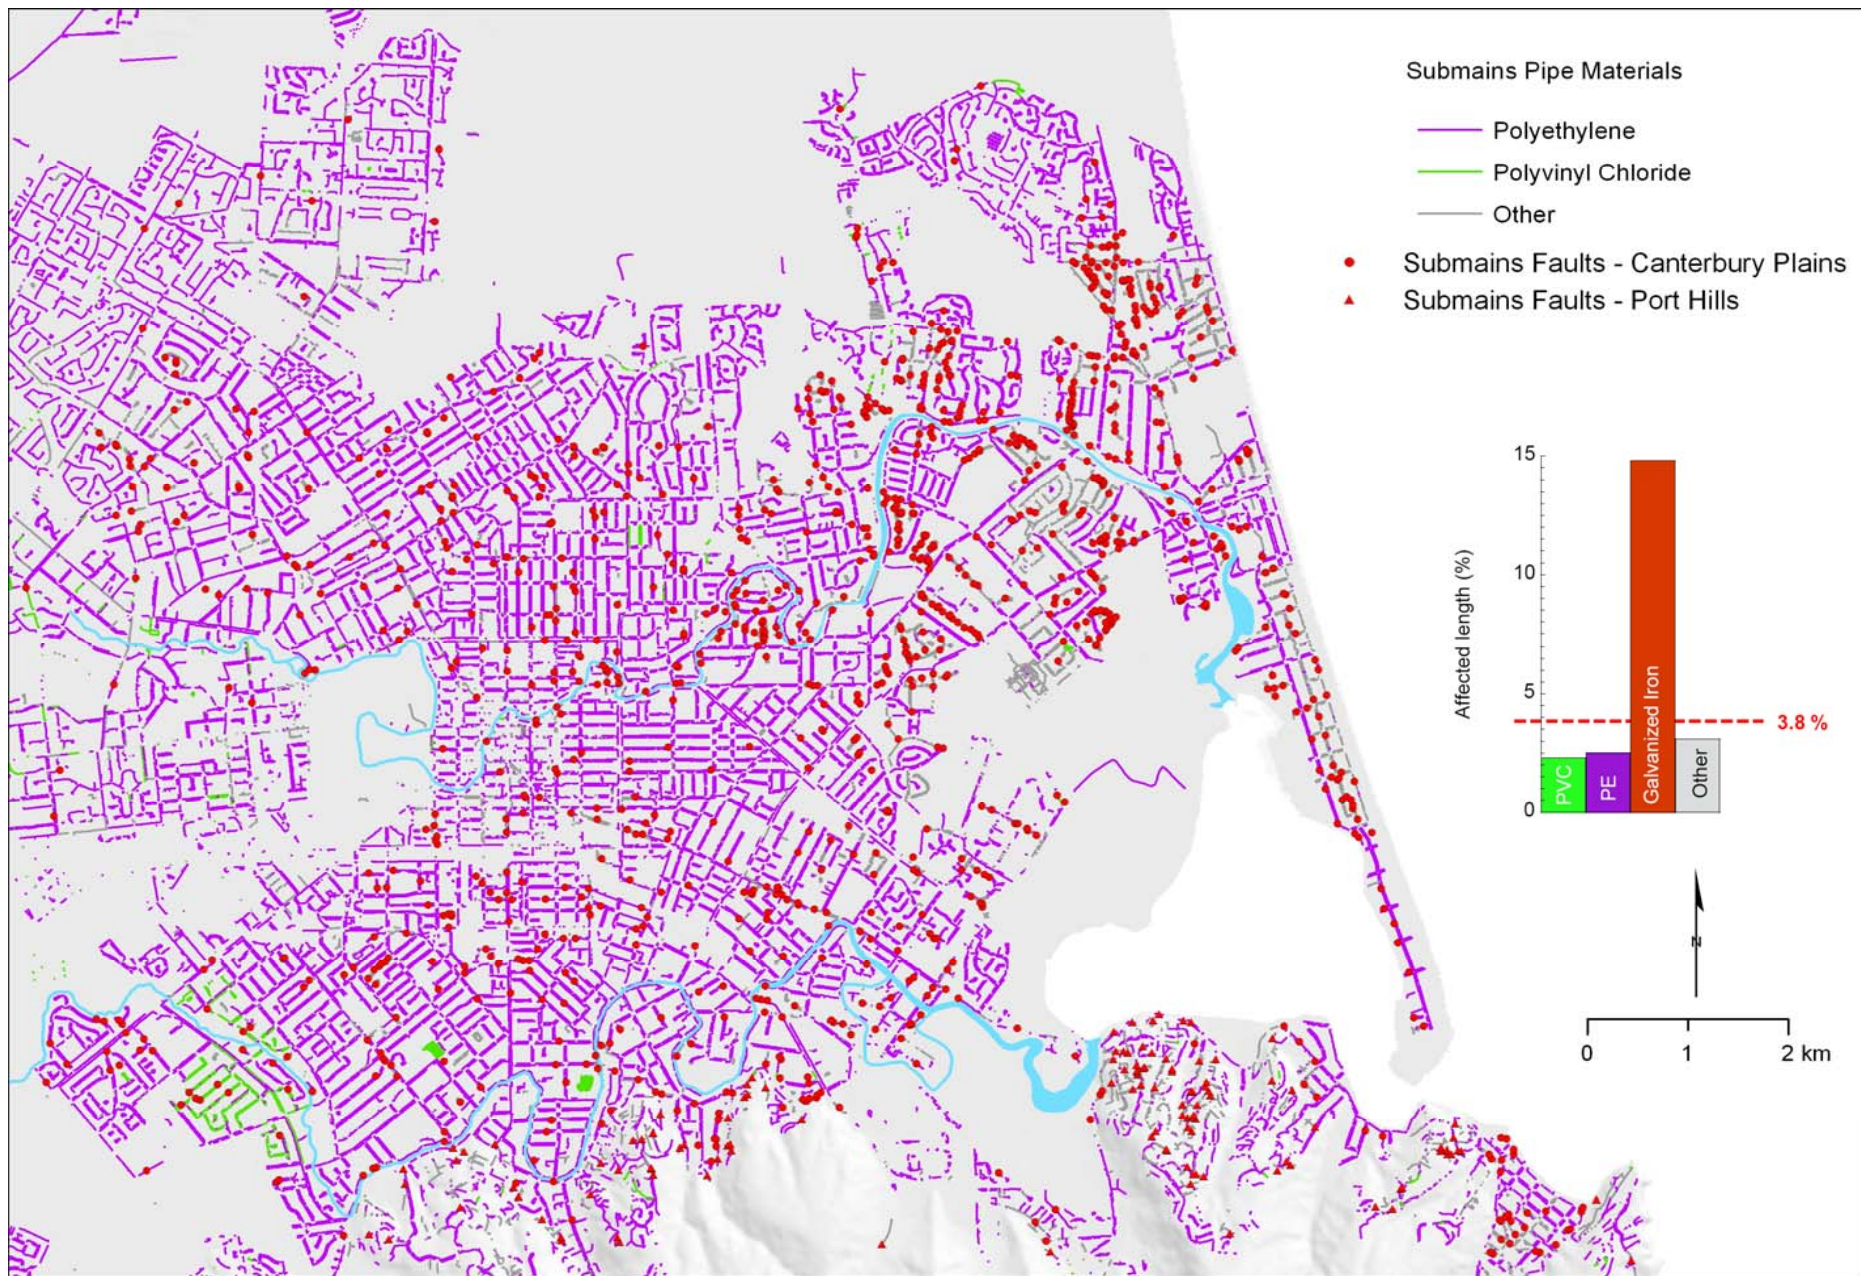
Figure 19. Locations of repairs/faults (red symbols) on the Christchurch submains network following the 22 February 2011 earthquake

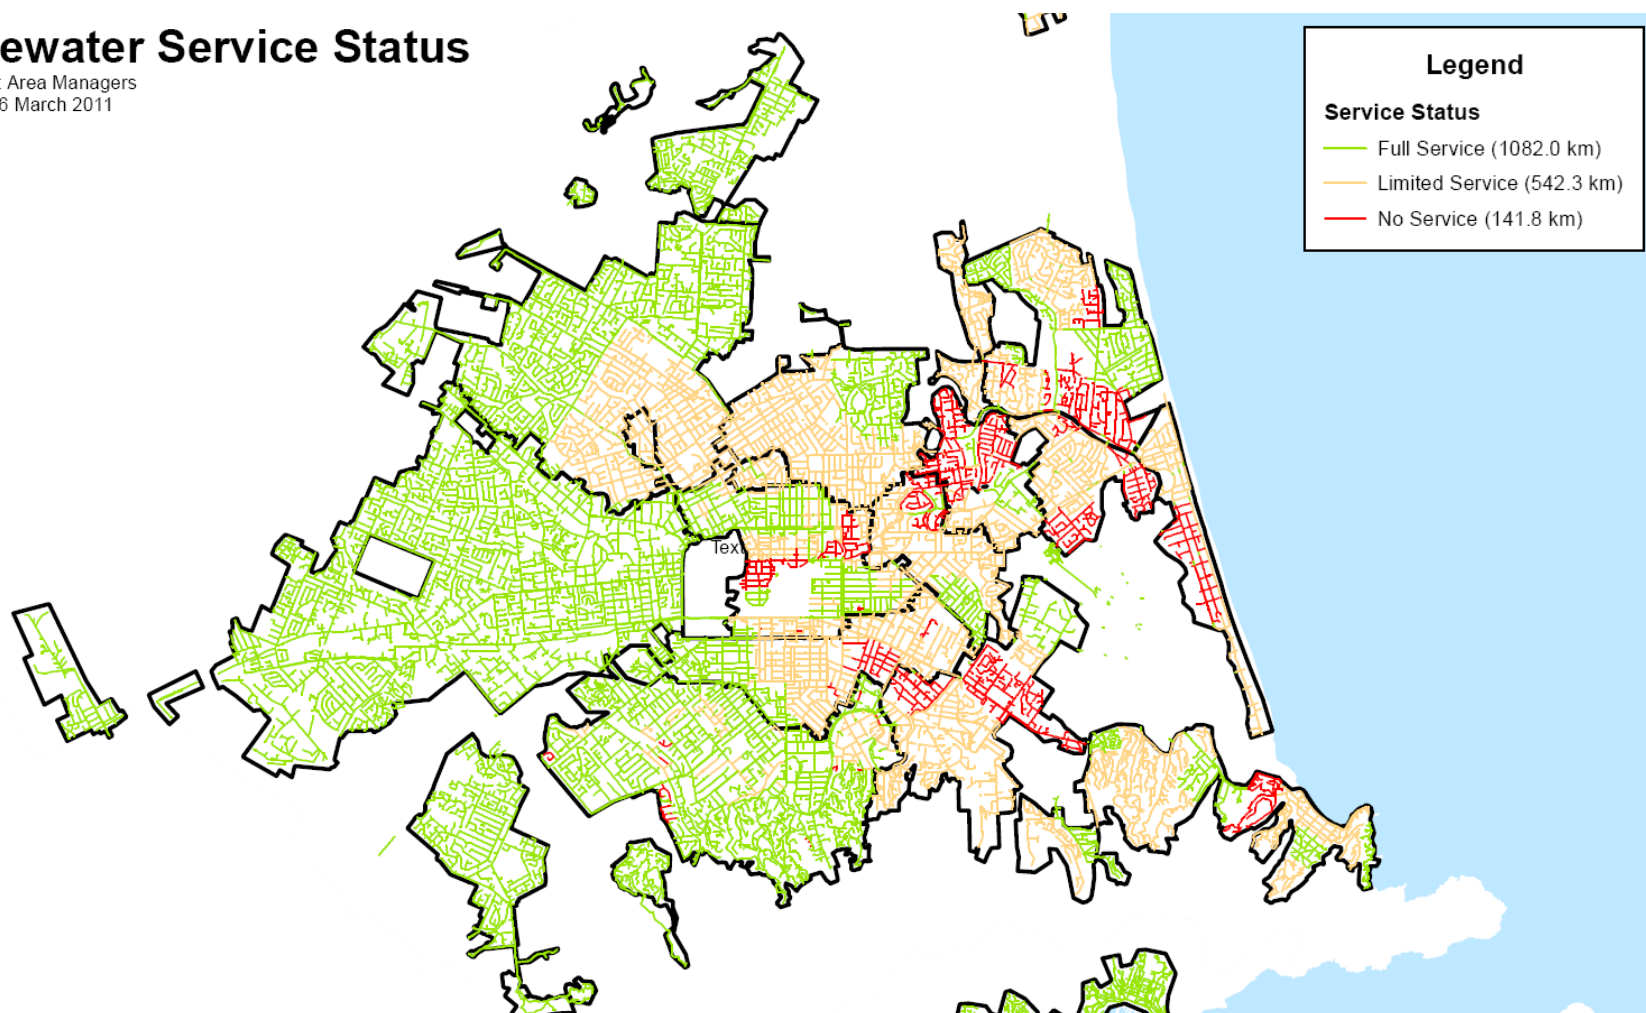
Figure 22. Wastewater network status as of 16 March 2011 illustrating distribution and severity of damage inflicted by the 22 February 2011 earthquake

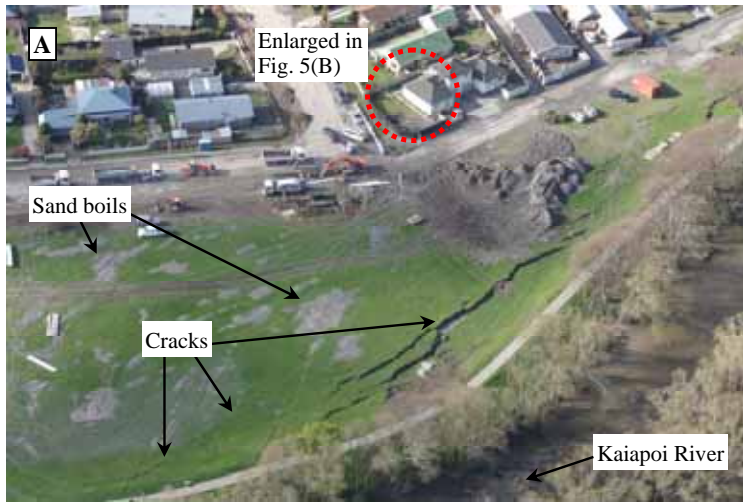
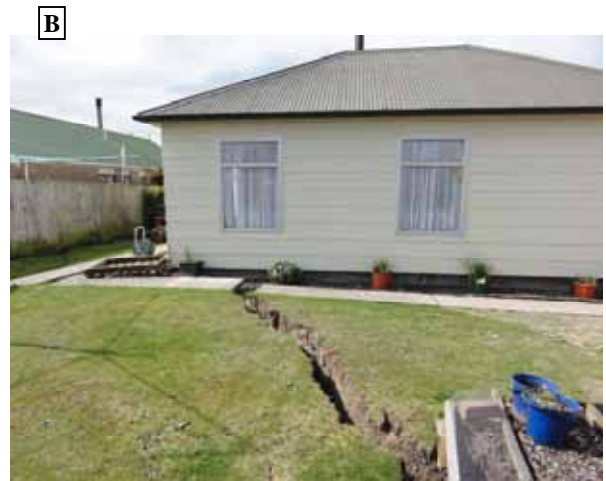
Figure 5 A, Aerial view of North Kaiapoi after the 4 September 2010 earthquake showing impacts of liquefaction and lateral spreading **B**, Lateral spreading cracks affecting residential properties approximately 50 m away from the Kaiapoi River

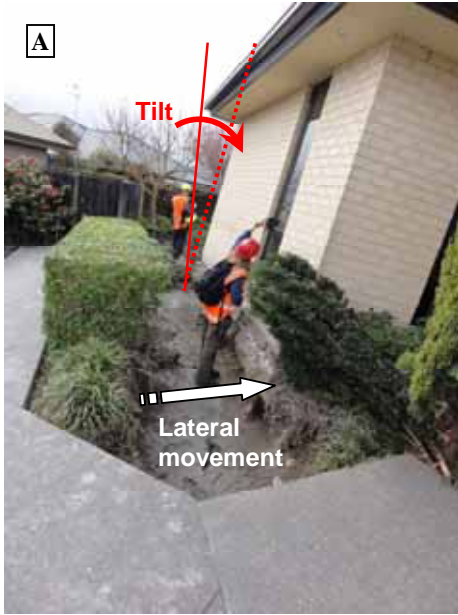
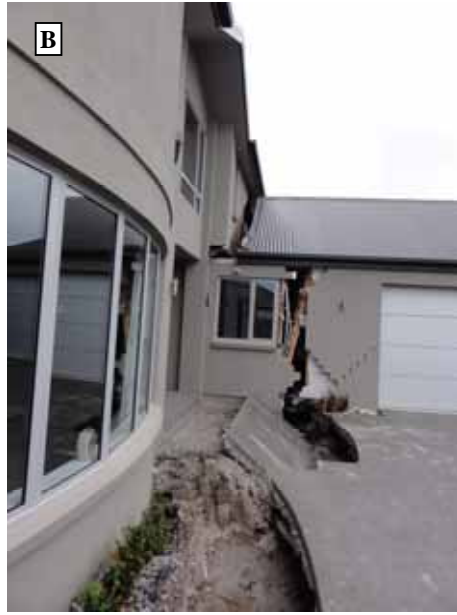
Figure 6 Spreading-induced damage to residential buildings in South Kaiapoi during the 4 September 2010 earthquake

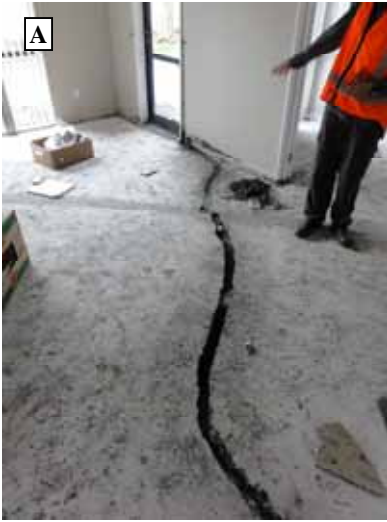
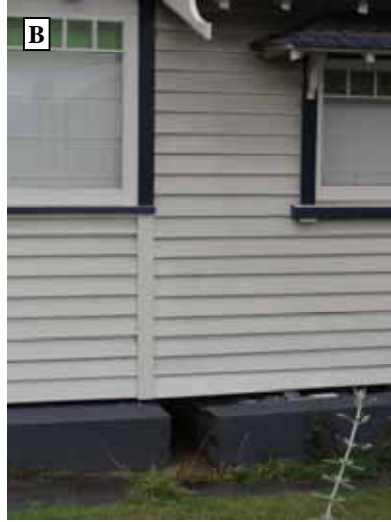
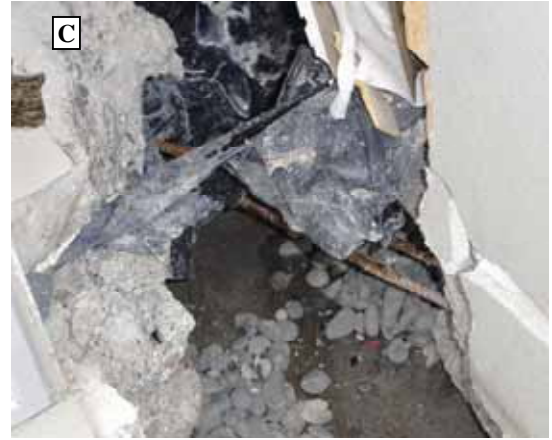
Figure 7 Damage to foundations of residential buildings due to liquefaction and lateral spreading: **A**, Unreinforced slab on grade, **B**, unreinforced perimeter footing, **C**, reinforced perimeter of a concrete slab

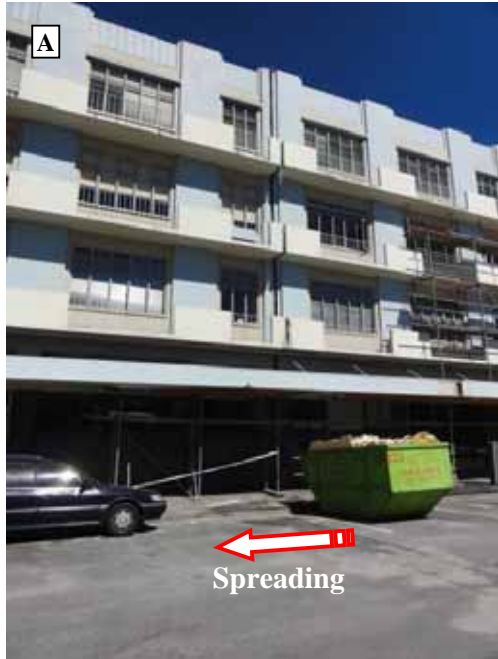
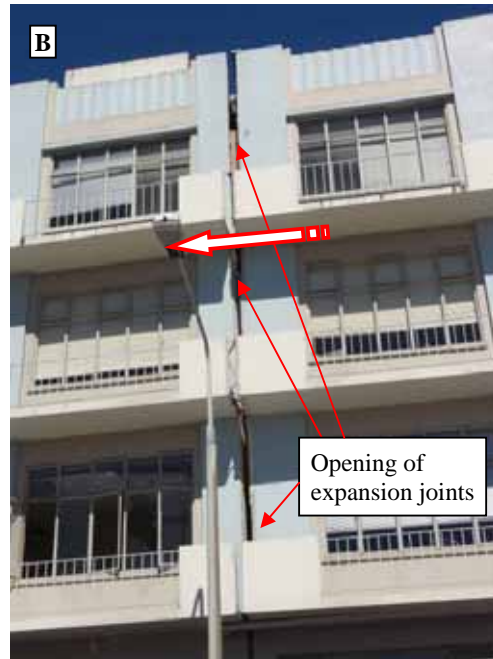
Figure 8 Stretching of foundations due to lateral spreading (A) resulting in opening of the expansion joints of a CBD building (B)

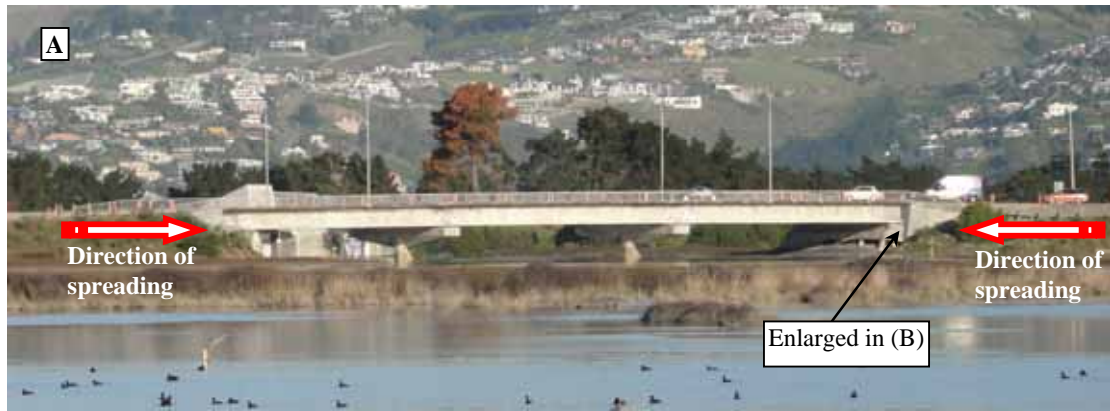
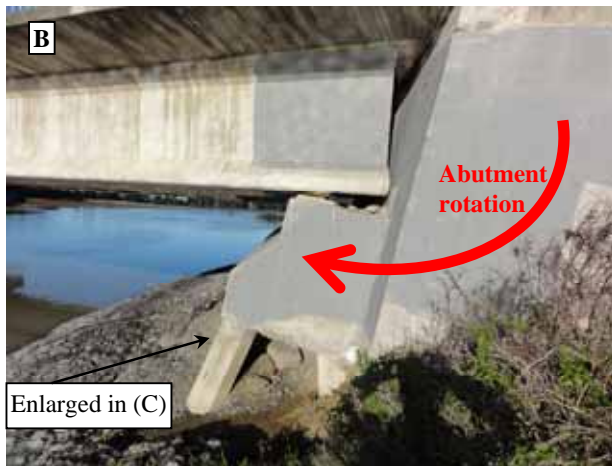
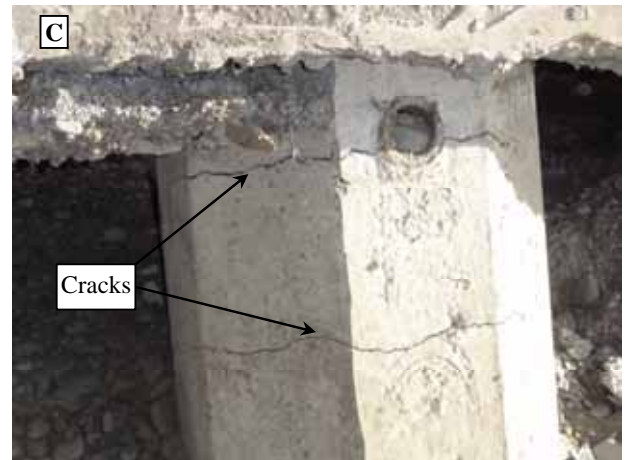
Starting from the Colombo St Bridge, practically all bridges downstream Avon River were severely impacted by lateral spreading. Rotational movements of abutments, damage to foundation piles, subsidence of approaches to bridges and in some cases structural damage were the most typical spreading-induced damage to bridges. Typical damage pattern for bridges is illustrated in Appendix A.

Figure 9 Typical spreading-induced damage to bridges (Bridge St Bridge): **A**, Lateral ground displacement is resisted by the upper bridge structure, **B**, Abutment rotation due to pinning effect and lateral displacements of foundation soils, **C**, Spreading-induced damage (bending cracks) at the top of abutment piles

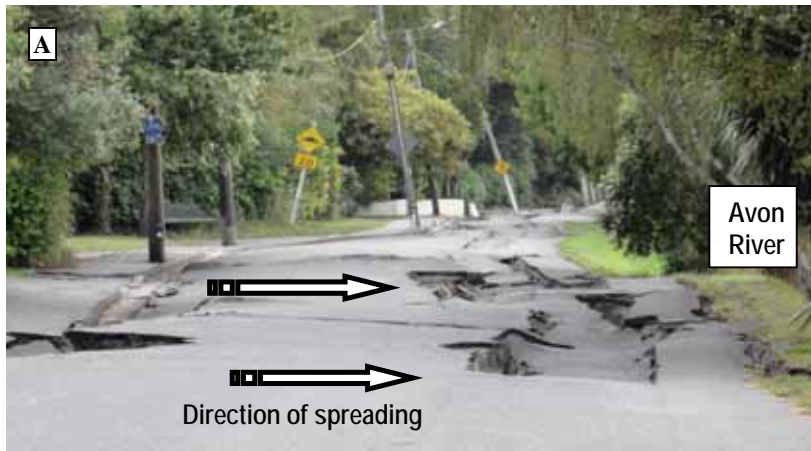
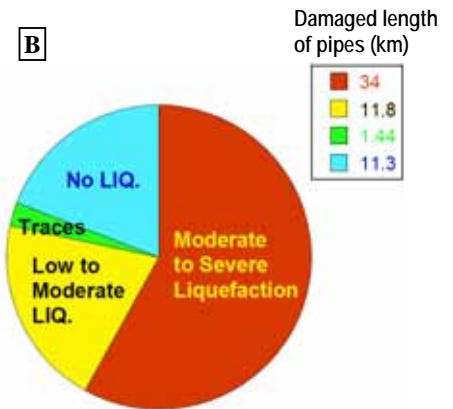
Figure 10 Ground cracks and distortion of road surface due to lateral spreading towards Avon River (A); pie chart indicating the distribution of damage for the water mains network and its relation to the occurrence and severity of liquefaction (B)
