Determination of the Post-Earthquake Capacity of an Eccentrically Braced Frame Seismic Resisting System

Written by: Associate Professor G Charles Clifton and Professor Emeritus George Ferguson
University of Auckland

November 2015
Status: Final Report

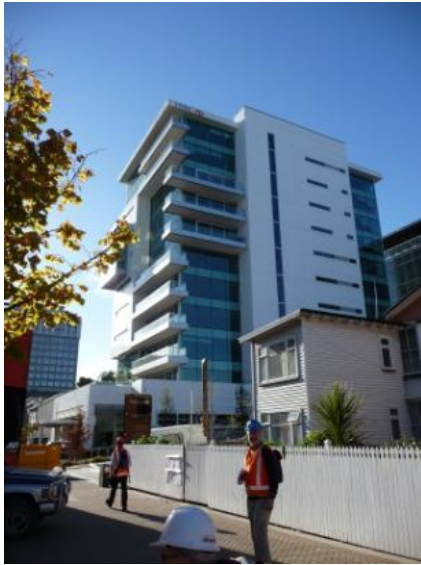
The 2010/2011 Christchurch earthquake series were the first earthquakes worldwide to push EBFs significantly into the inelastic condition and impacted on a range of EBF buildings ranging from 2 to 22 storeys in height (Clifton, Bruneau et al. 2011). One of these, HSBC Tower, is shown in Figure 1; this picture was taken in the week following the most intense earthquake of the series, the earthquake of 22 February 2011.

Figure 1 HSBC Building, Christchurch, March 2011 (from (Clifton, Bruneau et al. 2011))

1. Undertake a survey of the vertical profile of the building to determine that it has self centered to within acceptable limits. The experience from Christchurch is that these limits are more severe than the 0.3% drift typically quoted in the literature. For example, the HSBC building, shown in Figure 1, returned to 0.14% maximum residual drift following the earthquake series. At this level of drift, the lift shaft guide rails needed realignment to prevent excessive wear on the lifts into the future, so it is likely this will be required for any non-low damage building following a severe earthquake. Rounding up that drift limit to 0.15% residual drift is a desirable target to meet.

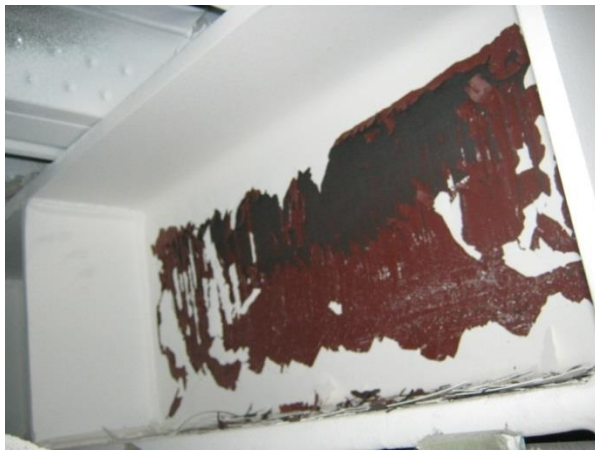
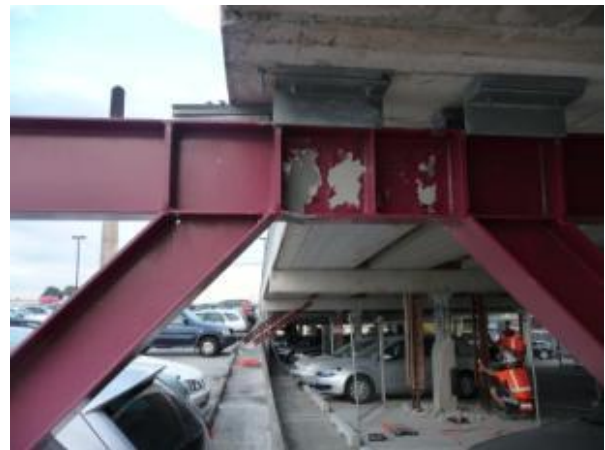
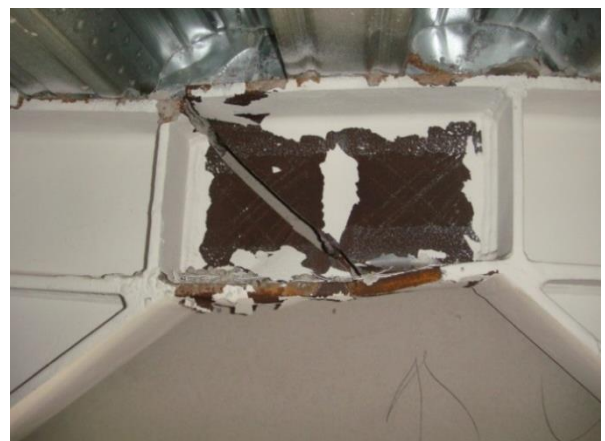
Figure 2 Yielded Active Links from Christchurch 22/02/2011 Earthquake (from (Clifton, Bruneau et al. 2011))

Clockwise from top left: (a) Yielded active link level 3, 12 storey HSBC Tower, (b) Active link at edge of building with slight flange local buckle, level 1, 3 storey car parking building; (c) Fractured and yielded active link, level 6, 22 storey Pacific Tower; (d) Yielded active link, level 4, 22 storey Pacific Tower

That event caused yielding of most of the active links in every EBF building in the Christchurch central business district. Four examples are shown in Figure 2. These include two active links with yielding of the webs and no local buckling, cracking or fracture, Figure 2 (a) and (d); one with yielding of the webs and local buckling of the bottom flange at one end, Figure 2(b) and one which underwent web yielding and then fracture, Figure 2(c).

In the Pacific Tower building, a fractured link was discovered in the top level of an EBF system. This link is shown in Figure 2 (c). All active links in that EBF frame were cut out and replaced, with each active link being subjected to detailed structural and metallurgical examination. Details are given in Chapter 5 of (Nashid 2015) and the key points are:

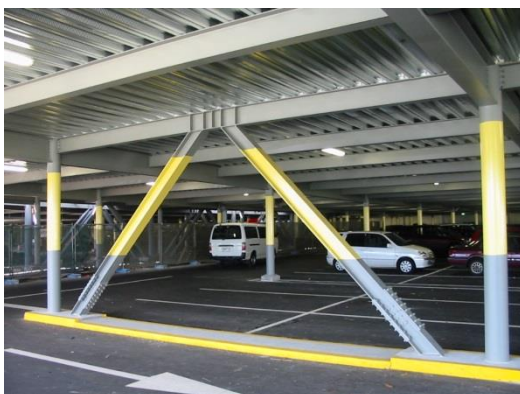
Figure 5 Two Forms of EBFs Integral with the Surrounding Structural System

(a) EBF with continuous active link and collector beam

(b) EBF with bolted replaceable active link

Prior to the Christchurch earthquake series, the EBF member containing the active link was typically continuous with the collector beam or beams and the brace was welded to these members. This made active link replacement difficult. Since then, bolted active links have become the standard detail in EBFS which are built integrally with the structural frame. Figure 5 shows examples of both sorts used in buildings.

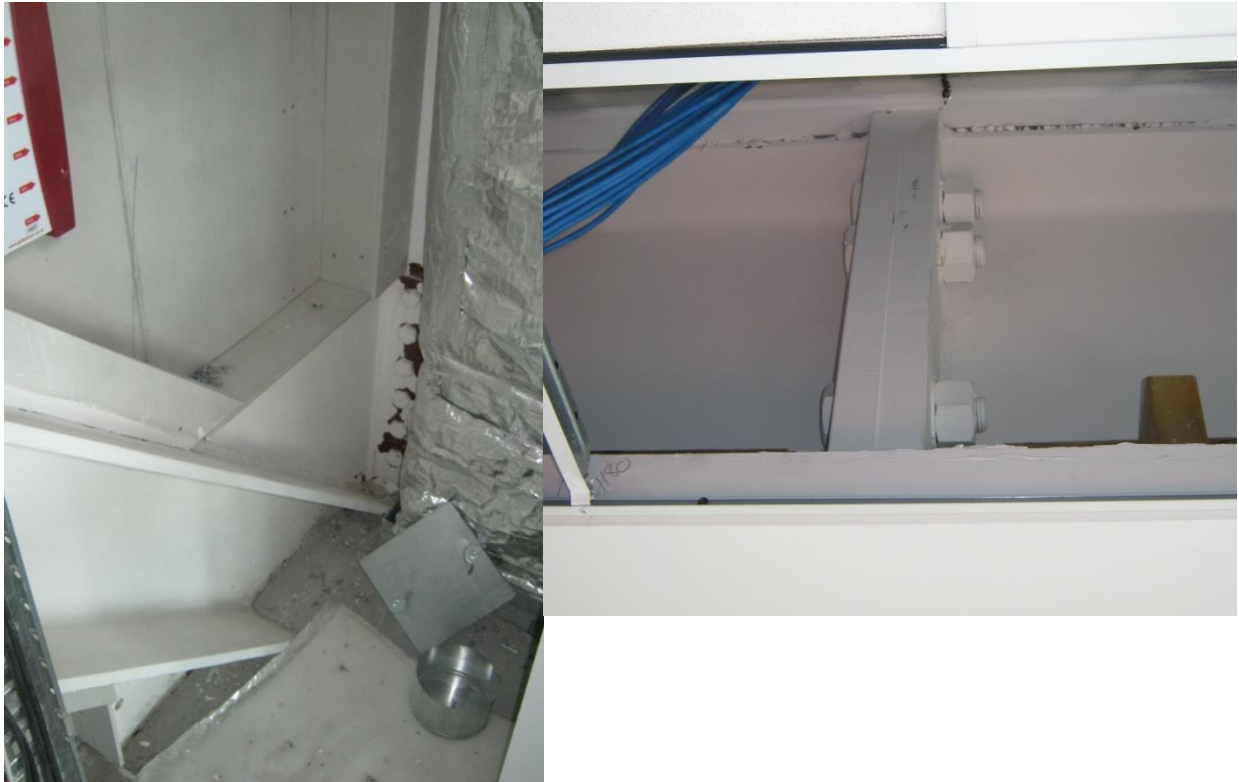
Connections in Buildings, Christchurch From left to right ; (a) Brace/beam/column connection showing out-of-plane yielding in endplate but no inelastic demand in gusset plate; (b) Flush moment endplate splice connection. Figure 6 Connections in Buildings Post Earthquake (from (Clifton, Bruneau et al. 2011))

3. Check the structural system for all visible evidence of inelastic demand and document its location. In painted steelwork this could be evident from cracking or spalling of paint; examples are given in Figure 2 and Figure 6, left hand side. Determine the likely cause of this deformation. In the EBF system, this should be confined to the active link web region of active links, and also to the flexible endplate in the brace/beam/column connection where the flexible endplate connecting the gusset plate to the column (or to the beam but typically to the column) accommodates the opening of the initial gap between the beam and the column as the frame deforms inelastically during the earthquake. Figure 6 left hand side shows an example of this, which is consistent with the inelastic deformation of the EBF system. Check splices for movement; no examples of this were noted in the steel framed buildings from Christchurch; Figure 6 right hand side shows an example of a flush beam splice.

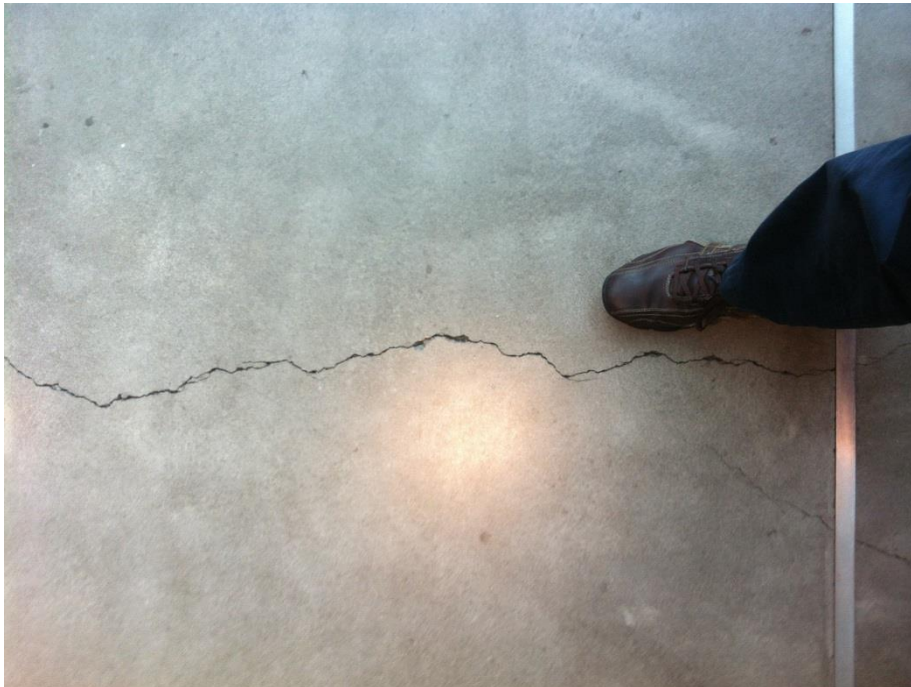
Figure 7 Crack over 0.75mm wide In Floor Slab Developed From Normal In-service Conditions

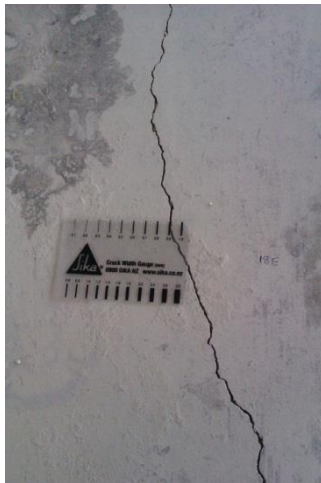
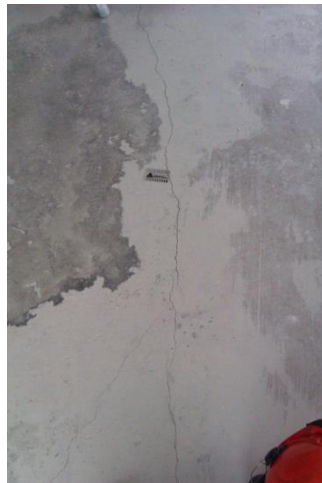
Figure 8 Two Examples of Post Earthquake Cracks in Floor Slab

(a) 0.9mm width crack post earthquake

(b) 0.2mm crack post earthquake

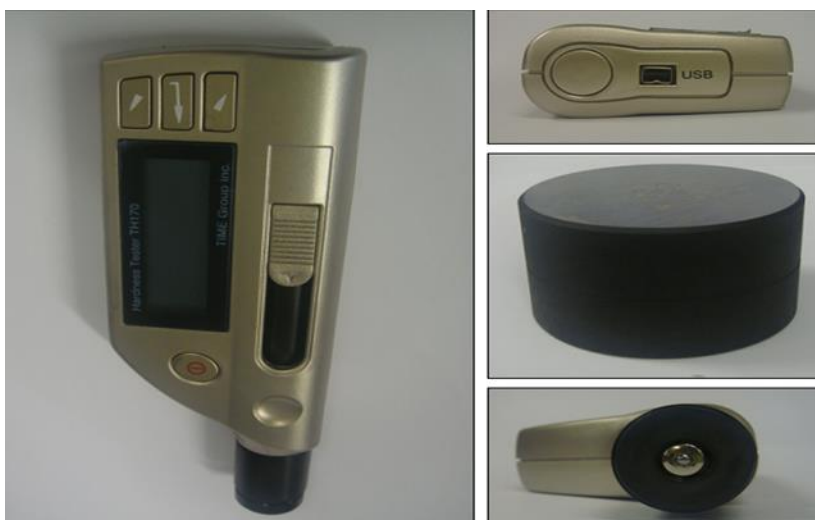
Figure 10 Integrated Portable Leeb Hardness Tester TH170

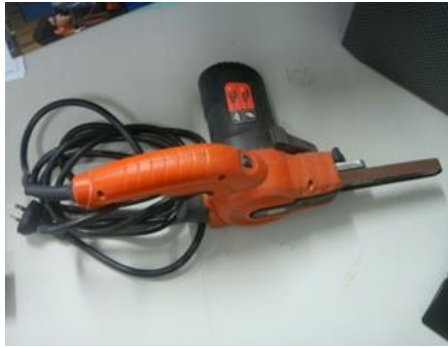
Figure 11 Powerfile Sander by Black&Decker

3. Within this region, choose at least 5 sites to do the testing from.
4. Each site for surface testing must be cleaned to an average surface roughness Ra not exceeding 0.4µm. According to Nashid, this is most effectively achieved by using an electric *Powerfile* (see Figure 11) with P120 belt to remove all surface coatings and expose bare metal, following by hand sanding with a sandpaper grit number less than P180. These processes can be undertaken with either battery power or a portable generator if mains electricity is not available.

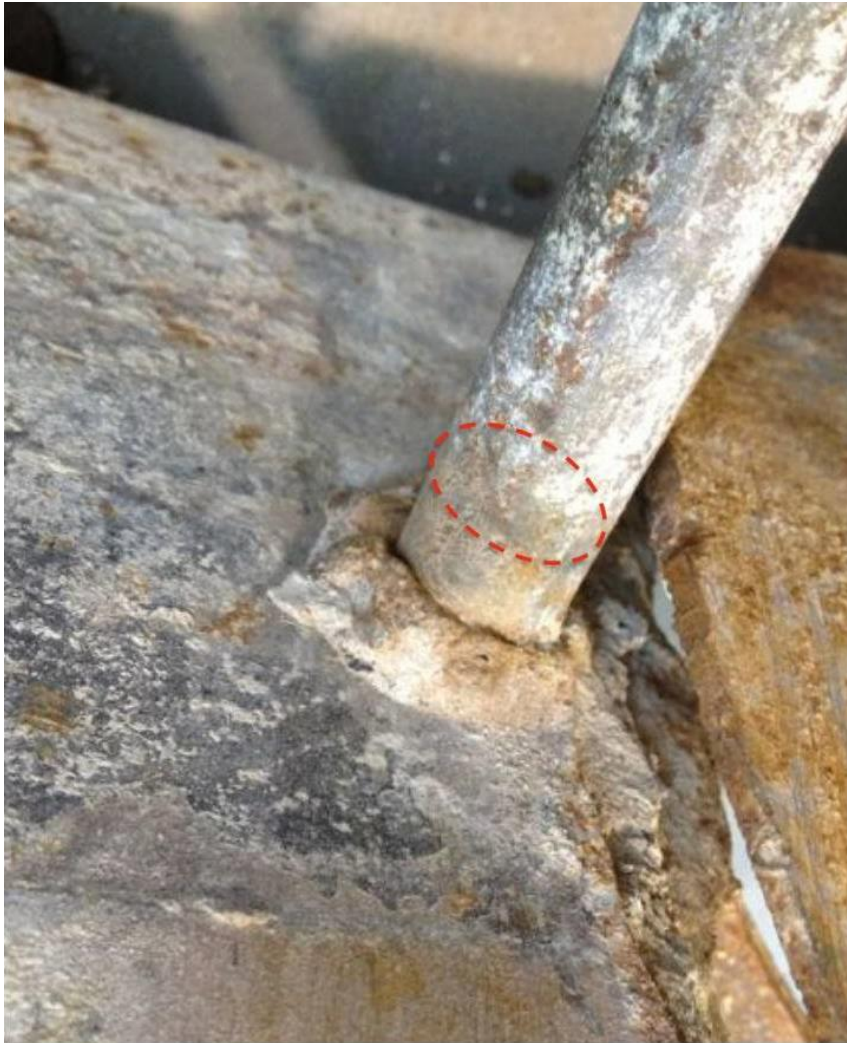
Figure 15 Fracture of Active Link Flange Adjacent to Shear Stud (from (Gardiner, Clifton et al. 2013))

- (b) The active link which fractured had two shear studs welded onto the top flange over the stiffener at the end face of the active link side of the active link/brace/collector beam panel zone (see Figure 4). This was the crack initiation site for the fracture of that link, being in the region of very high local flange curvature at the ends of the active link where the local plastic hinge lines form. The fracture is shown in Figure 15

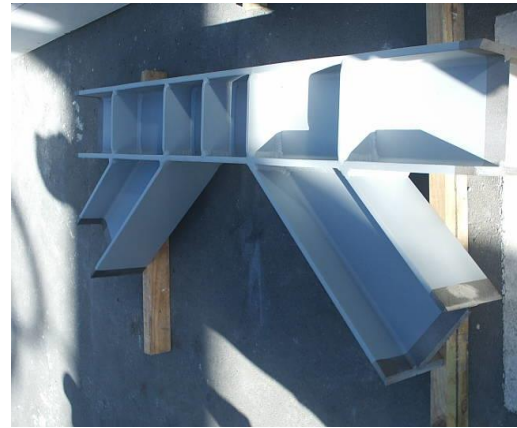
Figure 16 Welded In Replacement V Brace Active Link (from(Gardiner, Clifton et al. 2013))

(a) Drawing of replacement active link

(b) Fabricated link prior to installation on site

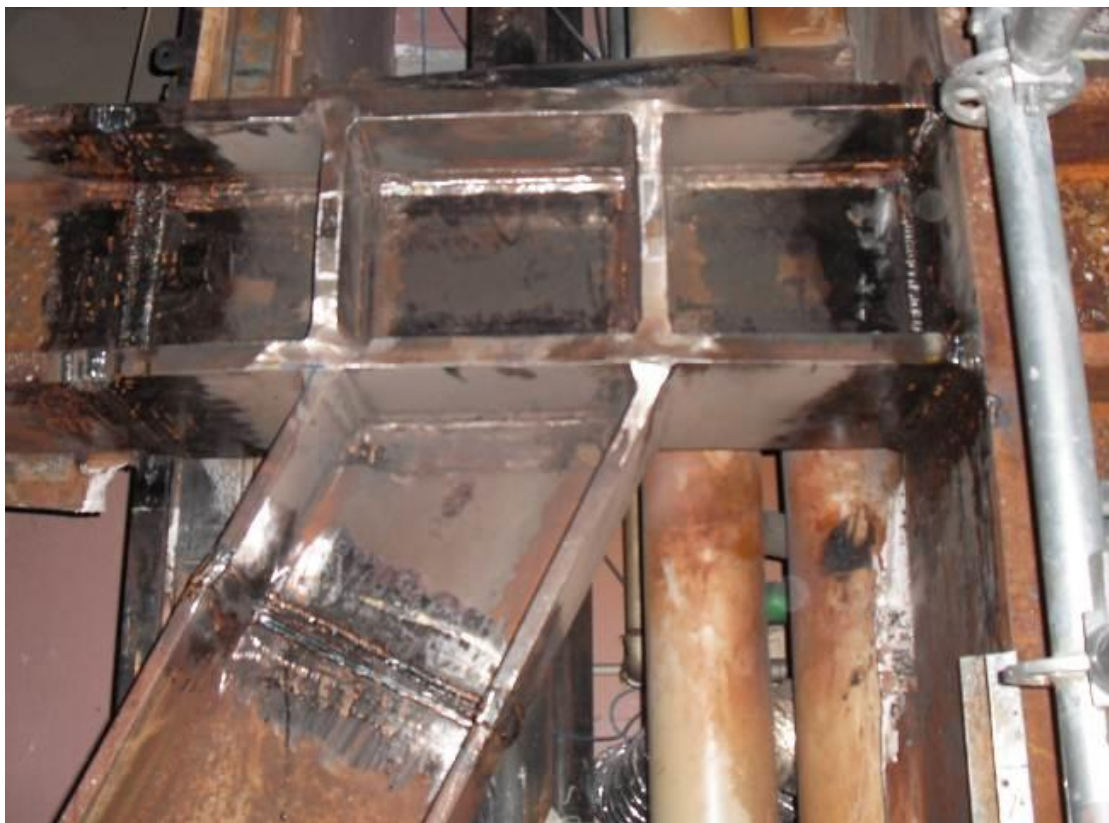
Figure 17 Welded In Place D Brace Active Link (from(Gardiner, Clifton et al. 2013))

Option 2: Cut out the active link, as closely as practicable to the ends of the active link behind the end stiffener, prepare the end and weld a new stiffener in place onto the existing active panel zone. Measure the gap between the two ends into which the active link endplates will be bolted, fabricate a new active link with endplates that is 1mm shorter than the gap and bolt into place. Figure 18 shows the drawings for replacement of a D brace active link, while Figure 19 shows an installed D brace active link.

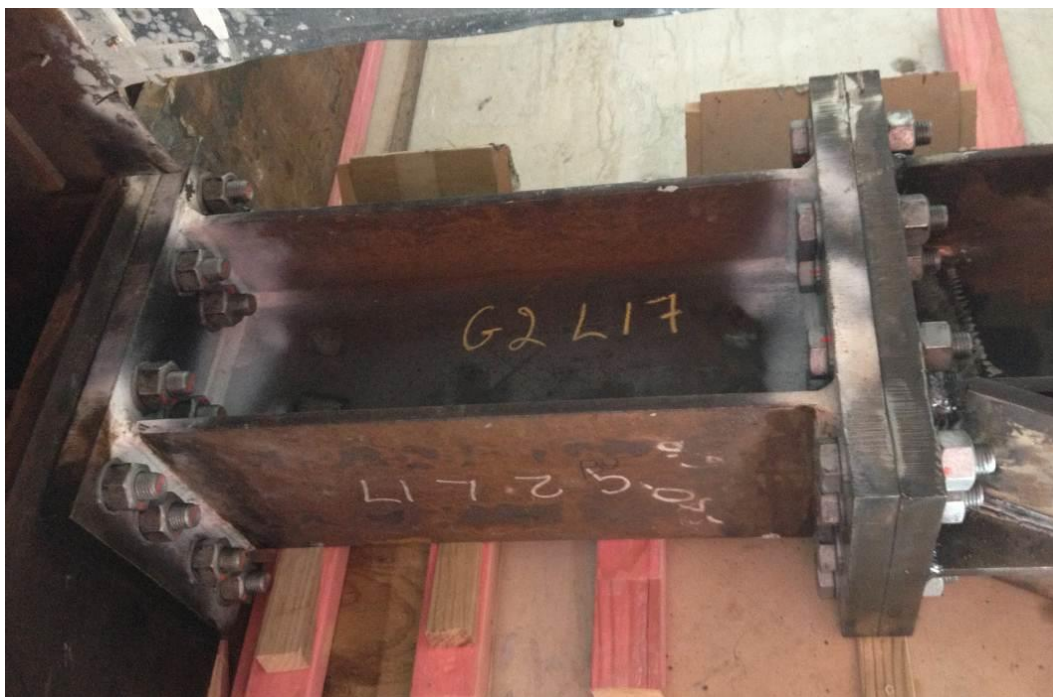
Figure 19 Bolted in Active Link Installed (from (Gardiner, Clifton et al. 2013))

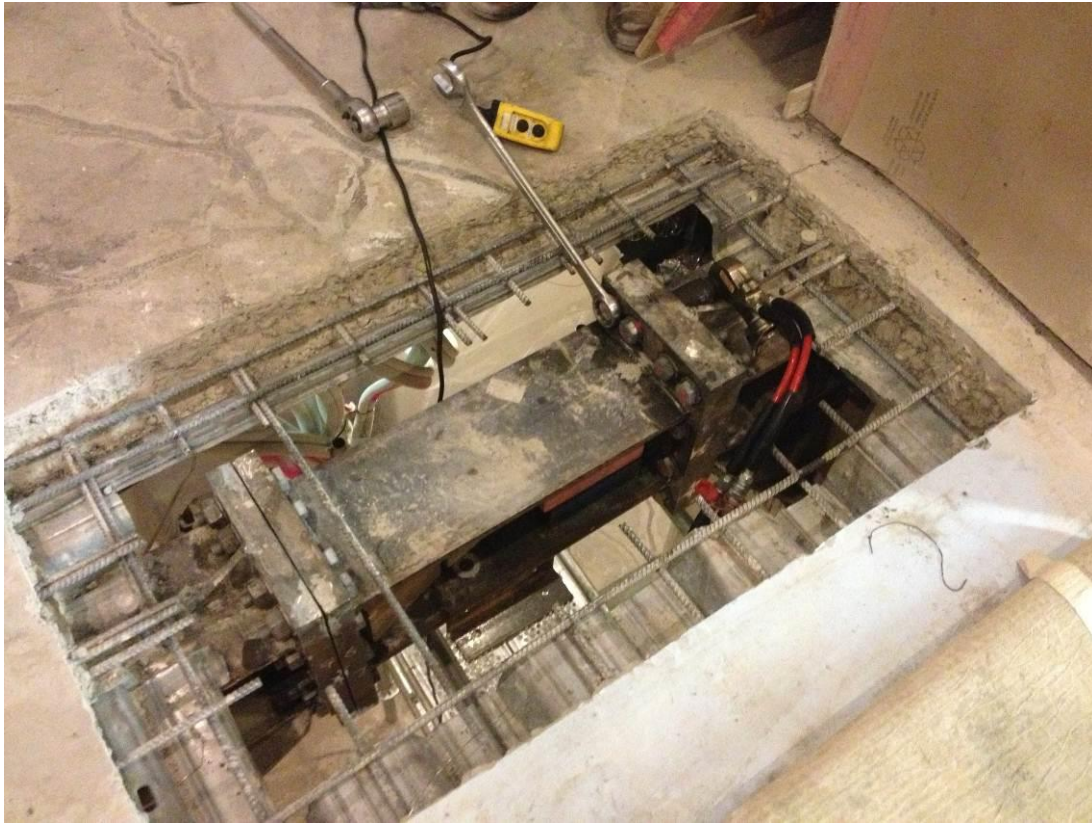
Figure 20 Slab Removed to Allow Bolted in Replacement Active Link to be Installed (from (Gardiner, Clifton et al. 2013))

In either case of replacement, where the active link has a slab over the top of it, the region of slab around the active link will need to be cut out for the replacement and reinstated. Figure 20 shows an example from Pacific Tower. Typically the slab will not need temporary support during this process.

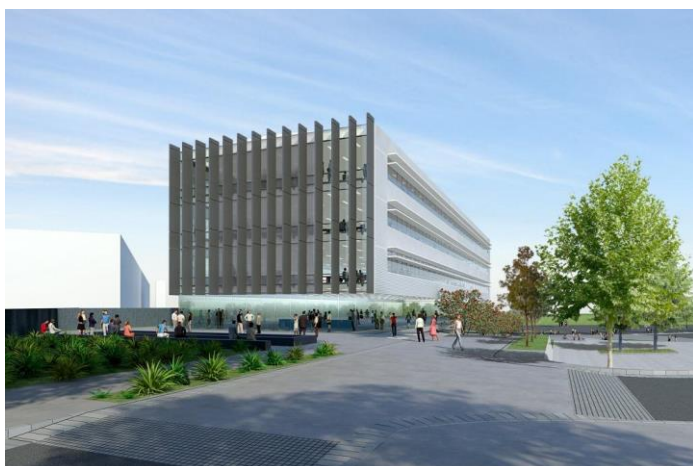
Figure 21 Example Four Storey Building For Application of Assessment Process
