Review of Design and Installation Practices
for
Non-Structural Components

Prepared for the Engineering Advisory Group by New Zealand Consultants,
Industry and Related Experts

June 2012

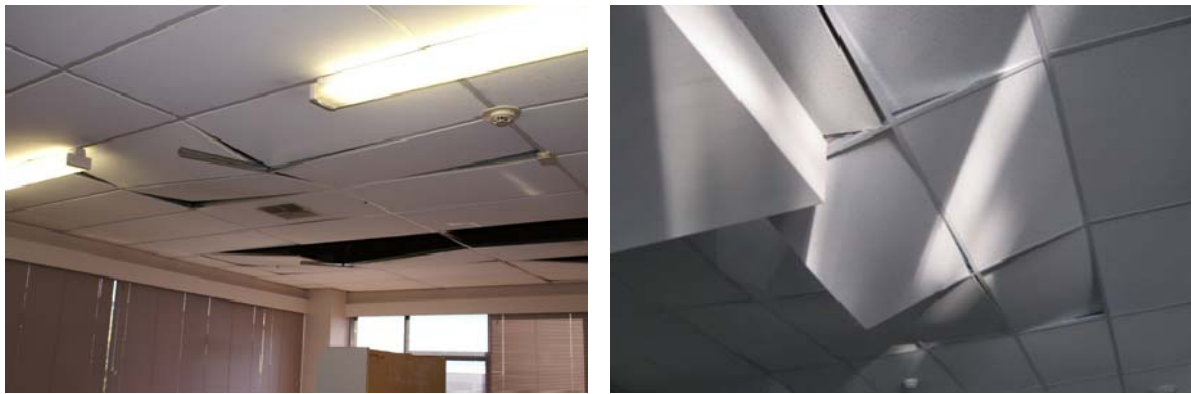
Grid damage results from excessive force on the grid members or connections. This then results in ceiling grid distortion under compression and subsequent buckling of the grid members or failure of the connections while the perimeter connections remain intact. Below are several examples of grid damage:

Figure 2.4.1 Damage resulting from the disconnection of the cross-tee from the main beam resulting in localized collapse of the grid and loss of tiles (Photos: Hush Interior Ltd)

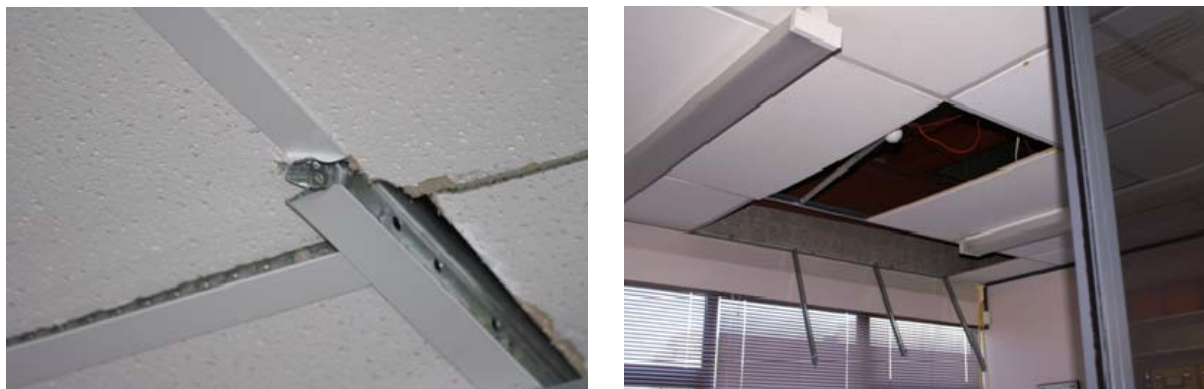
Figure 2.4.3 Damage resulting from main beam splice failure (left) and cross-tee disconnection with main beam (right) (Photos: Hush Interior Ltd)

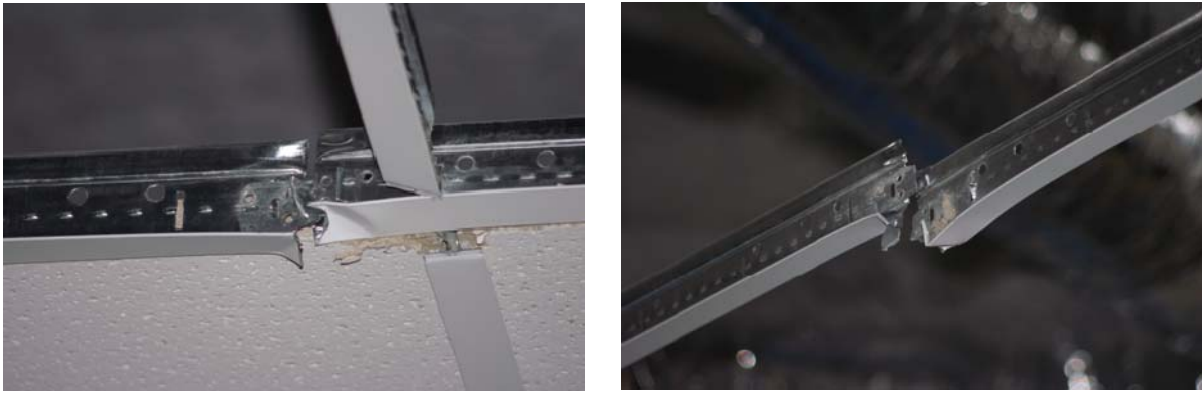
Figure 2.4.4 Damage resulting from main beam splice connection (left) and buckling of cross-tee connections and main beam splice failure (right) (Photos: Hush Interior Ltd)

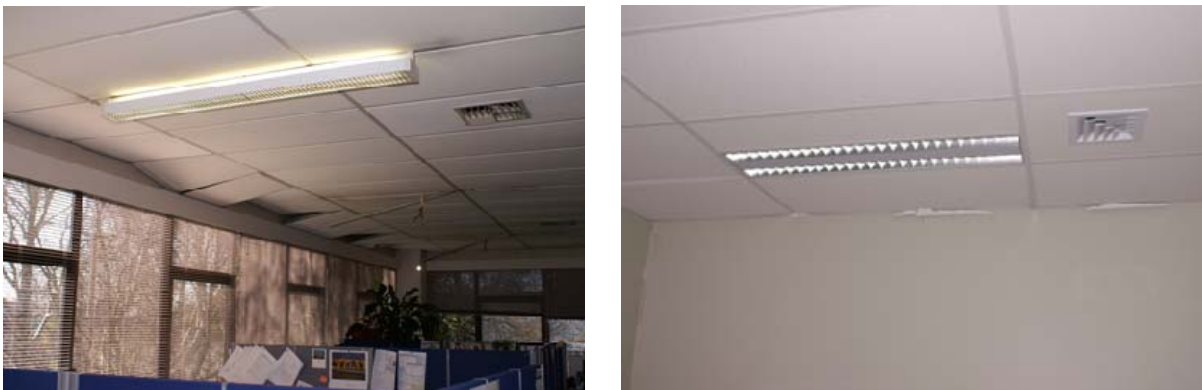
Perimeter damage results from the main tee or cross-tee losing seating on the perimeter angle around the ceiling. Loss of seating can result due to a lack of a rivet to connect the grid member to the angle or failure of the rivet itself. This results in the grid members and tiles dropping from the ceiling. Edge perimeter hanging wires can prevent the member and tiles from falling, however, this can result in the tile and members being forced back into the angle causing damage to the tiles and members; see Figure 2.4.5 (right) below.

Figure 2.4.5 Damage caused by disconnection of main beams and cross-tees. Note damage to panels at right which have not dropped from the ceiling but have been forced back into the wall angle causing damage (Photos: Hush Interior Ltd)

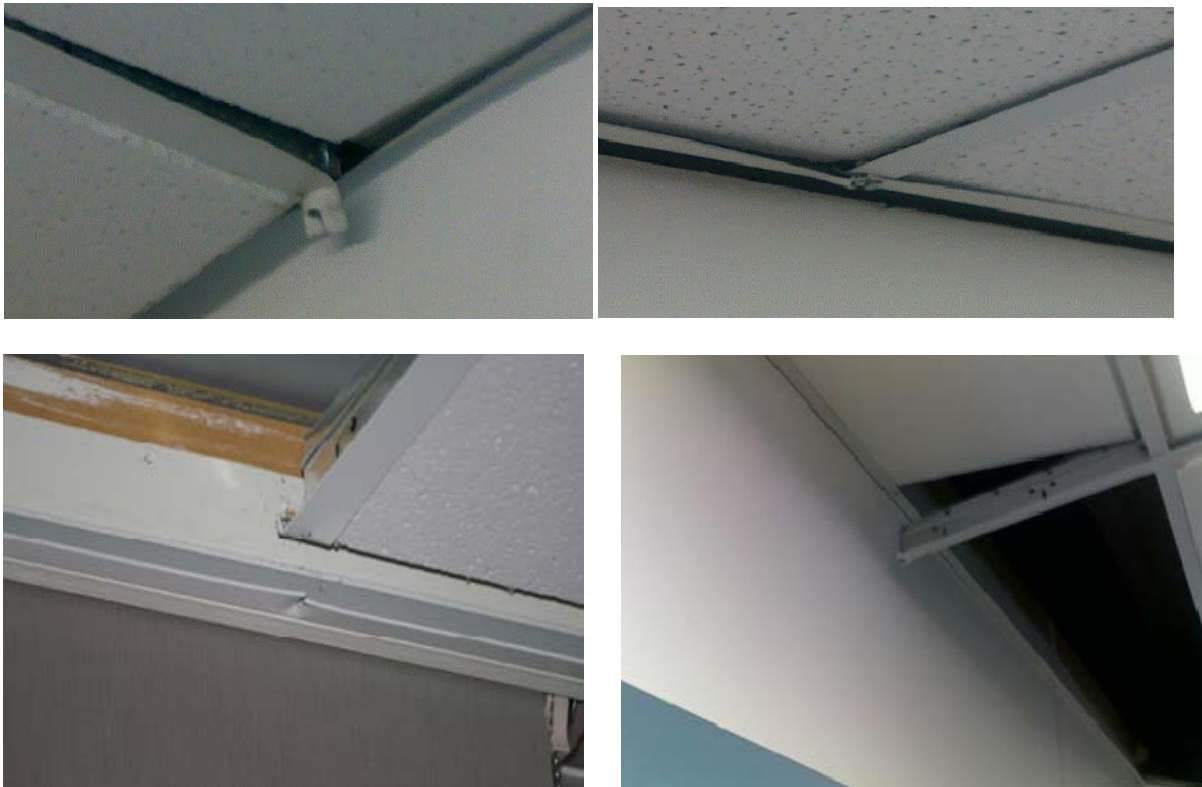
Common current practice is to connect the grid members to the perimeter angle with centre single-size riveting which only connects to the face cap. Such a riveting system was found to be inadequate. In some cases, the inadequate rivets were observed to fail in tension, leaving only the aluminium cap to hold the system together. In other cases, the rivets were also found to have ripped through the steel wall angles and tee rails. Probably, the standards need to

Figure 2.4.6 Damage caused by failure of the main beam/cross-tee to wall angle rivet (Photos: Hush Interior Ltd.)

provide detail specifications on the number, size and locations of rivets for such perimeter connections.

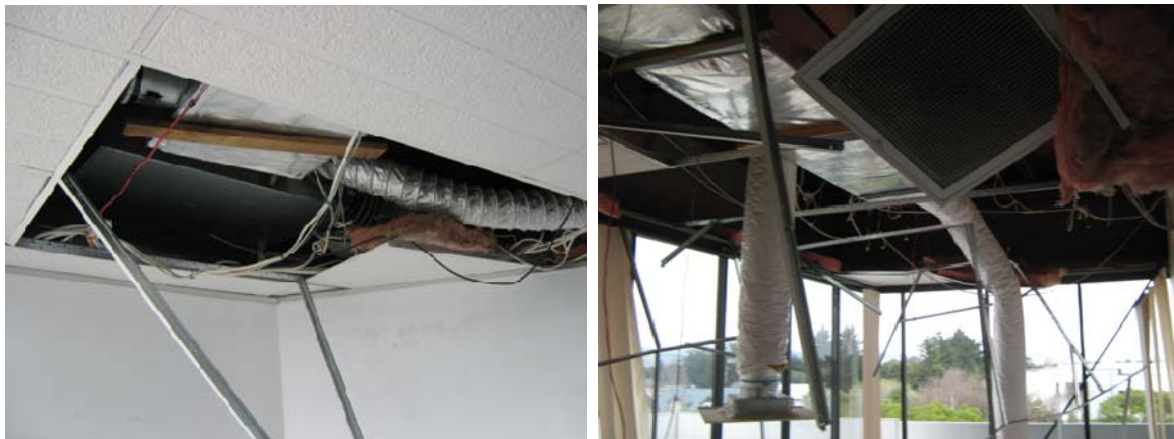
above the ceiling can mean this is not possible. As a result suspended ceilings are sometimes partially hung from services within the ceiling (most commonly HVAC ducting and plant). As this plant is rarely secured properly, when it moves it imparts force into the ceiling, causing damage. Additionally, services above the ceiling moving during an earthquake can impact the hanging wires of the suspended ceiling, once again imparting force into the ceiling. Suspended ceilings are not designed to take the additional force from this plant. Grills within the ceiling plane were often observed to have fallen from the ceiling and localised loss of tiles often occurred around the location of these grills. Some instances of ceiling failures resulting from the interaction with the services are shown in the figures that follow.

Figure 2.4.8 Damage caused by interaction with services above the ceiling (Photos Hush Interiors Ltd.)

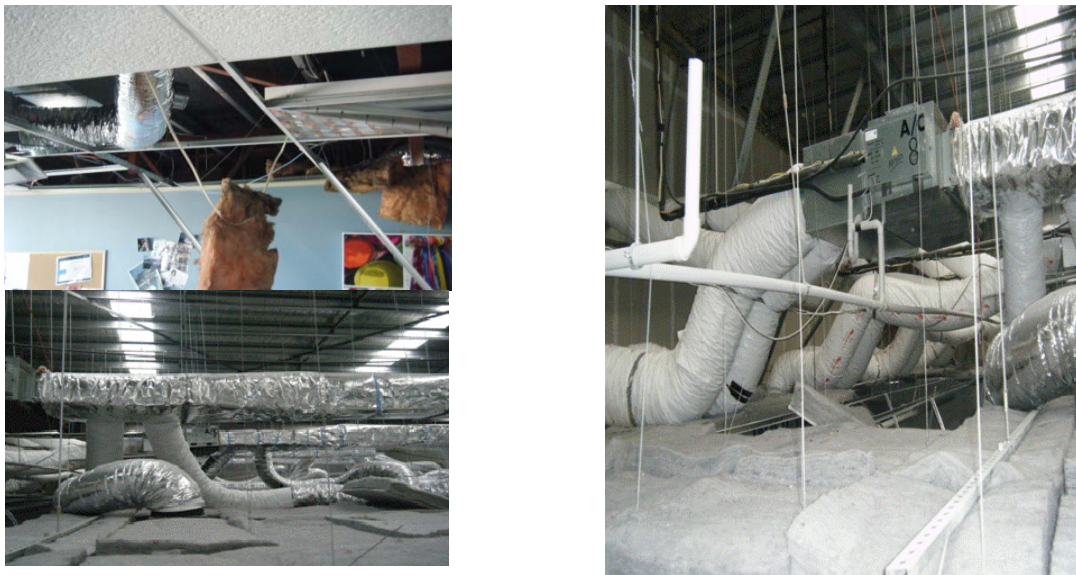
Figure 2.4.9 Damage caused by unbraced AC ducts swaying or causing damage (Photos: R Dhakal, K Hogg)

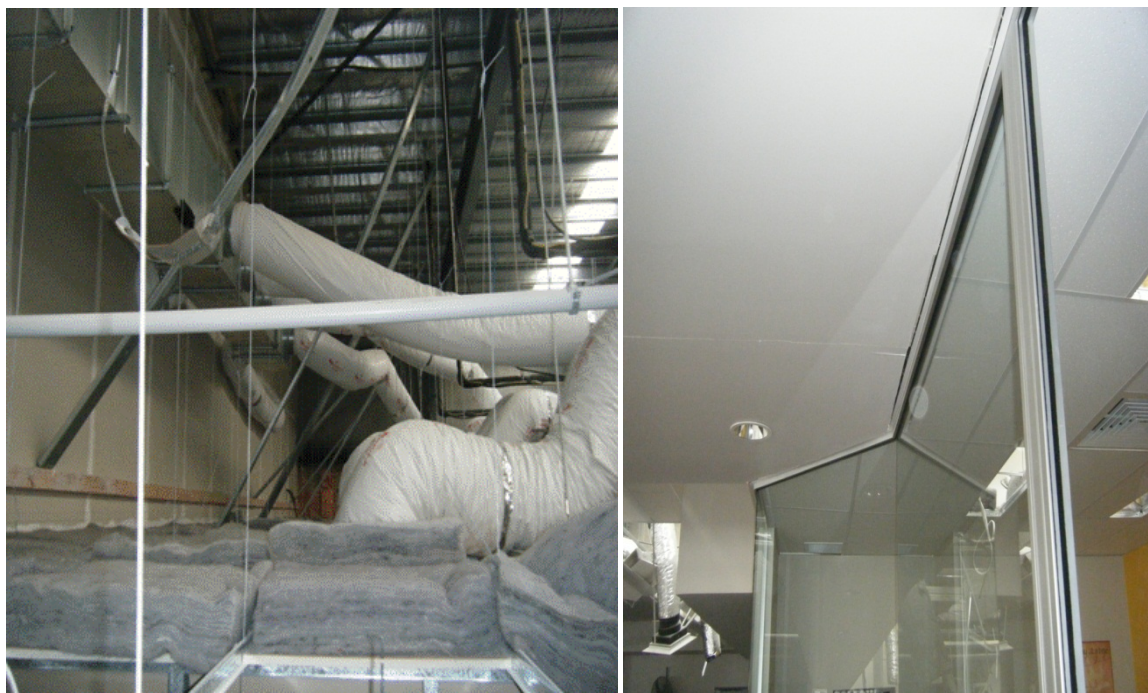
Interaction with partition walls also caused damage to some ceilings braced to the walls. Some internal walls extend to the floor above and are fixed either directly to the floor or beam or through inclined braces which are required to minimize buckling of slender walls. In some cases the ceiling may also be supported on these internal walls. The braces of these walls are close to the ceiling hangers and other equipment braces and are likely to interact with the system. It was found that the failure of the braces (some of which fell off) could easily have caused significant damage to the ceilings (see Fig 2.4.11 left).

Figure 2.4.11 Interaction between internal walls and ceiling (Photos: K Hogg)

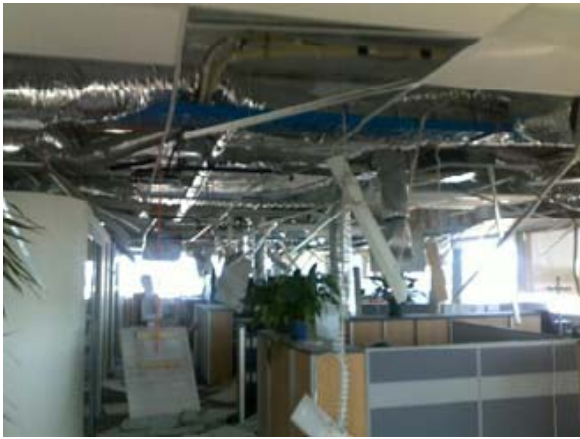
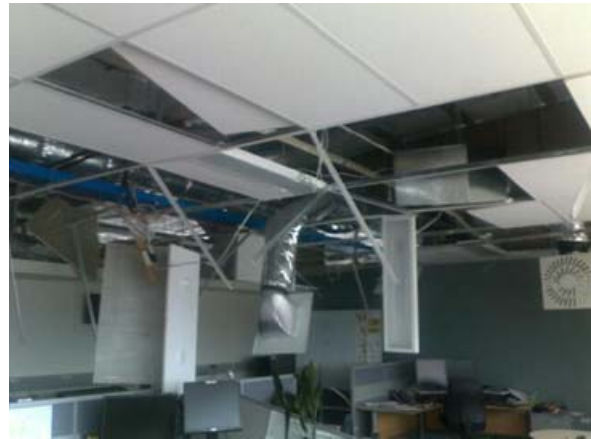
Figure 2.4.14 Widespread damage of a single ceiling (Photos: R Dhakal, T Abu and Hush Interior Ltd.)

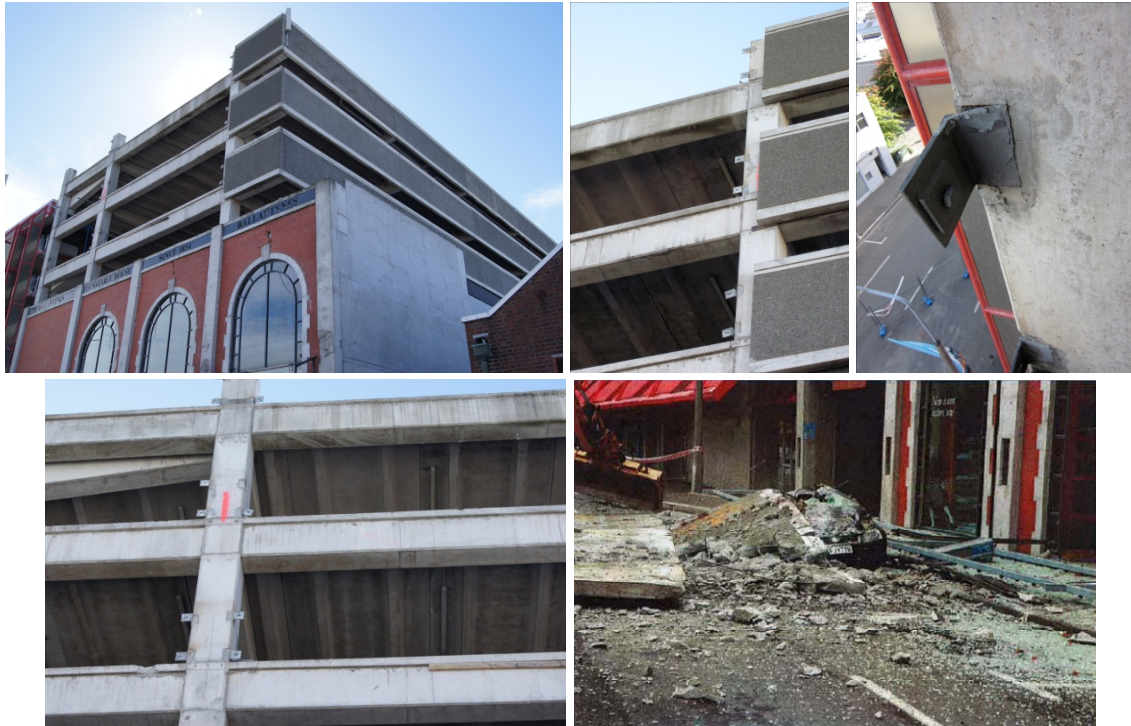
Figure 3.4.5 Disconnected precast spandrel panels (Photos: A. Baird, J. Marshall, NZ Police)

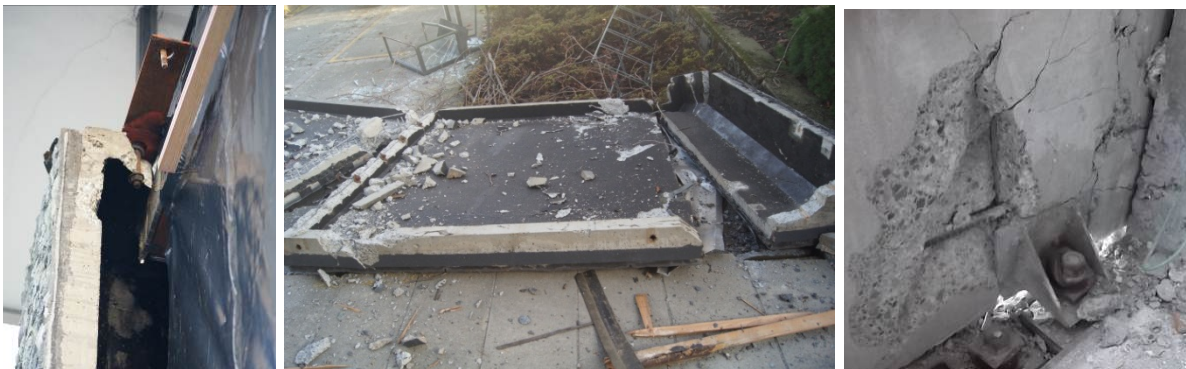
Figure 3.4.6 Connection of coffered precast panels that failed in June 13 aftershocks (left and centre), precast panel and connection damage due to beam elongation (right) (Photos: A. Baird)

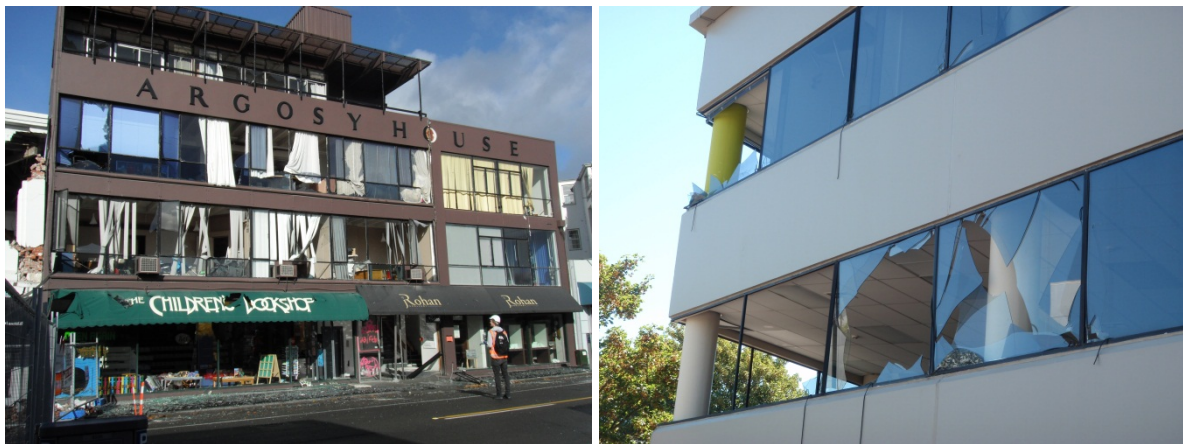
Figure 3.4.7 Damage to light-medium weight cladding systems (Photos: A. Baird)

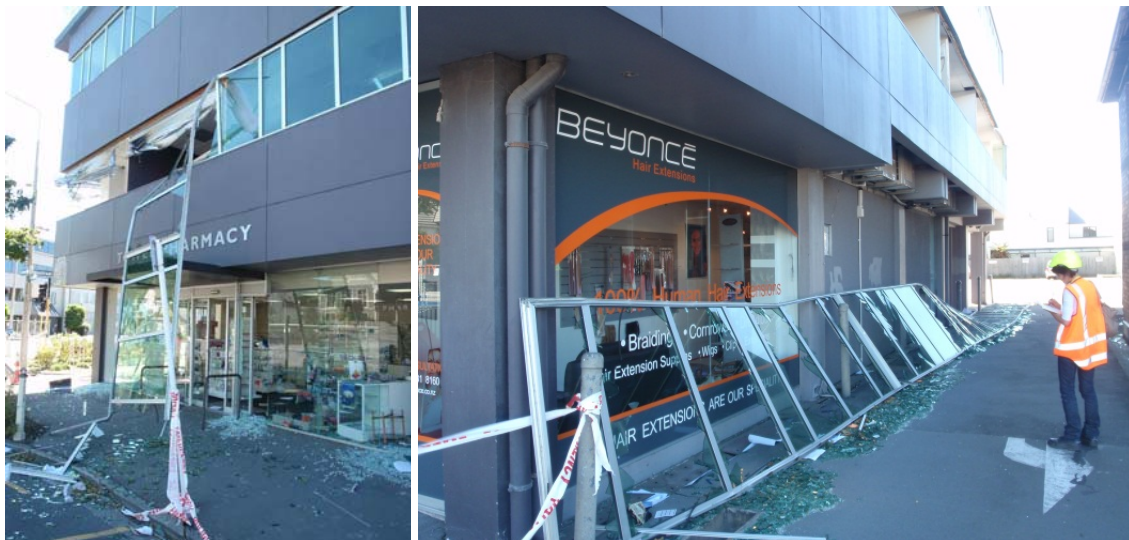
Figure 3.4.8 Disconnected cladding systems (Photos: A. Baird)

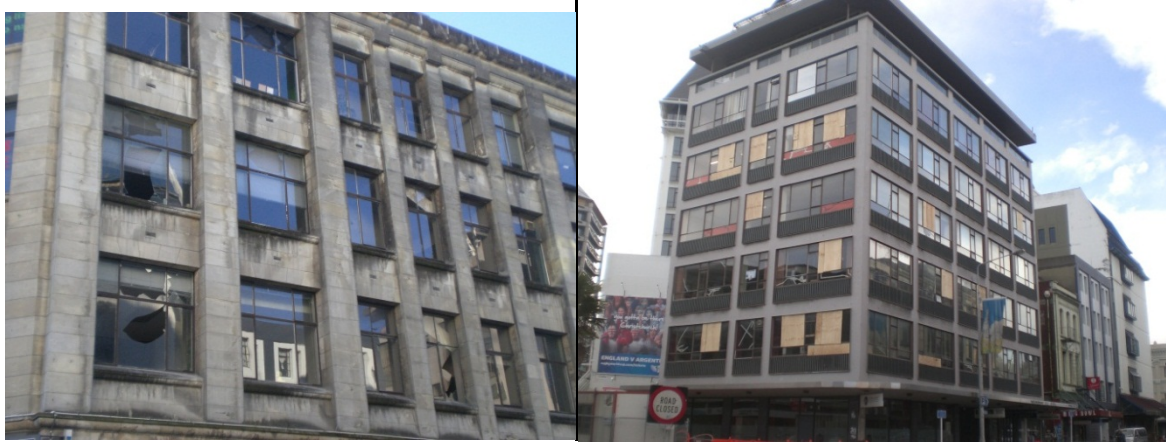
Figure 3.4.10 Infill glazing damage (Photos A. Baird)

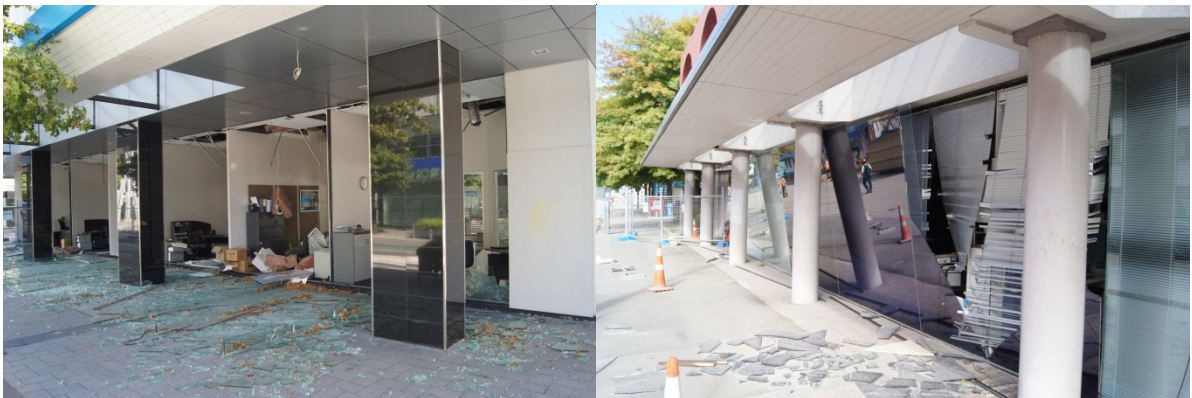
Figure 3.4.11 Shop-front glazing damage (Photos A. Baird)

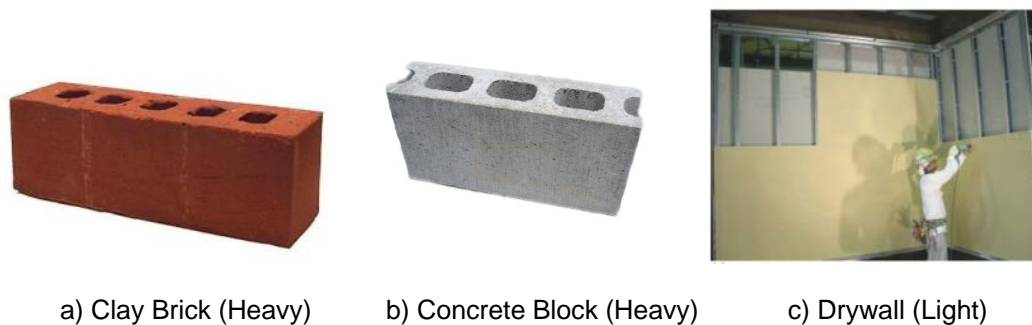
Figure 4.1.2 Partition (Infill) wall typologies

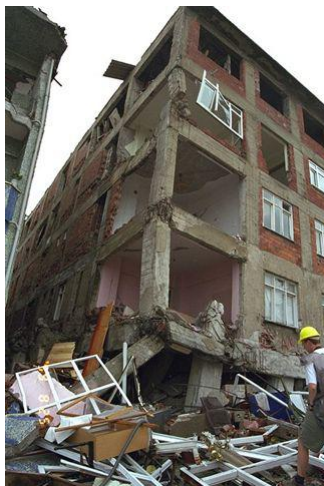
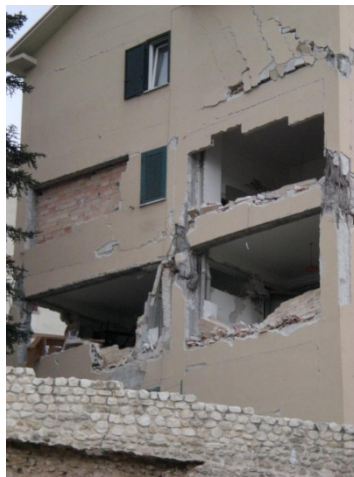
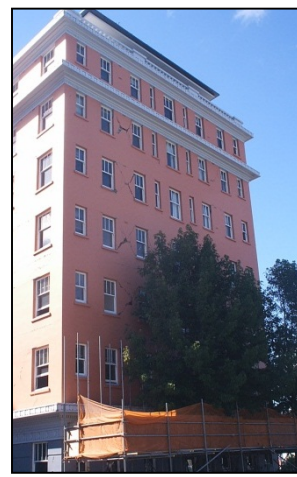
Figure 4.3.1 Damage to heavy (masonry) infill walls and interaction with the surrounding RC frame

a) Duzce, Turkey 1999

b) L’Aquila, Italy 2009

c) Christchurch, NZ 2011

In most of international design codes, infill walls and partitions are typically considered as “non-structural elements” and thus tend to be mostly neglected in the structural design process. However, the observations made after major earthquakes (Duzce 1999, L’Aquila 2009, Christchurch 2011) have shown that even though infill walls might be considered to be “non-structural” elements, their interaction with the structural system response during seismic actions can modify the overall bare frame system response, potentially leading to unexpected and undesired failure mechanisms either at a local level (e.g. shear failure in captive columns, damage to joint region) or a global level affecting the structure’s seismic response (e.g. soft storey mechanism). On the other hand, under moderate shaking intensity, infills can provide additional stiffness and strength to the building. The positive or negative effects of infills on the seismic response of a structure still represent a controversial and unsolved topic.

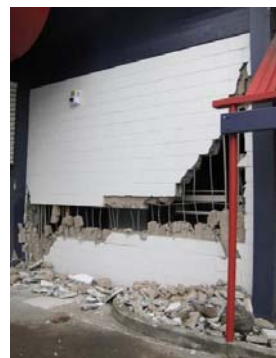
Figure 4.3.2 Potential Interaction between infills and surrounding frame (left). Example of reinforced concrete block infill damaged in Christchurch (right)

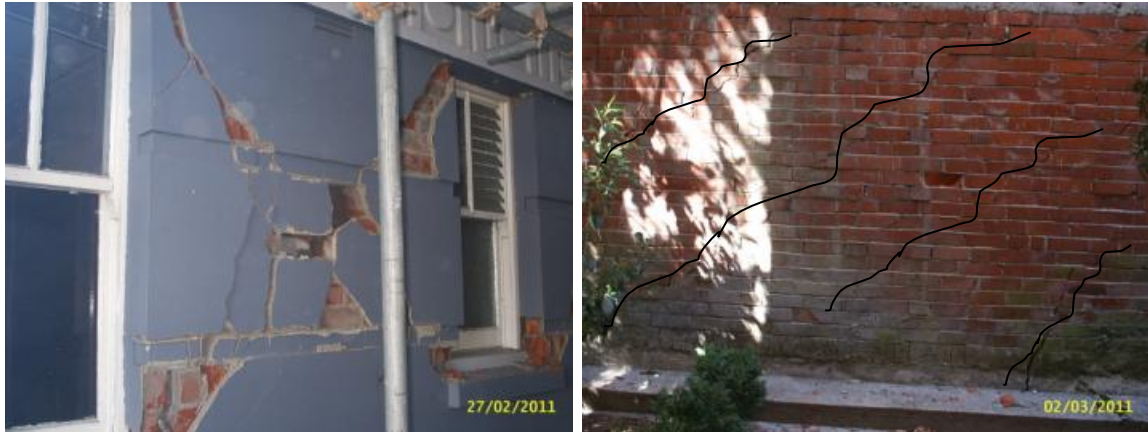
Figure 4.4.2 Diagonal cracking (Photos: A.S. Tasligedik)

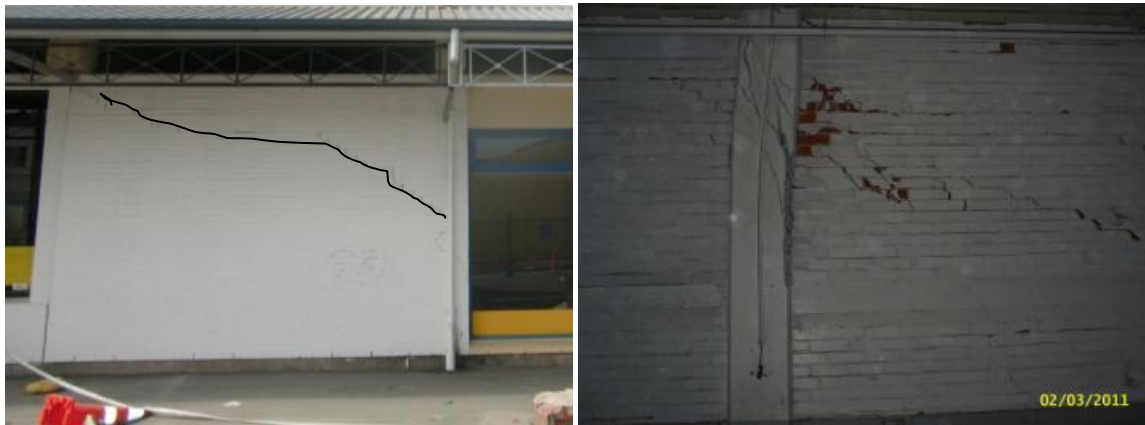
Figure 4.4.3 Sliding shear and interaction with surrounding frame (Photos: A.S. Tasligedik)

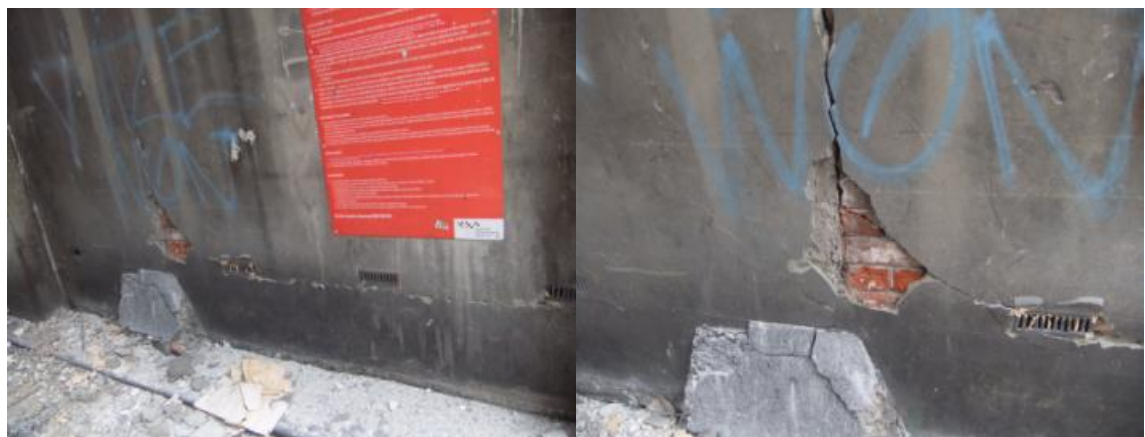
Figure 4.4.4 Corner crushing and interface cracking (Photos: A.S. Tasligedik)

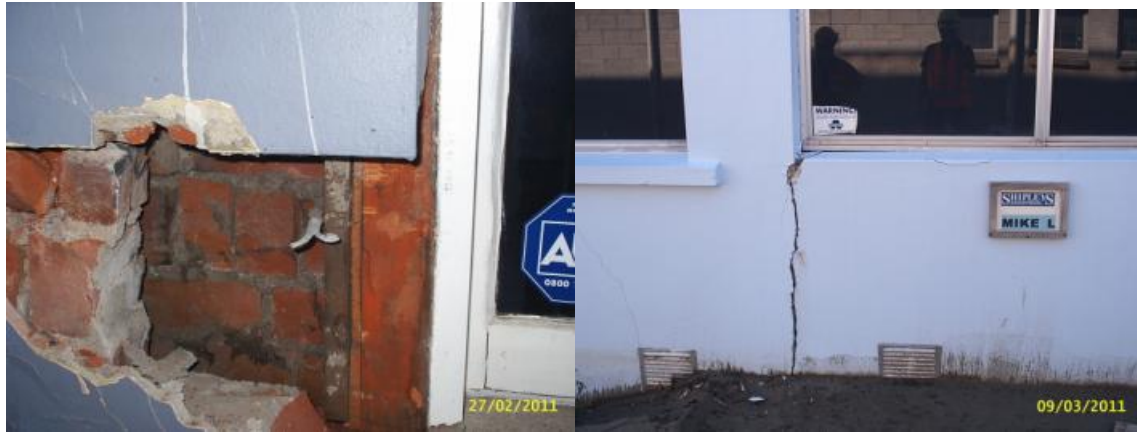
Figure 4.4.5 Spalling of bricks (left) and separation of infill from frame (right) (Photos: A.S. Tasligedik)

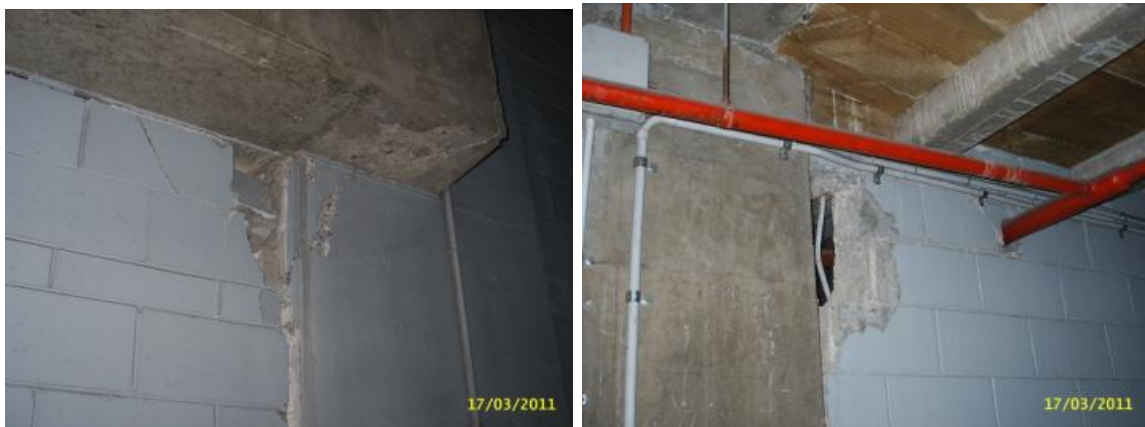
Figure 4.4.6 Corner crushing and revealed internal reinforcement of the infill wall (Photos: A.S. Tasligedik)

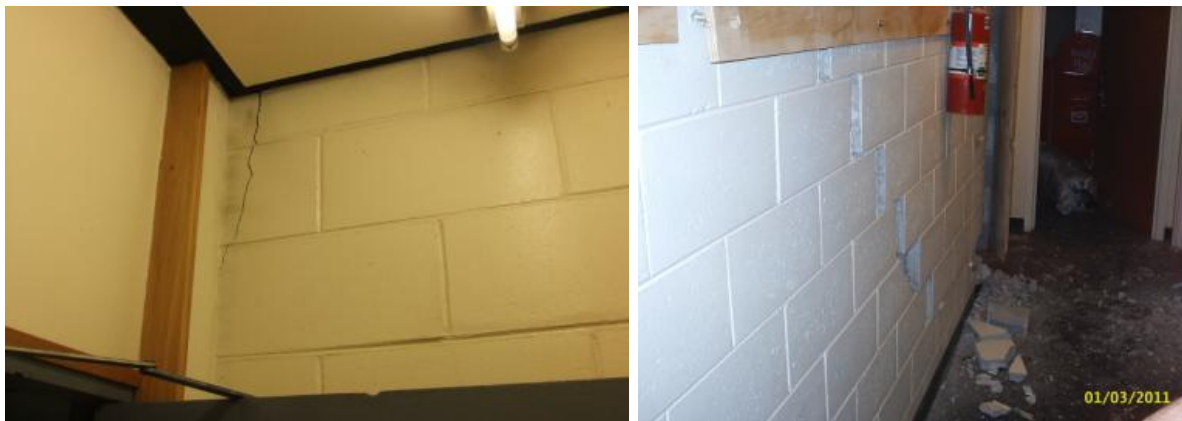
Figure 4.4.7 Splitting crack caused by corner compressive stresses Left) and stepped (or diagonal) cracking (right) (Photos: A.S. Tasligedik)

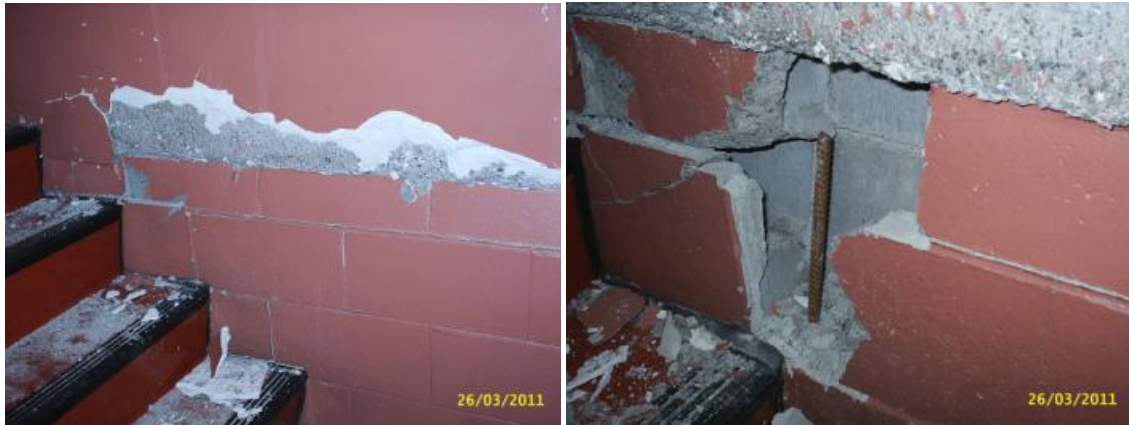
Figure 4.4.8 Crushing on top of the reinforced masonry infill wall (Photos: A.S. Tasligedik)

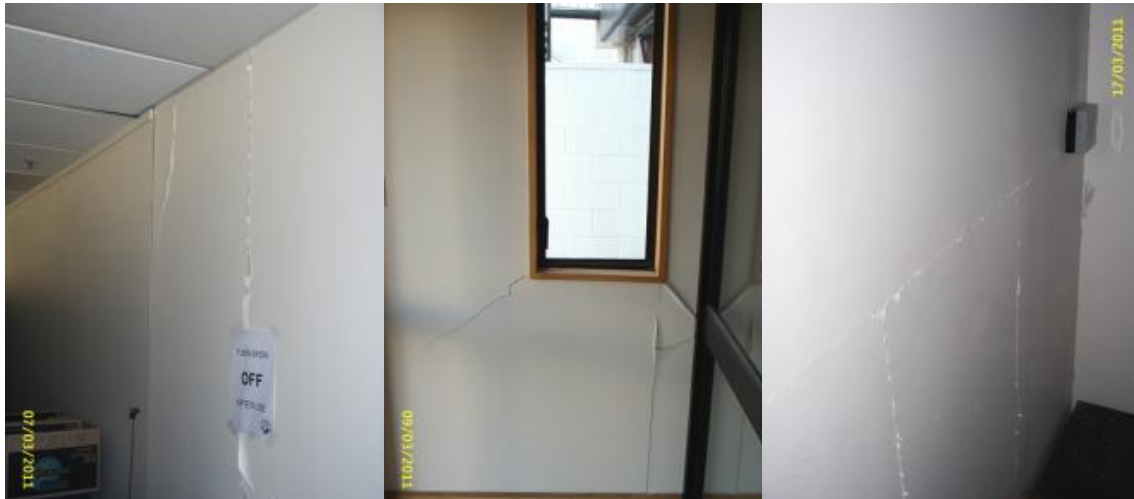
Figure 4.4.9 Cracking at lining interfaces (Photos: A.S. Tasligedik)

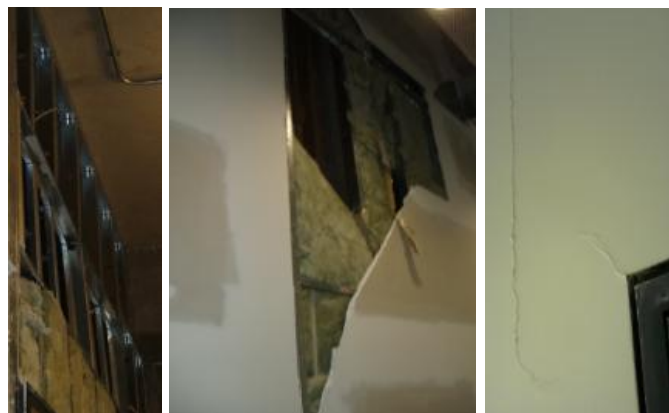
Figure 4.4.10 Steel stud buckling (left), broken lining (centre) and cracked lining at interface and the corner of doors (right) (Photos: Hans Gerlich)

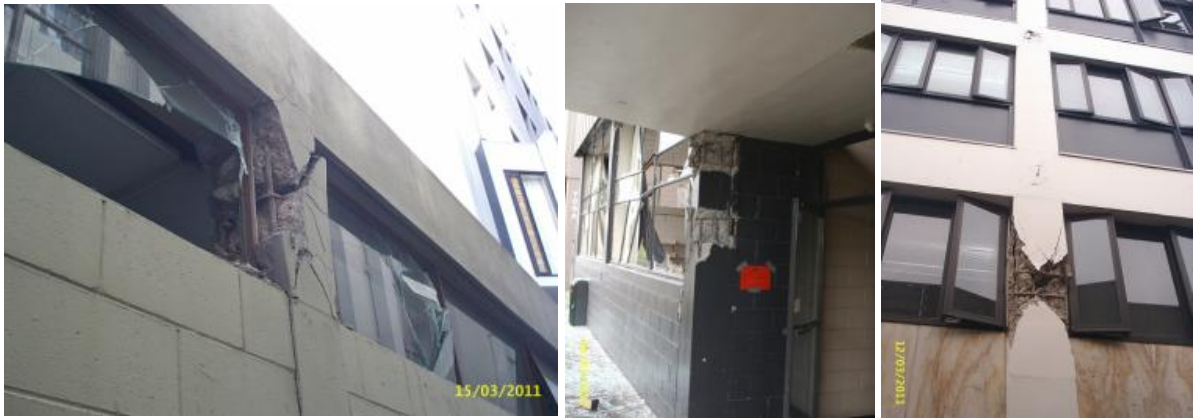
Figure 4.4.11 Short column shear failure due to infill presence (Photos: A.S. Tasligedik)

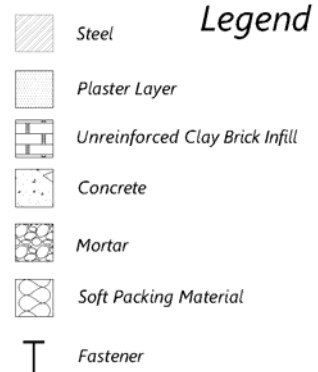
Figure 4.6.1 Unreinforced clay brick masonry recommended practice (Figure courtesy of A.S. Tasligedik)

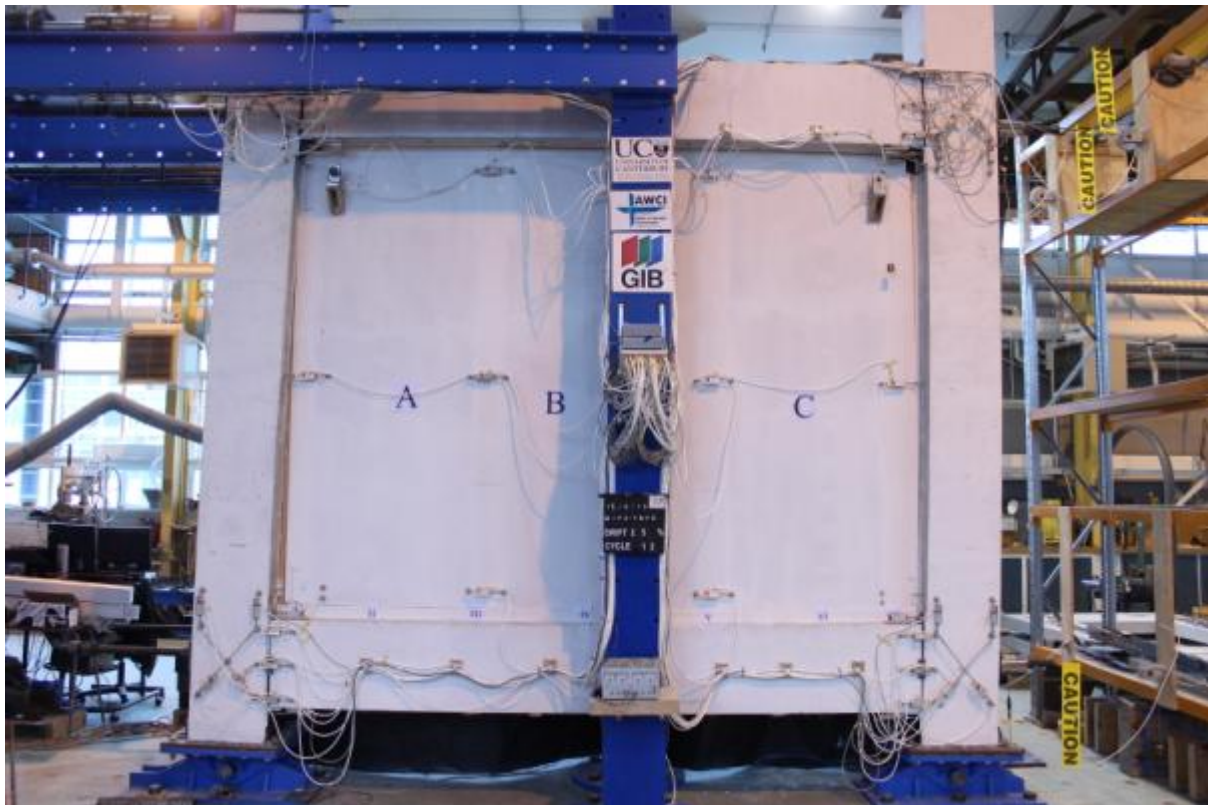
Figure 4.7.1 Damage resistant drywall solution at 2.5% drift level with only side plaster damage, still in serviceable condition. Experimental test campaign at University of Canterbury (Tasligedik et al., 2012)
