Kaikōura Earthquake Short-Term Project

Title: Assessment of existing concrete buildings in Wellington with precast floors

Assessment of existing concrete buildings in Wellington with precast floors

S.R. Corney, K. J. Elwood & R. S. Henry

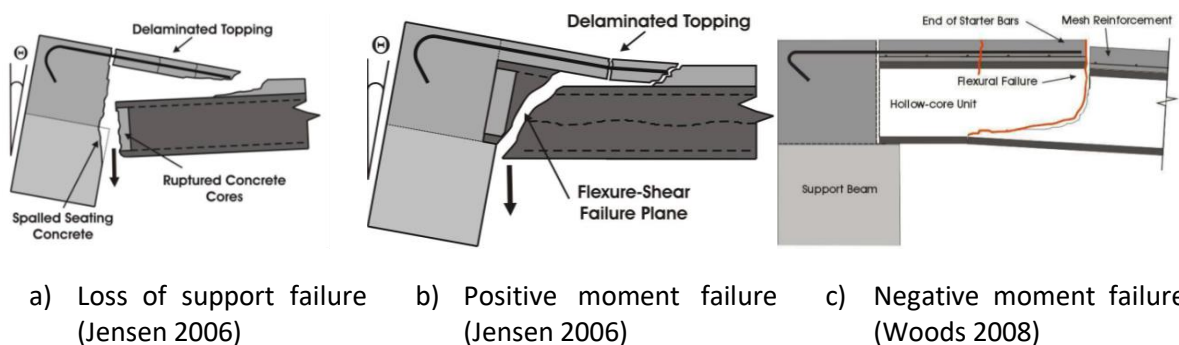
Figure 2. Previously identified failure modes for hollow-core floors

- **Loss of support:** The unit loses seating due to a combination of insufficient length of support to accommodate earthquake deformations, spalling of the support beam ledge, and entrapment of the end of the precast unit. Following loss of seating, the vertical reaction force to support the unit is transferred to the insitu topping concrete which will likely cause the topping to peel off the unit and a subsequent collapse of the floor unit.

- **Positive moment failure:** If the strength at the back face of the unit is sufficient to result in a weak section forming away from the support ledge. Cracking in this location will generally be initiated at low drift levels with any additional deformation becoming concentrated at this weak section. As the crack width at this location increases, gravity load transfer is compromised resulting in collapse of the floor unit.

- **Negative moment failure:** Where the continuity reinforcement is terminated too close to the support, the drop in negative moment capacity can result in a weak section. A crack in the top of the unit at this location can propagate into the webs of the unit causing loss of gravity load carrying capacity and collapse of the floor unit.

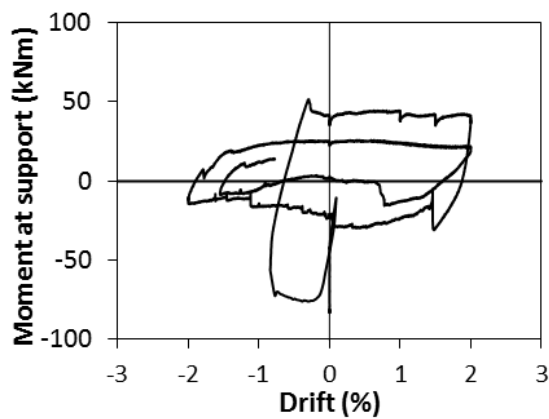
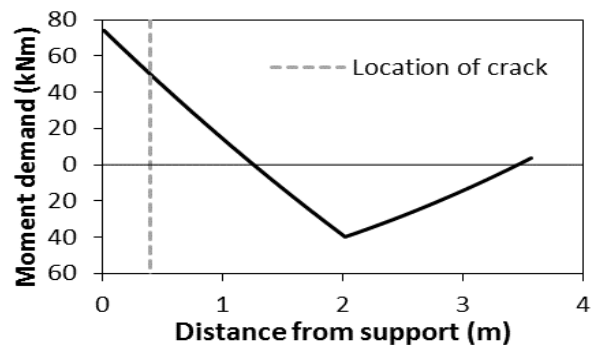
Figure 11. HC1 moment-rotation response

is then degraded prior to the application of further negative loading cycles later in the test. The delamination of part of the topping during loading to -2.0% drift (see Figure 10e) and the extent of damage sustained by this point in the test would have prevented significant negative moments from being sustained at the cracked interface and rather the floor dropped considerably relative to the support as it was rotated downwards. Figure 11a also indicates that significant positive moment capacity was developed by the connection during the first cycle to +2.0% drift with the damage sustained by the connection causing this capacity to drop considerably during the second cycle to this level of rotation.

Figure 11b shows the moment demand along the floor as the maximum negative moment is induced at the support (during loading to -0.9% drift). The magnitude of the moment demand at the crack relative to the support is consistent with the fact that deformation became concentrated at this location during the test. The lightly reinforced topping results in the capacity at the crack being significantly less than that required to crack the floor at the unit-to-beam interface. The proximity of the crack to the support connection and the shear at the support are therefore key factors in determining the susceptibility of negative moment cracks to widen as relative rotation is induced at the support.

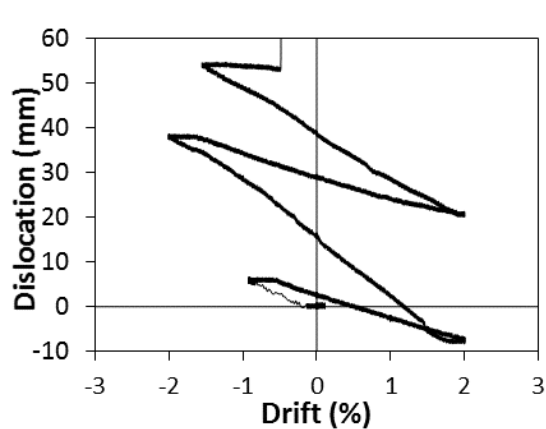
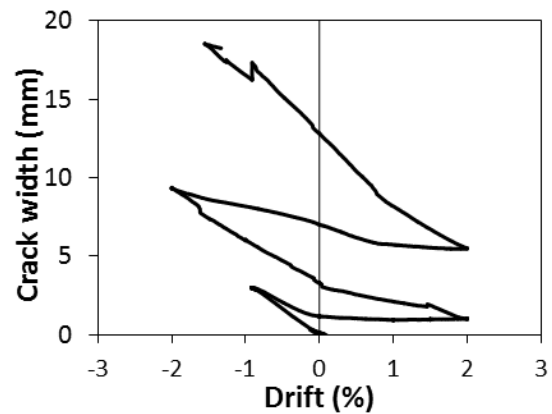
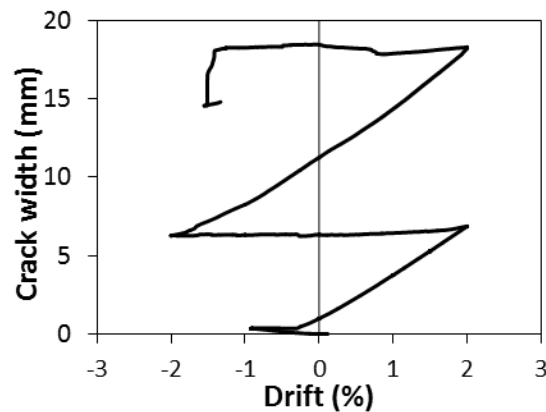
Figure 12. HC1 measured deformations

Vertical dislocation of the floor relative to the ground was measured by a displacement gauge positioned adjacent to the cracked interface (800 mm into the floor from the support beam) and began during the first loading cycle to -0.9% drift as indicated in Figure 12a. The skewed response of this dislocation is the result of the measurement recorded by this gauge being dependent on the rotation applied to the floor while the values measured at the zero drift cycles provide an accurate record of the dislocation of the floor relative to the beam at these points in the test. Following the first cycle to -0.9% drift, the residual dislocation of the floor was approximately 2 mm, a dislocation considered to be indicative of the floor vertical support being sustained by unreliable load paths. Following the first cycle to +2.0% and beginning at approximately +1.5% drift, the dislocation of the floor begins to rapidly increase due to the onset of the topping delamination discussed above (compare Figure 12a to the sharp drop in moment capacity at this point in the test shown in Figure 11a). The dislocation continually increases as the floor drops relative to the support as shown in the damage progression photos in Figure 10.

The measured crack widths throughout the progression of the test in the topping and the unit soffit are shown in Figure 12b and Figure 12c respectively. The crack width at the soffit approximates the length over which the prestressing strands are required to support the floor via dowel action. It can be seen in Figure 12c that this crack opened up approximately proportionally to the increase in positive rotation applied to the floor whilst remaining constant through the subsequent negative loading cycle. Measurements of the topping crack width became distorted during the latter testing cycles due to the vertical dislocation of the floor and partial delamination of the topping concrete. The residual crack widths at the zero drift position each cycle are a record of the elongation of the floor as the floor pries apart under cyclic loading.

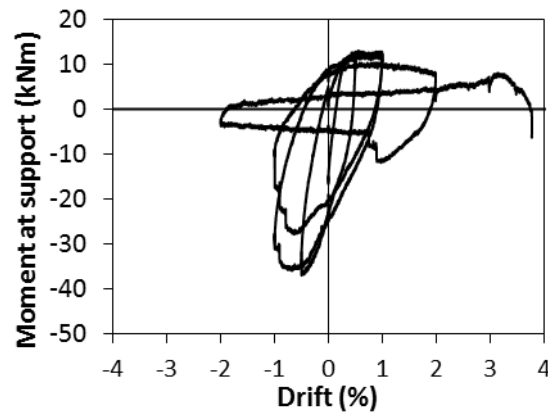
Figure 16. HC2 moment-rotation response

Figure 16 shows the moment-rotation response of the floor throughout the progression of the applied loading. The degradation the connection due to the induced damage meant that no appreciable positive moment capacity was developed and capacity was limited by the resistance of the prestressing strands as they debonded from the concrete. This capacity decreased during the final monotonic cycle as the strands became free of the end of the unit. Capacity during the negative loading cycles was provided by the mesh bars at the interface in tension. This tensile force resulted in an ultimate negative moment capacity of 38 kNm prior to the fracture of these bars, characterised by the ratcheting response of the connection. The ultimate negative moment capacity of the floor away from the connection is approximately 54 kNm due to contribution of the partially developed prestressing strands. This capacity was measured during the testing of specimen HC1 and shown previously in Figure 11b. Furthermore, the demand away from the connection is also reduced as the floor section becomes closer to the point of contra-flexure. As a result of the relative demand-to-capacity ratios, negative rotational deformation can be expected to become concentrated at the floor-to-beam interface for a cracked section where the topping reinforcement is constant through the floor-to-beam interface.

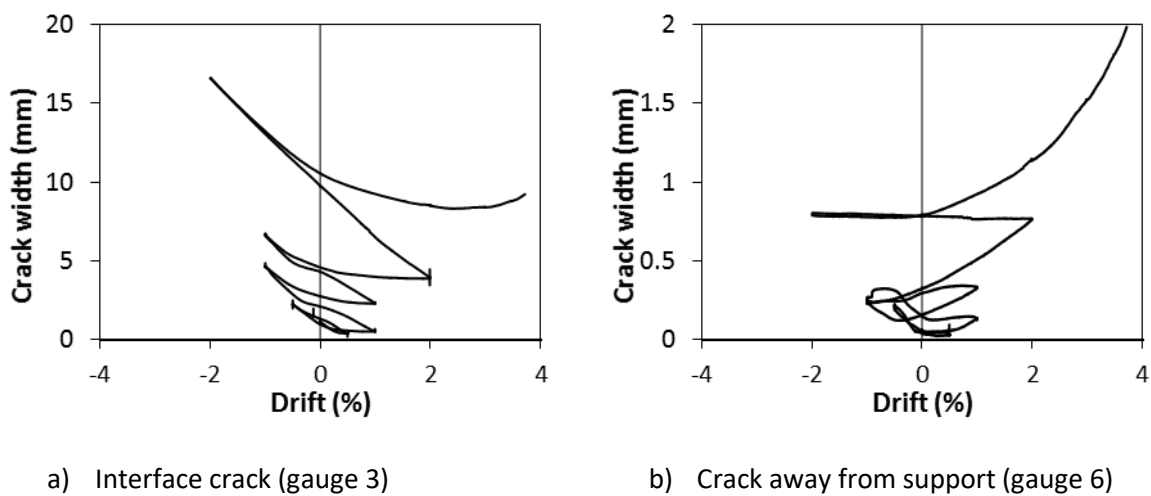
Figure 17. HC2 measured deformations in the topping

This concentration of deformation at the interface is indicated in Figure 17 also. Figure 17b indicates that there was some elastic straining of the mesh crossing the diagonal shear crack during the cycles to -0.5% and -1.0% while the mesh was still intact at the floor-to-beam interface. These strains were reduced as the demand dropped following the fracture of the bars at the interface. This crack is indicated to open up during the latter positive cycles in the test, however, this is only as a result of the floor dropping.

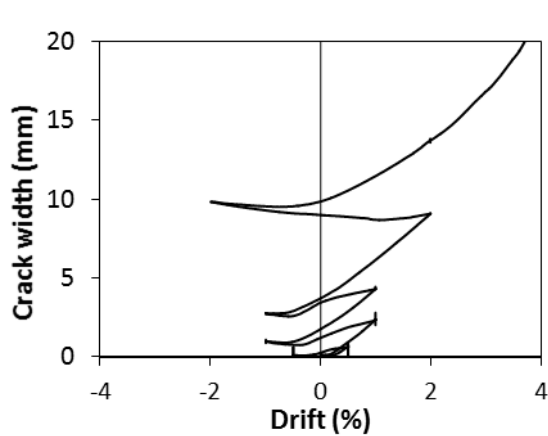
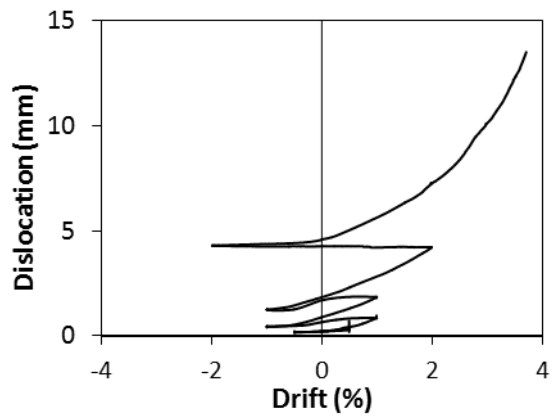
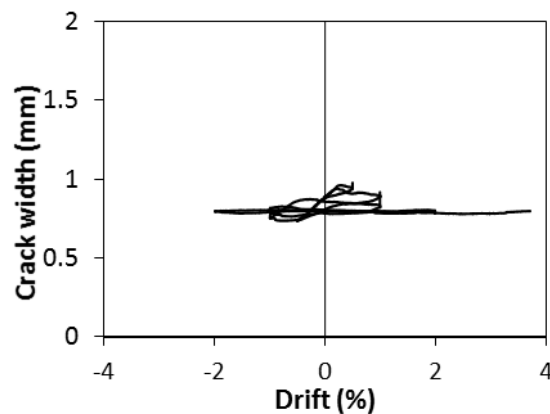
Figure 18. HC2 measured deformations at the soffit.

Figure 18a shows the growth of the shear crack at the support ledge during the test. The vertical component of this crack as it widened (shown in Figure 18b) meant that the dislocation of the floor went beyond 2 mm during the first cycle to +2.0% drift as described above, by which point it can be considered that the floor had lost reliable load paths to the support. Figure 18b also indicates that the floor had dropped considerably prior to the strands properly being pulled out of the end of the unit and collapse of the floor. Despite the formation of two cracks further into the floor on the eastern side of the connection (see Figure 15c) these cracks did not open up significantly during the test as deformation became concentrated at the crack close to the support where the prestressing strands were the least developed. It can be seen in Figure 18c that these cracks had opened up slightly during the earlier cycles but no further deformation was concentrated here later in the test as the connection degraded and the strand slipped out of the end of the unit.

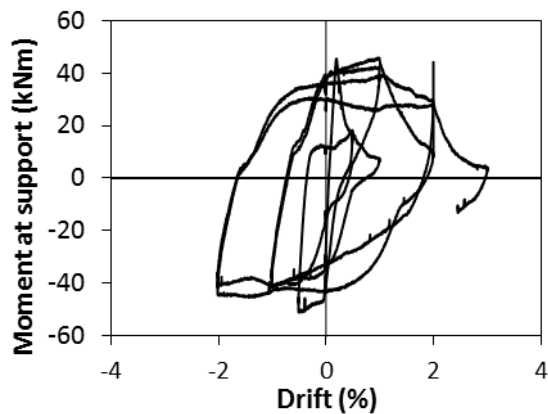
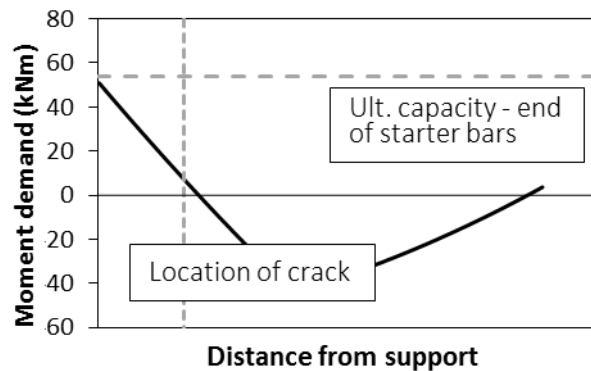
Figure 21. HC3 moment-rotation response

Figure 21a shows the moment-rotation response of the connection. As axial tension was applied through the horizontal actuator to achieve the pull-off deformation targets during the cycles to $\pm 1.0\%$ onwards, the negative moment capacity of the connection was reduced following the first cycle to -0.5% drift where only rotation was applied. This reduction in negative moment capacity was despite the fact that the starter bars were strain hardening as the applied deformation was increased. As a result, the peak negative moment demands in the floor were induced while the stress in the starter bars was only approximately equivalent to their yield strength. For the deformation targets to be achieved during the positive loading cycles, the floor was in compression where axial load was applied. As a result of this compression force through the unit, it can be seen in Figure 21a that the positive moment capacity of the floor remained high despite cracking at the floor-to-beam interface and a drop in capacity during the rotation-only cycle to +0.5% drift.

Figure 21b shows the bending moment profile along the floor at the point where the maximum bending moment demand was sustained at the connection. It can be seen from this bending moment profile that the demand was well below the capacity of the floor at the end of the starter bars and hence significant stress was not induced in the mesh. It should be noted that the location of the additional gravity load relative to the support was calculated based on inducing a reaction force at the support connection equivalent to that in the typical structure where the floor was simply supported. However, the increase in reaction force at the support connection with an increase in

The calculated ultimate negative moment capacity of the floor at the end of the starter bars shown in Figure 21b was based upon an assumed level of stress in the prestressing strands as well as assumptions made by Woods (2008) regarding the strain present in the mesh. This capacity was calculated to be 54 kNm, approximately equivalent to that measured during the testing of specimen HC1.

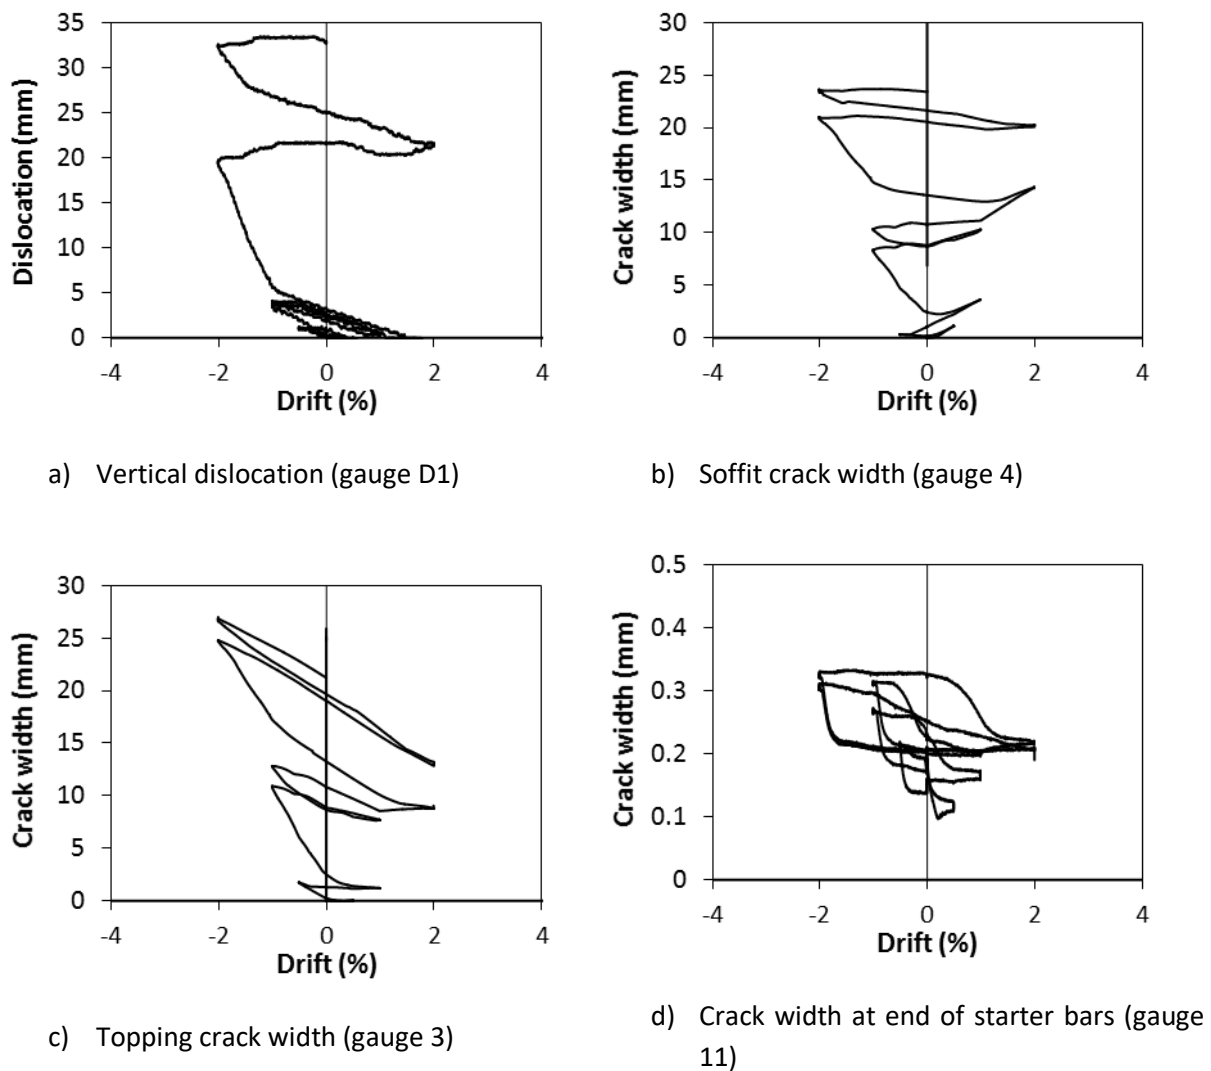
Figure 22. HC3 measured deformations

Figure 22 shows deformation measurements recorded throughout the seismic test. Unlike specimens HC1 and HC2, the crack widths sustained were induced as a direct result of the seismic loading protocol and the applied pull-off deformation; rather than the floor being pushed away from the support due to the applied rotation. Figure 22a shows the vertical dislocation of the floor recorded on the eastern side of the floor with the vertical dislocation on this side significant due to

The effective length of spalling was approximated from the applied deformation at the time the floor was considered to fail subtracted from the initial length of seating. As the initial seating for the unit was measured to be 47 mm and the applied deformation towards the height of the ledge was measured to be 14 mm at the point of failure (see Figure 22b); the effective length of spalling was approximated to be 33 mm, sustained following a maximum achieved drift of 2.0%.

Figure 22c and Figure 22d show the deformation within the topping at the floor-to-beam interface and at the end of the starter bars respectively. It can be seen that almost all of the applied deformation was concentrated at the floor-to-beam interface, consistent with the damage observations discussed above, while Figure 22d indicates that only small elastic strains had been sustained by the mesh during the negative loading cycles.

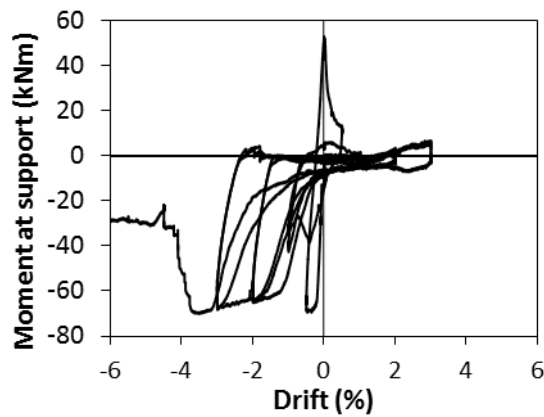
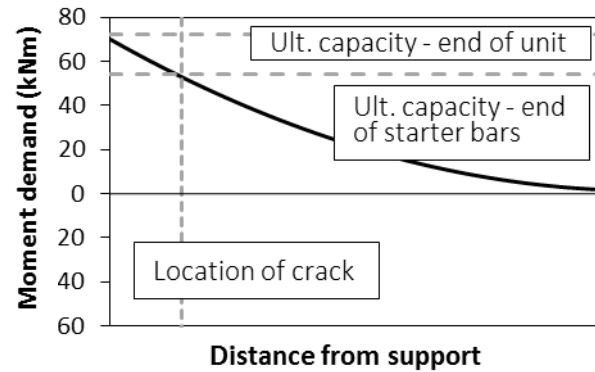
Figure 25. HC4 moment-rotation response

The response of the connection is illustrated in Figure 25a and it can be seen that the moment sustained at the connection during the cycles following cracking at the floor-to-beam interface was less than that which had caused yielding of the mesh during the earlier cycle to -0.5% drift. Approximately the same negative moment demand was induced at a drift of approximately -3.8% as that had been sustained by the uncracked interface at -0.5% drift, causing plastic straining and fracture of the mesh as discussed above. Figure 25b illustrates the bending moment demand along the floor as the maximum negative moment demand was induced and the mesh was yielding. It can be seen that for the mesh to approach ultimate capacity at the location where the starter bars were

terminated, the starter bars must also be very close to ultimate capacity at the floor to beam interface. As discussed above, the bending moment profile in the floor was unrealistically shallow during this test, meaning that for a regular 300HC floor, the starter bars would either have to be stronger or terminate close to the support to induce sufficient demand to induce this failure.

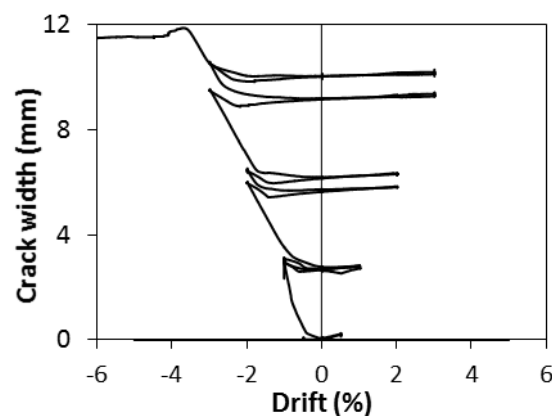
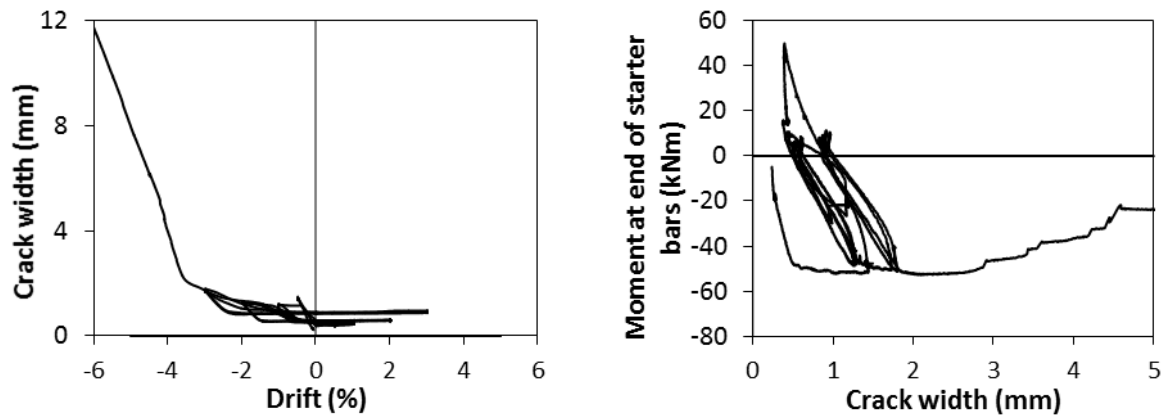
Figure 26. HC4 measured deformations

Figure 26 compares the measured deformations of both the crack in the topping at the floor-to-beam interface as well as the crack at the end of the starter bars. The gauges at each location confirm the observations discussed above and show that the applied deformation was almost solely concentrated at the end of the unit during the cycles to $\pm 1.0\%$, $\pm 2.0\%$ and $\pm 3.0\%$ drift, following which the demand at the end of the starter bars became sufficient to cause further deformation and ultimately failure of the floor to occur here.
