NHRP Kaikōura Earthquake Short-Term Project

**Co-seismic and ongoing land deformation
at Mt Lyford Village, North Canterbury**

Leader: Robert Langridge

Organisation: GNS Science

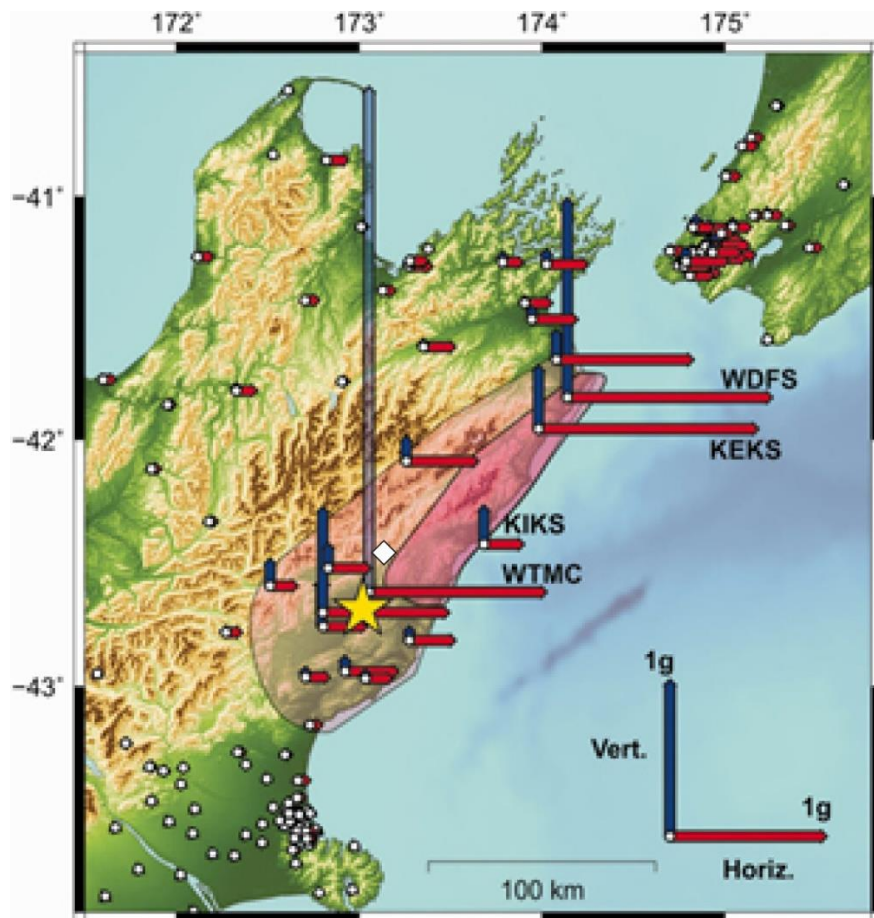
Figure 1.1 Peak ground accelerations in the horizontal (red) and vertical (blue) directions recorded at GeoNet strong-motion stations (from Kaiser et al., 2017). The epicentre of the Kaikōura earthquake is shown as a yellow star and Mt Lyford Village as a white diamond. The approximate extent of mapped landslides is shown as pink shaded area, with the majority occurring in the darker shaded region.

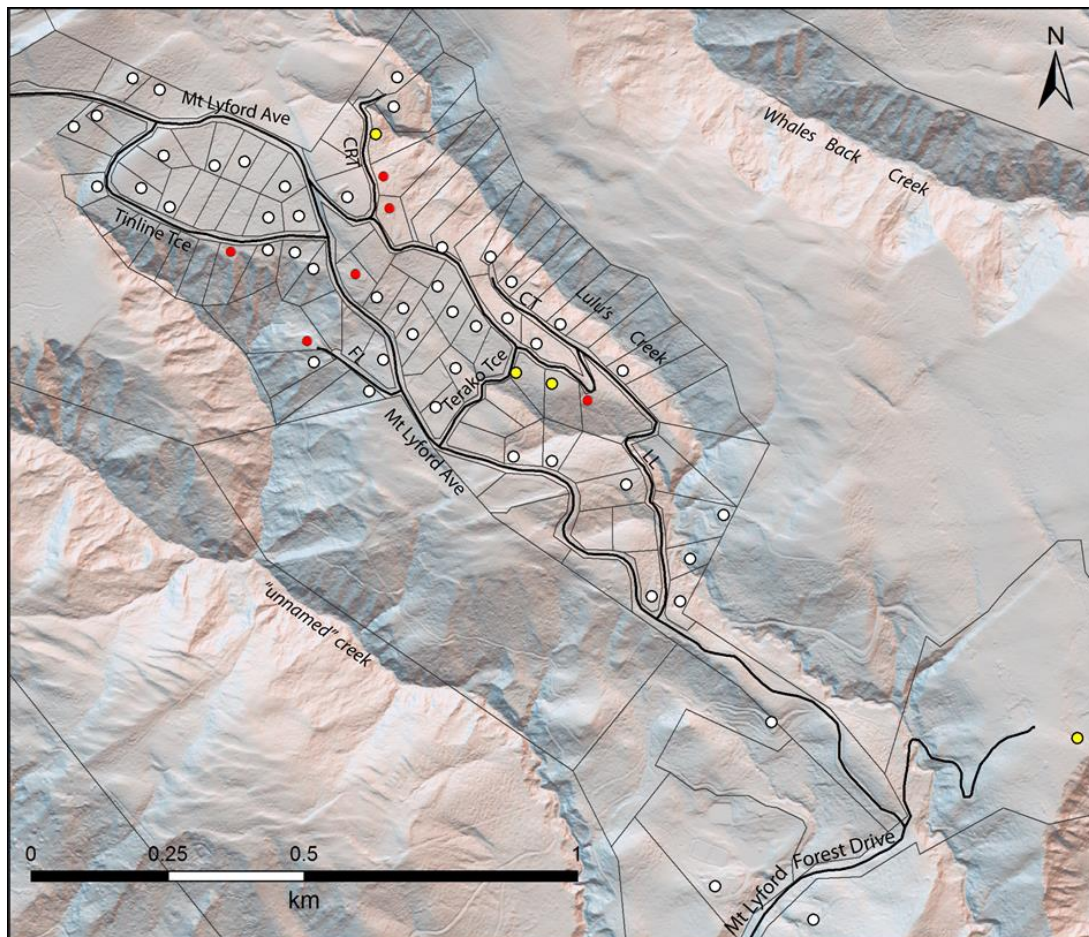
Figure 1.2 Airborne LiDAR-derived hillshade model of the Mt Lyford Village area highlighting street names, property boundaries, and post-earthquake rapid assessment placarding on houses. Dots are house sites, and the colours correspond to red, yellow and white 'placarding'. Abbreviations for street names are: FL, Foggy Lookout; LL, Lulus Lane; CT, Charwell Terrace; CRT, Cloudy Range Terrace.

As part of the earthquake response, HDC dispatched engineers to the village to assess and categorise the damage to built structures. The result of this assessment was a standard classification of red/yellow/white placarding being assigned to each dwelling in the village (Figure 1.2). These designations were later reviewed as part of the shift from post-earthquake response to council-led Section 124 notices under the Building Act 2004 (dangerous building, prohibited access) being placed on some log cabin homes. The log cabins in the village had a variable response to the strong shaking. Seven of the buildings within the village were given red placards (dangerous building, no access) and four yellow placards (damaged building, limited access) for a variety of reasons. Forty-five other dwellings were given a white placard designation (undamaged building, no access restrictions). A preliminary assessment of the performance of the log cabin buildings was undertaken by PTL (NZ), a private log cabin engineering company (Buchanan and Moroder, 2017). Dr. Daniel Moroder of PTL (NZ) was invited to be part of the project team to provide advice on the performance of log cabins relative to land damage and ground conditions.
