SEISMIC PERFORMANCE OF REINFORCED CONCRETE BUILDINGS IN THE 22 FEBRUARY CHRISTCHURCH (LYTTELTON) EARTHQUAKE

Weng Y. Kam¹, Stefano Pampanin², Ken Elwood³

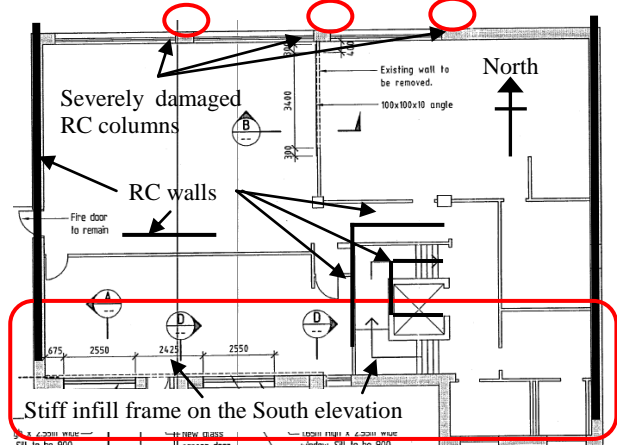
The poor seismic behaviour of these buildings is as expected. In many buildings, the presence of plan and vertical eccentricity intensified the seismic displacement and force demands on non-ductile RC elements.

Plan irregularity and column shear failure: Figure 9 and Figure 10 show a 4-storey 1950s RC frame-wall building with severe columns damage on the Northern frame. The building is reinforced with plain round bars. As seen in Figure 10, the columns, which failed in shear, have almost negligible transverse reinforcement.

Figure 9: Plan stiffness eccentricity due to stiff infill frame and internal RC ‘non-structural’ RC walls.

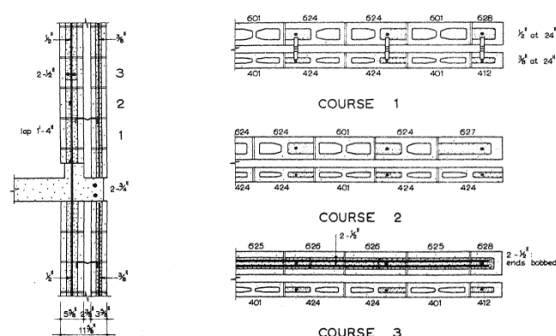
With the introduction of the New Zealand masonry code in the 1960s [44], the material quality and masonry workmanship were perceived to have significantly improved. In Christchurch, mid-rise residential buildings up to 6-storey were built using RC block masonry. Figure 22 shows some typical detailing of RCM lateral and gravity load-bearing walls used in the 1960s.

Typically observed deficiencies of RCM buildings are: a) Ungrouted cell with vertical reinforcement, b) Poor anchorage of reinforcement and foundation/bond beams, c) Lack of or inadequate horizontal (shear) reinforcement, and d) poor concrete block material.

Figure 22: Typical detailing of RCM lateral and gravity load-bearing walls used in New Zealand in the 1960s (taken from [33]). The external veneer can be unreinforced or reinforced with no grouting.

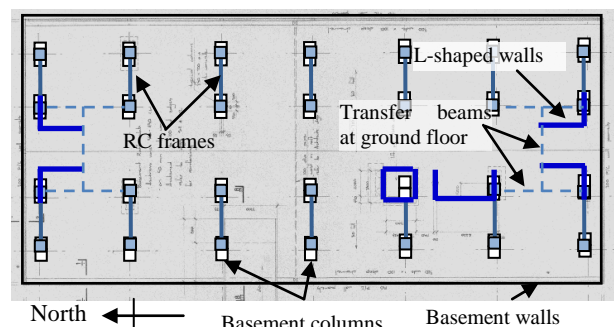
Figure 31 and Figure 32 show an example of an 11-storey RC frame and wall building. The lateral resisting systems (frames and walls) are terminated at the ground floor level with the ground floor slab acting as a transfer diaphragm to the basement perimeter walls. 175 mm thick ground floor slab was reinforced with high-strength 12 mm diameter bars at 300 mm to 350 mm centres are provided (see Figure 32c).

Figure 31: Schematic plan of an 11-storey building with plan and vertical irregularity resulting in severe basement columns shear-axial failure and transfer slab failure.

Four L-shaped 200 mm thick RC walls terminated at ground floor level and relied on a set of transfer beams (dashed lines in Figure 31) and slabs for inertia force transfer to the 150 mm-200 mm thick perimeter basement walls. The 300x500 mm deep transfer beams were initially damaged in the 4 September 2010 earthquake and were repaired (see Figure 32b).

There is also a plan stiffness irregularity, with the additional two sets of core walls on the Southern side. The plan irregularity resulted in torsional amplification and higher demand in the basement columns on the Northern side. Nearly all of the basement columns on the Northern side (first three gridlines) had suffered shear-axial failure (see Figure 32a).

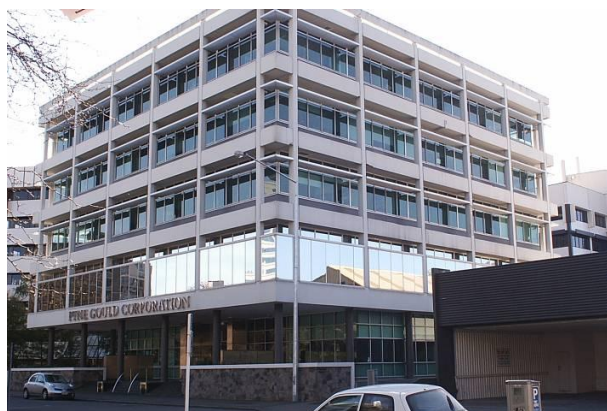
Figure 46: Pyne Gould Corp (PGC) Building photographed from the South-East elevation after the 4 September 2011 earthquake.

The Pyne Gould Corp (PGC) building was designed and built in 1963-64, near the time of seismic code revision in 1964-65 (NZS1900:1965 [44]). It is a six-storeys five-by-five bays RC frames building (Figure 46) with an internal core wall. Figure 47 shows the typical upper floor's structural plan view.

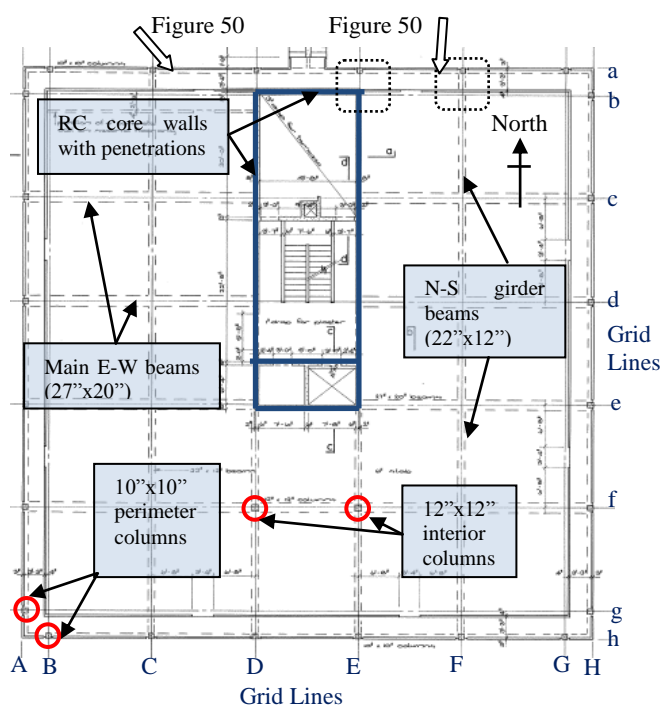
Figure 47: Plan view of the typical upper floors (2nd to 4th Floors).

In the East-West direction, six RC three-bays (10m-5m-10m) frames (most likely designed for gravity-load only) would contribute a minor level of lateral strength and stiffness. The E-W direction main beams are 33"x24" (840x 610 mm) at the 1st floor and 27"x20" (685 x 510 mm) at 2nd floor to roof. At the Northern side of the building, four of the RC frames are framing into the core walls. In the second Southern frame line, there are two interior columns, measuring 16"x16" at the ground floor, and 12"x12" at the upper levels (see Figure 47).

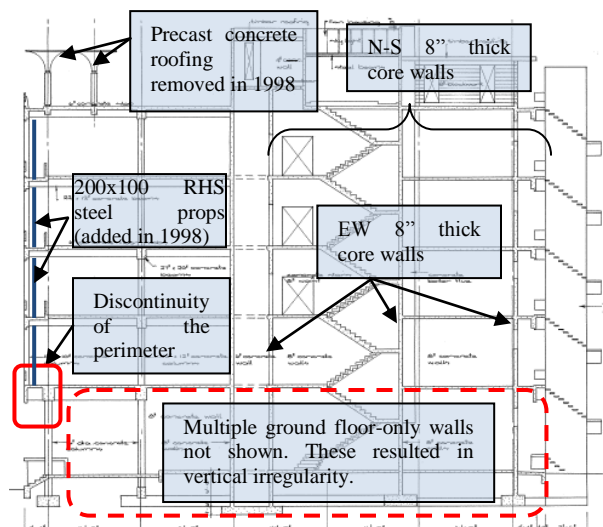
Figure 48: North-South elevation on Grid Line D.

Structural systems: The lateral load resisting system consists of 8" (200 mm) thick RC core walls with two 15 m long RC walls along Grid Line D and E (acting in the North-South direction), and three shorter (two 5 m and one 2.6 m long) RC walls along Grid b and e (acting in the East-West direction). Figure 48 shows the East-West cross elevation view, which indicates some of the openings in the North-South 15 m long walls. The shorter RC walls have significant openings (two door openings of approximately 850 mm x 2,200 mm dimensions).

After a seismic structural review in 1997, 18 200x100RHS steel props were installed behind each perimeter column (see Figure 48). Several precast concrete roof canopies were removed to reduce the falling hazard.

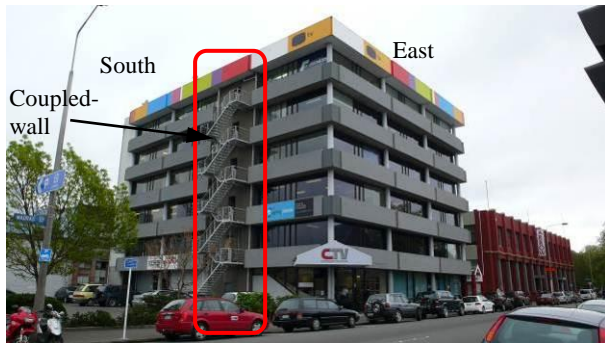
Figure 51: The CTV Building from the South-East corner. Photograph is courtesy of Dr Yuji Ishikawa.

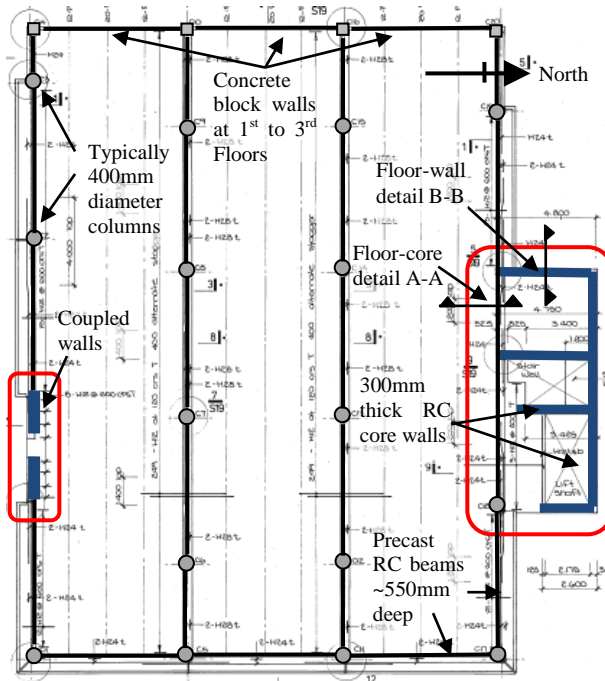
Figure 52: Typical floor plan of the CTV building.

The 6-storey RC building comprises a coupled-shear wall on the Southern side and a core RC wall on the Northern side of the building. Four RC frame lines provided some lateral

The 300mm thick RC core walls on the Northern side of the building, measuring 4.8 m x 11.5 m long, were generally well-reinforced with ductile detailing typical of 1980s construction. However, the RC core walls had limited connections to the floor diaphragm of the building, with approximately 11.5 m length of floor-slab (minus some void area due to lift penetration).

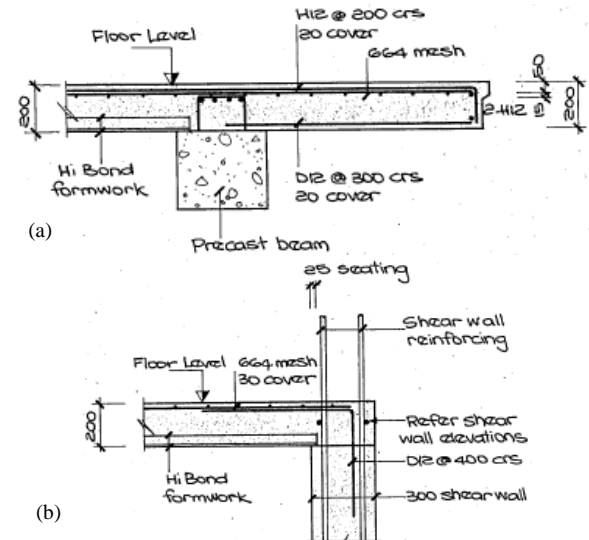
Figure 53 illustrates the typical slab-to-core walls (slab and wall) connection detail. A Hi-Bond steel deck with 200 mm thick concrete reinforced with one-layer of cold-drawn wire mesh and one layer of H12 bars at 200 mm centres was relied upon for transferring the seismic inertial load from the main structure to the RC core walls.

Figure 53: Structural detail of the diaphragm connection to the RC core walls (refer to Figure 52): a) Slab – core wall connection A; b) Slab walls connection B.

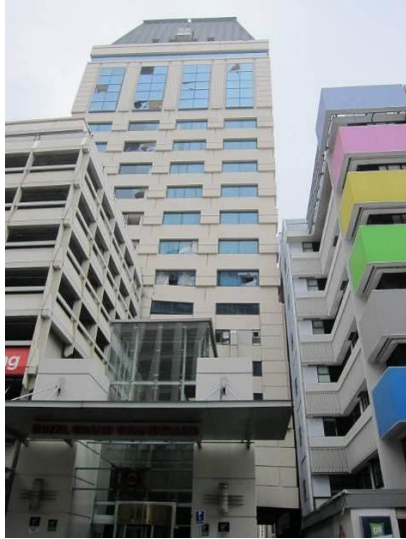
The 22-storey Grand Chancellor Hotel (GCH) (1970s parking structure + 1986-1988 hotel tower construction) was severely damaged during the 22 February 2011 earthquake, leading to an approximately 1,300 mm horizontal lean of the top of the tower and restricted access to the potential fall zone around the building (Figure 57).

Figure 57: The Southern elevation of the Grand Chancellor Hotel, with a distinct 200 to 400mm lean towards the East (right) side immediately after the 22 February 2011 earthquake.

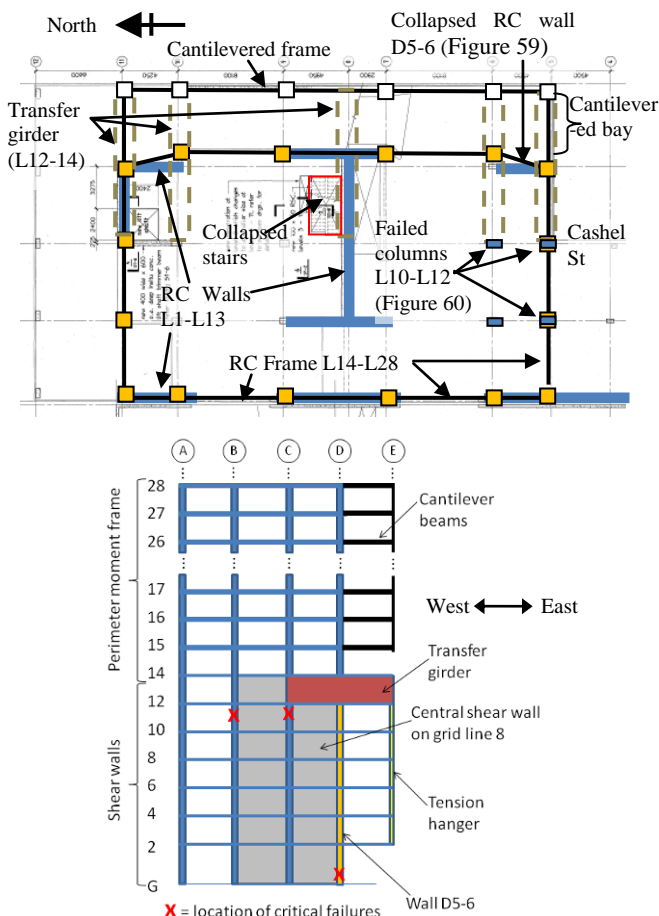
Significant structural irregularities influenced the behaviour of the GCH building in the 22 February earthquake. Most notably the east side of the building (bay D-E) was cantilevered over Tattersalls Lane (Figure 58), which was a subsequent redesign due to unexpected legal issues.

As indicated in Figure 58, the Eastern bay of the lower 14 half-height floors was cantilevered using several very deep transfer girders between levels 12 and 14. The southernmost transfer girders were supported on a critical shear wall denoted as D5-6 in Figure 59. Above the 14th floor, bay D-E is cantilevered by beams at each level and grid line.

Figure 58: Schematic plan and elevation of the Grand Chancellor Hotel. The floor numbering is based on the original construction drawings – the lower 14 floors are half-height car park floors. The building comprises 22 suspended storeys which includes a plant room level.

The 5 m long 400 mm thick RC wall D5-6 on the Southern side, supports a disproportionately large tributary gravity load from all floors as a result of the cantilever system. Wall D5-6 was reinforced with two layers of 20 mm diameter vertical bars at 300 mm centres and two layers of 16 mm diameter horizontal bars at 200 mm centres. The wall boundary reinforcement consisted of 4-D24 supported by a single plain round 10 mm diameter hoop at 150 mm centres. The symmetrical wall on the Northern side was more heavily reinforced (one bar size up and more boundary reinforcing) as it has a lower “design” axial force level compared to wall D5-6.
