Liquefaction Impacts on Pipe Networks

Short Term Recovery Project No. 6 Natural Hazards Research Platform

**Misko Cubrinovski¹⁾, Matthew Hughes¹⁾, Brendon Bradley¹⁾
Ian McCahon²⁾,
Yvonne McDonald³⁾, Howard Simpson⁴⁾, Rod Cameron⁴⁾,
Mark Christison⁴⁾, Bruce Henderson⁴⁾,
Rolando Orense⁵⁾ and Thomas O'Rourke⁶⁾**

December 2011

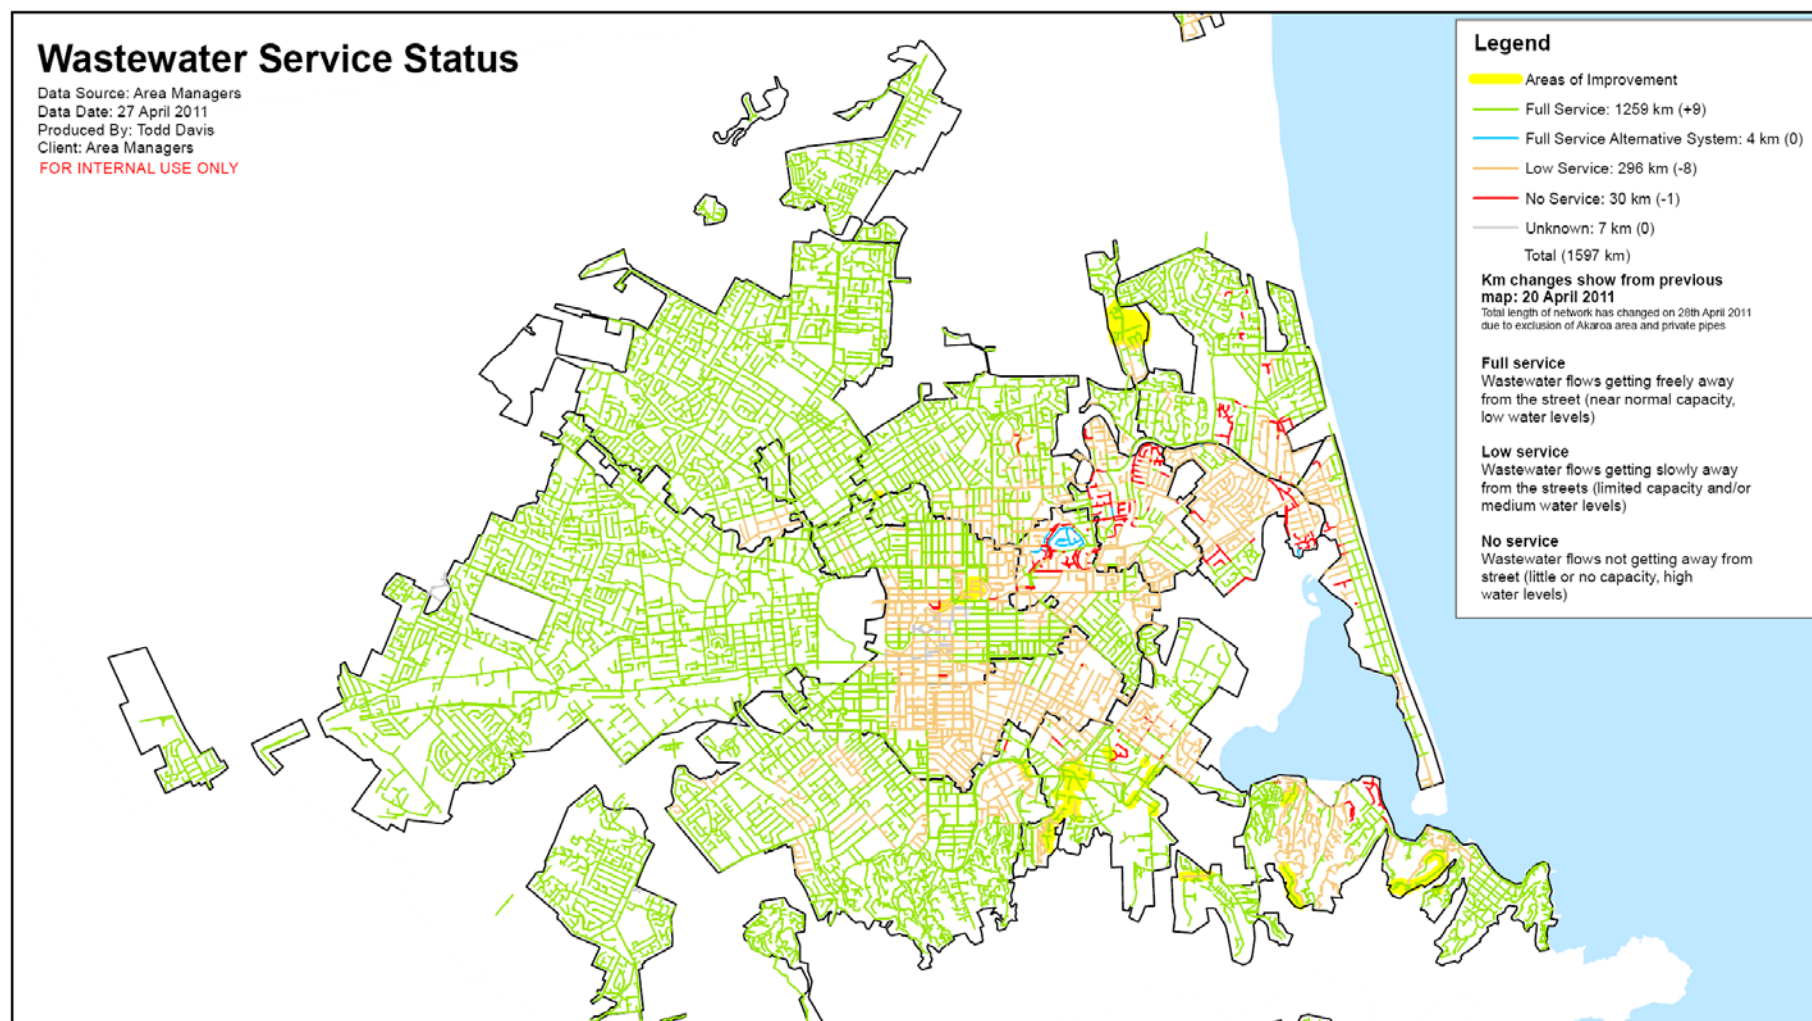
Figure 23. Wastewater network status as of 27 April 2011 indicating the speed of reinstatement of services in conjunction with the status map shown in Figure 22

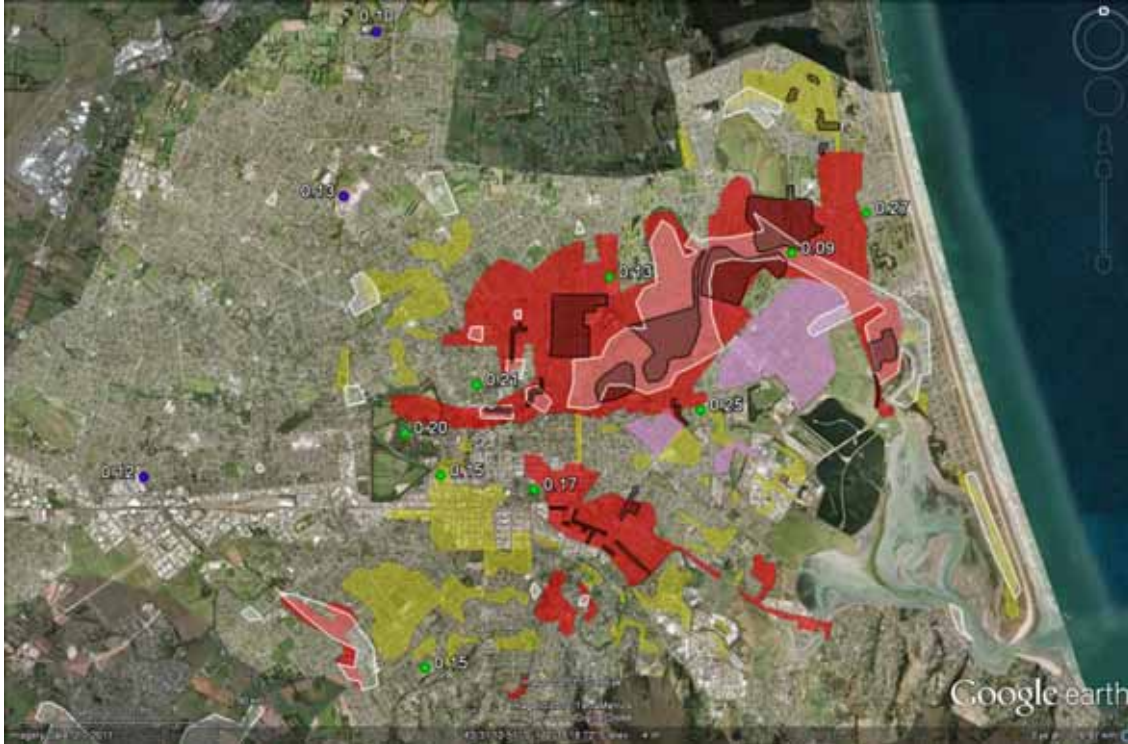
Figure 1 indicates areas within Christchurch that liquefied during the 4 September 2010 earthquake (white contours/shaded area), 22 February 2011 earthquake (red = moderate to severe liquefaction; yellow = low to moderate liquefaction; magenta = moderate liquefaction predominantly on roads with some on properties; Cubrinovski and Taylor, 2011) and 13 June 2011 earthquakes (dark grey contours/shaded area; Cubrinovski and Hughes, 2011). The liquefaction was particularly extensive and damaging along the meandering loops of Avon River, from the CBD to the estuary, where multiple episodes of severe liquefaction occurred during the earthquakes. In areas close to waterways (rivers, streams), the liquefaction was often accompanied by lateral spreading, a particular form of ground movement/failure associated with liquefaction that produces excessive lateral ground displacements (from tens of centimetres to several metres), and hence, is very damaging for buildings and infrastructure. In addition to the areas along Avon River shown in Figure 1, substantial damage to residential buildings and lifelines due to liquefaction and lateral spreading also occurred in North Kaiapoi, South Kaiapoi, Brooklands and parts of Spencerville during the 4 September 2010 earthquake. Lateral spreading was consistently associated with the largest and most severe damage, and many of the nearly 6,000 residential properties that will be abandoned (New Zealand Government, 2011) were affected by spreading of liquefied soils.

Figure 1 Preliminary liquefaction maps documenting areas of observed liquefaction in the 4 September 2010 (white contours), 22 February 2011 (red, yellow, magenta areas), and 13 June 2011 (black contours) earthquakes; note that only parts of Christchurch were surveyed and that the aim of the surveys was to capture only general features and severity of liquefaction manifestation as observed from the roads, hence, the zoning is not applicable to specific properties. Normalized cyclic stress ratios at water table depth, $CSR_{7.5(wt)}$, which were calculated using the recorded geometric mean peak ground accelerations and respective earthquake moment magnitude are also shown. For the Strong Motion Stations (SMS) denoted with green symbols, the 22 February 2011 produced the highest $CSR_{7.5(wt)}$ value whereas the 4 September 2010 earthquake produced the highest $CSR_{7.5(wt)}$ value at the SMS depicted with blue symbols. The corresponding maximum cyclic stress ratio at Kaiapoi was $CSR_{7.5(wt)} = 0.19$ (produced by the 4 September 2010 earthquake)

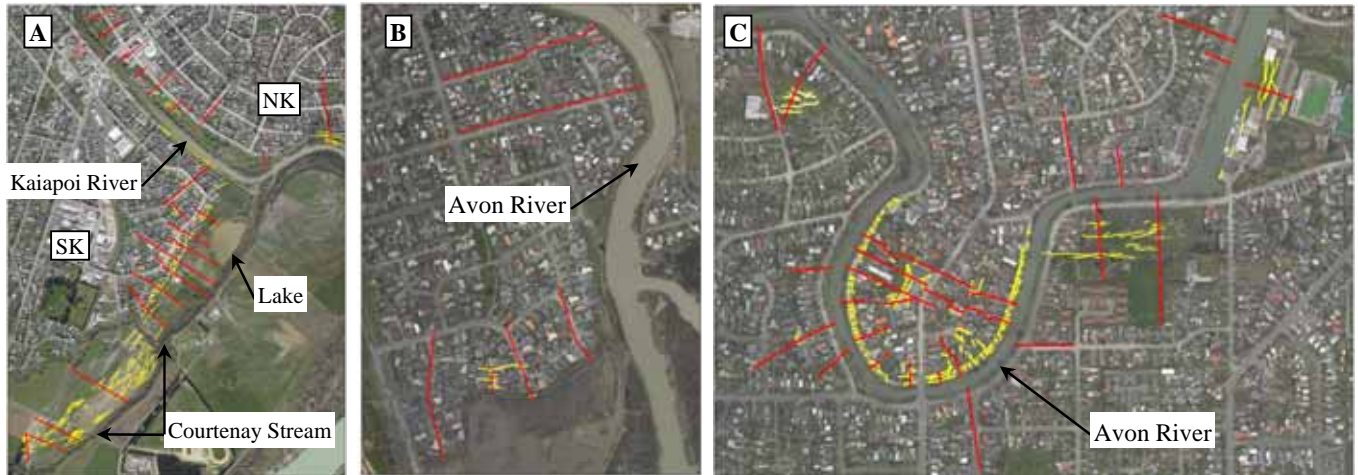
Figure 2 shows aerial photographs of Kaiapoi (A), Bexley (B), and Avonside and Dallington (C) where ground surveying measurements of lateral spreads were conducted after the 4 September earthquake, in the period September – November 2010. Red solid lines indicate the transect alignments while yellow solid lines indicate major cracks and fissures caused by spreading. As illustrated in this figure, areas along waterways (rivers, streams, lakes and wetlands) were targeted in the lateral spreading measurements.

Figure 2 Aerial photographs indicating transect locations (red lines) and major ground cracks/fissures (yellow lines) in areas of ground surveying measurements of lateral spreading in **A**, Kaiapoi; **B**, Bexley; **C**, Avonside and Dallington.

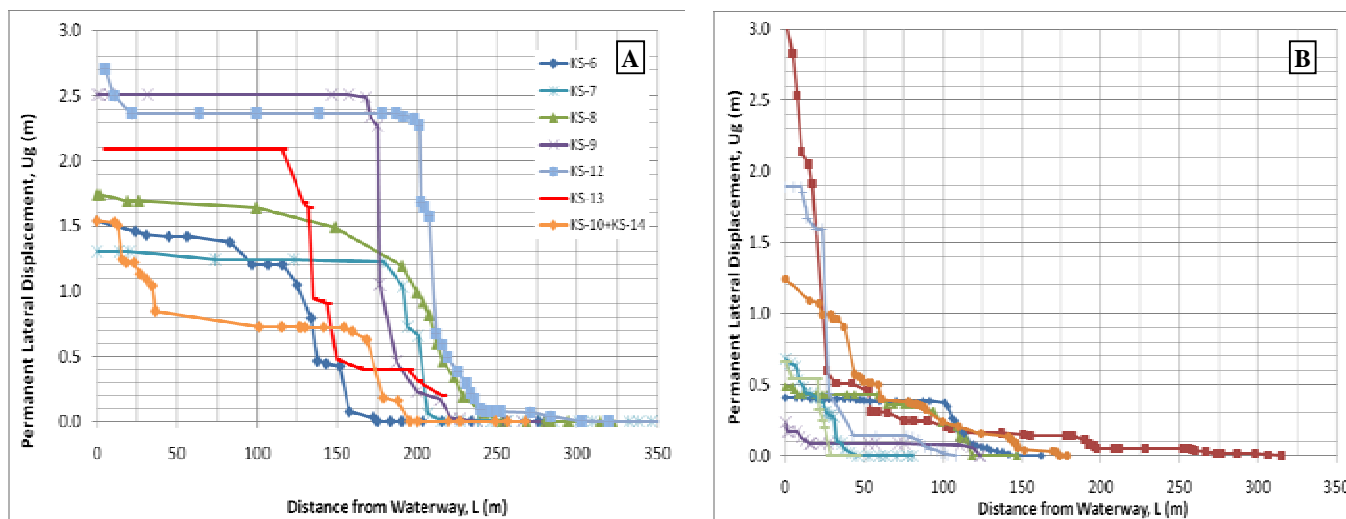
Results of measured permanent lateral spreading displacements in South Kaiapoi (A) and North Kaiapoi (B) after the 2010 Darfield earthquake are shown in Figure 3. The locations of measurements (transect alignments) are those indicated in Figure 2A. In South Kaiapoi, the most dominant ground failure feature was the massive lateral spread along the Courtenay Stream and Courtenay Lake which caused substantial damage to the residential properties along the eastern branch of Courtenay Drive. The area affected by lateral spreading was approximately 1-km long in the north (northeast) - south (southwest) direction and extended up to 200-300 m inland from the Courtenay Stream/Lake. The lake was artificially created during the construction of the northern end of Courtenay Dr. Borrow material was removed from the area where the lake is presently located and used as hydraulic fill (about 1 m thick) for the northern branch of Courtenay Dr (Waimakariri District Council, 2010a). Swedish Weight Sounding (SWS) penetration tests and Spectral Analysis of Surface Waves (SASW) measurements of shear wave velocities consistently indicated a loose to very loose liquefiable layer from 1 m to 5-6 m depth in this area (Cubrinovski et al., 2010).

Each relationship between the lateral ground displacements (U_G) and distance from the waterway (L) shown in Figure 3 was obtained by summing up the width of the cracks measured along a particular transect alignment. Strictly speaking, each line indicates permanent horizontal displacements relative to a reference point, which is located approximately at the furthest lateral-spreading crack or the right-most point of the line where the displacement is practically zero. A long horizontal section of the U_G - L line indicates that there were no cracks/fissures on the ground surface within that range of distances, while a steep (nearly) vertical line indicates a large crack at the particular distance, the size of which is readily available from the difference in

displacements between the high and low points of the vertical-line segment. With this in mind, the following observations can be made from the results shown in Figure 3:

As described in the previous sections, lateral spreading involves large lateral ground movement at/near open faces (banks of waterways), but also substantial differential displacements in the direction of spreading resulting in large extensional deformation and ground fissuring. Figure 3 implies, for example, that the equivalent extensional strains in the zone of largest ground cracks were on the order of 5-10% while the 'average' extensional strains in the area affected by spreading were approximately 0.5-1.0%. The spreading was often accompanied by slumping of the soils near the banks (large settlement/subsidence), which was particularly noticeable at the approaches of bridges. Both lateral and vertical ground displacements induced by spreading were spatially non-uniform resulting in large localized deformation, stretching, tensile cracking and shearing of the ground. The non-uniformity of the ground deformation was further exacerbated by the spatial variability in the severity of liquefaction as well as the influence of soil-structure interaction on the movement, deformations and flow of water during dissipation of excess pore water pressures. Finally, as implied in the description of the mechanism of lateral spreading, spreading-induced loads involve combined inertial (due to accelerations) and kinematic (due to ground movement) effects, the characteristics of which depend on the evolution of the lateral spreading process in relation to the particular acceleration time history (ground motion at the site) and the site/soil response. Clearly, engineering structures that were located within the spreading zone were subjected to very large and highly non-uniform (both spatially and temporally) ground deformation and seismic forces which were more often than not above the available capacity to sustain such movements/loads, hence resulting in substantial and widespread damage to buildings and infrastructure.

Figure 3 Permanent lateral ground displacements plotted against the distance from the waterway, measured in lateral spreading ground surveying in **A**, South Kaiapoi; and **B**, North Kaiapoi.

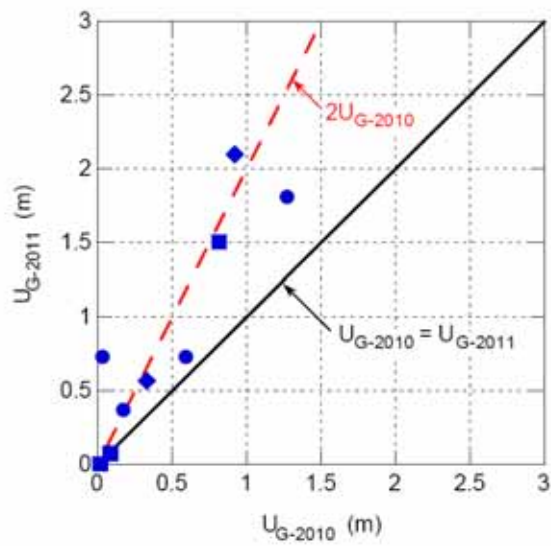
After the 22 February 2011 earthquake, the ground surveying measurements were repeated at 25 locations to quantify the additional lateral ground movements due to spreading induced by the February event. Figure 4 comparatively shows the spreading

Figure 4 Comparison of permanent lateral ground displacements along Avon River (Avonside, Dallington, Bexley) caused by the 4 September 2010 earthquake (horizontal axis) and cumulative displacements due to the 4 September 2010 and 22 February 2011 earthquakes (vertical axis)

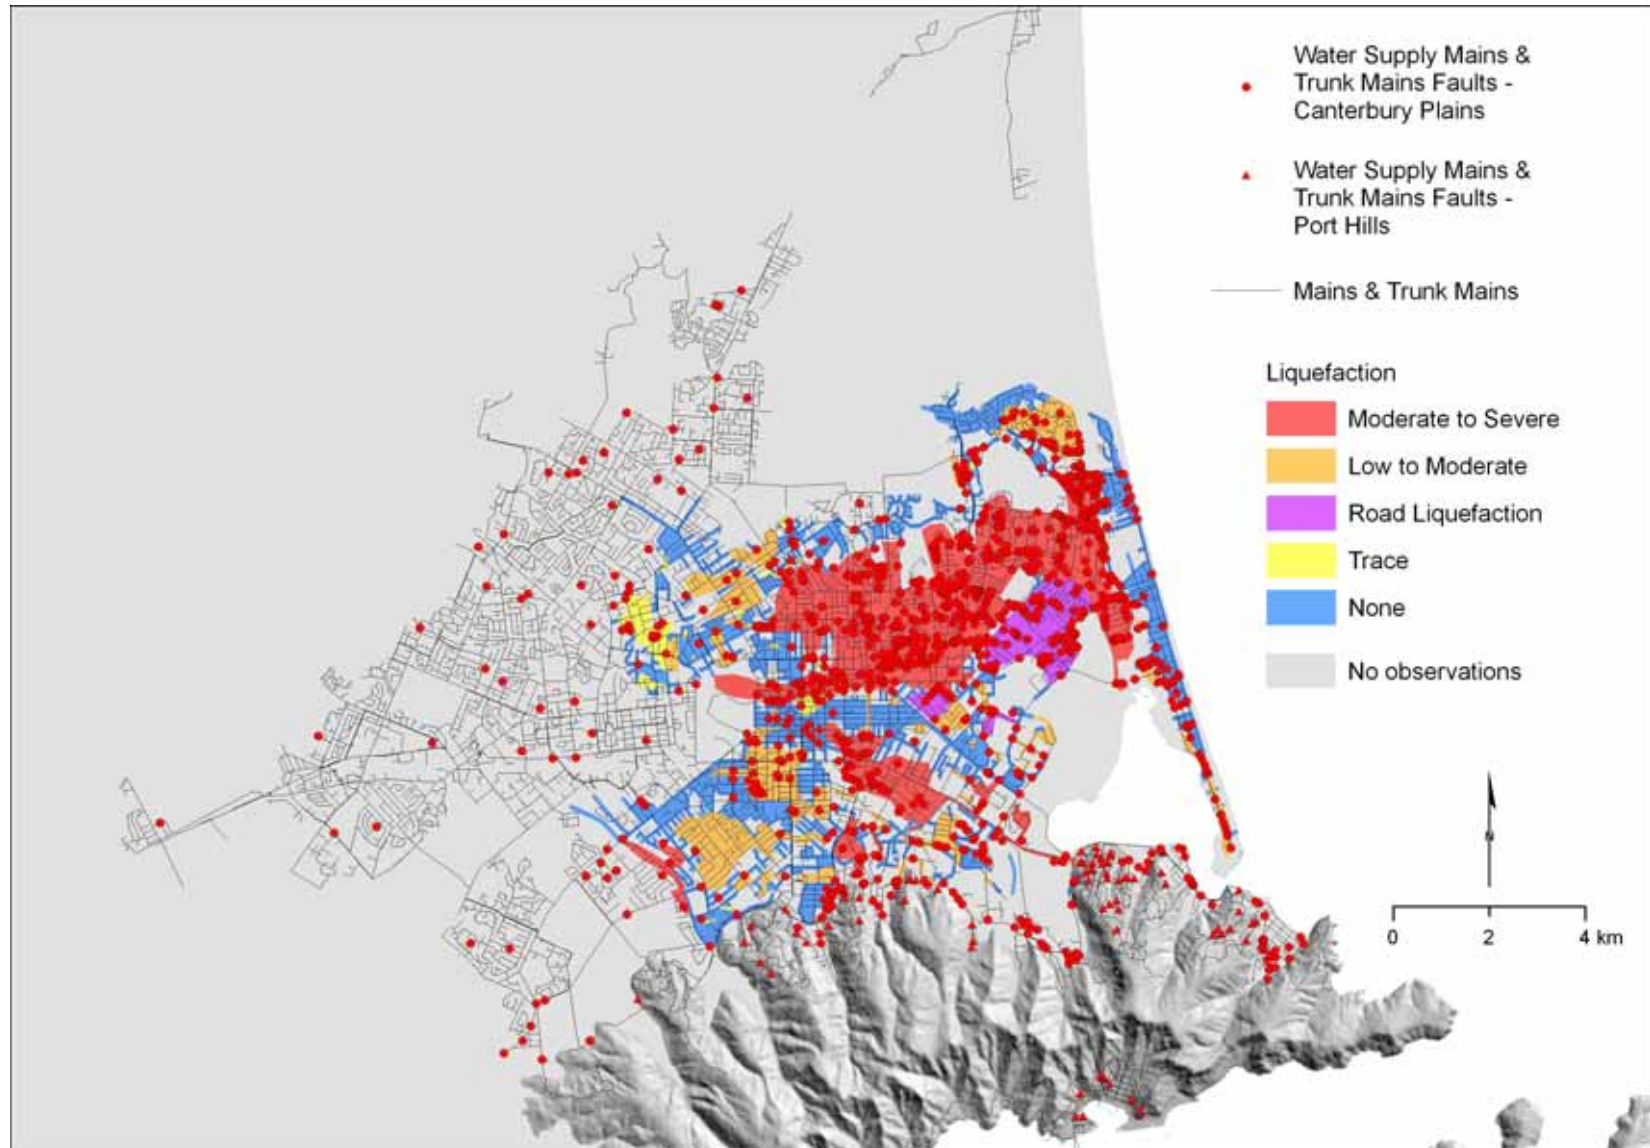
Figure 1. Christchurch City water supply mains and trunk mains system, showing in-service pipes as of 21 February 2011. Water supply pipe fault locations on the Canterbury Plains and Port Hills are shown, with 22 February 2011 liquefaction zones as mapped by University of Canterbury.

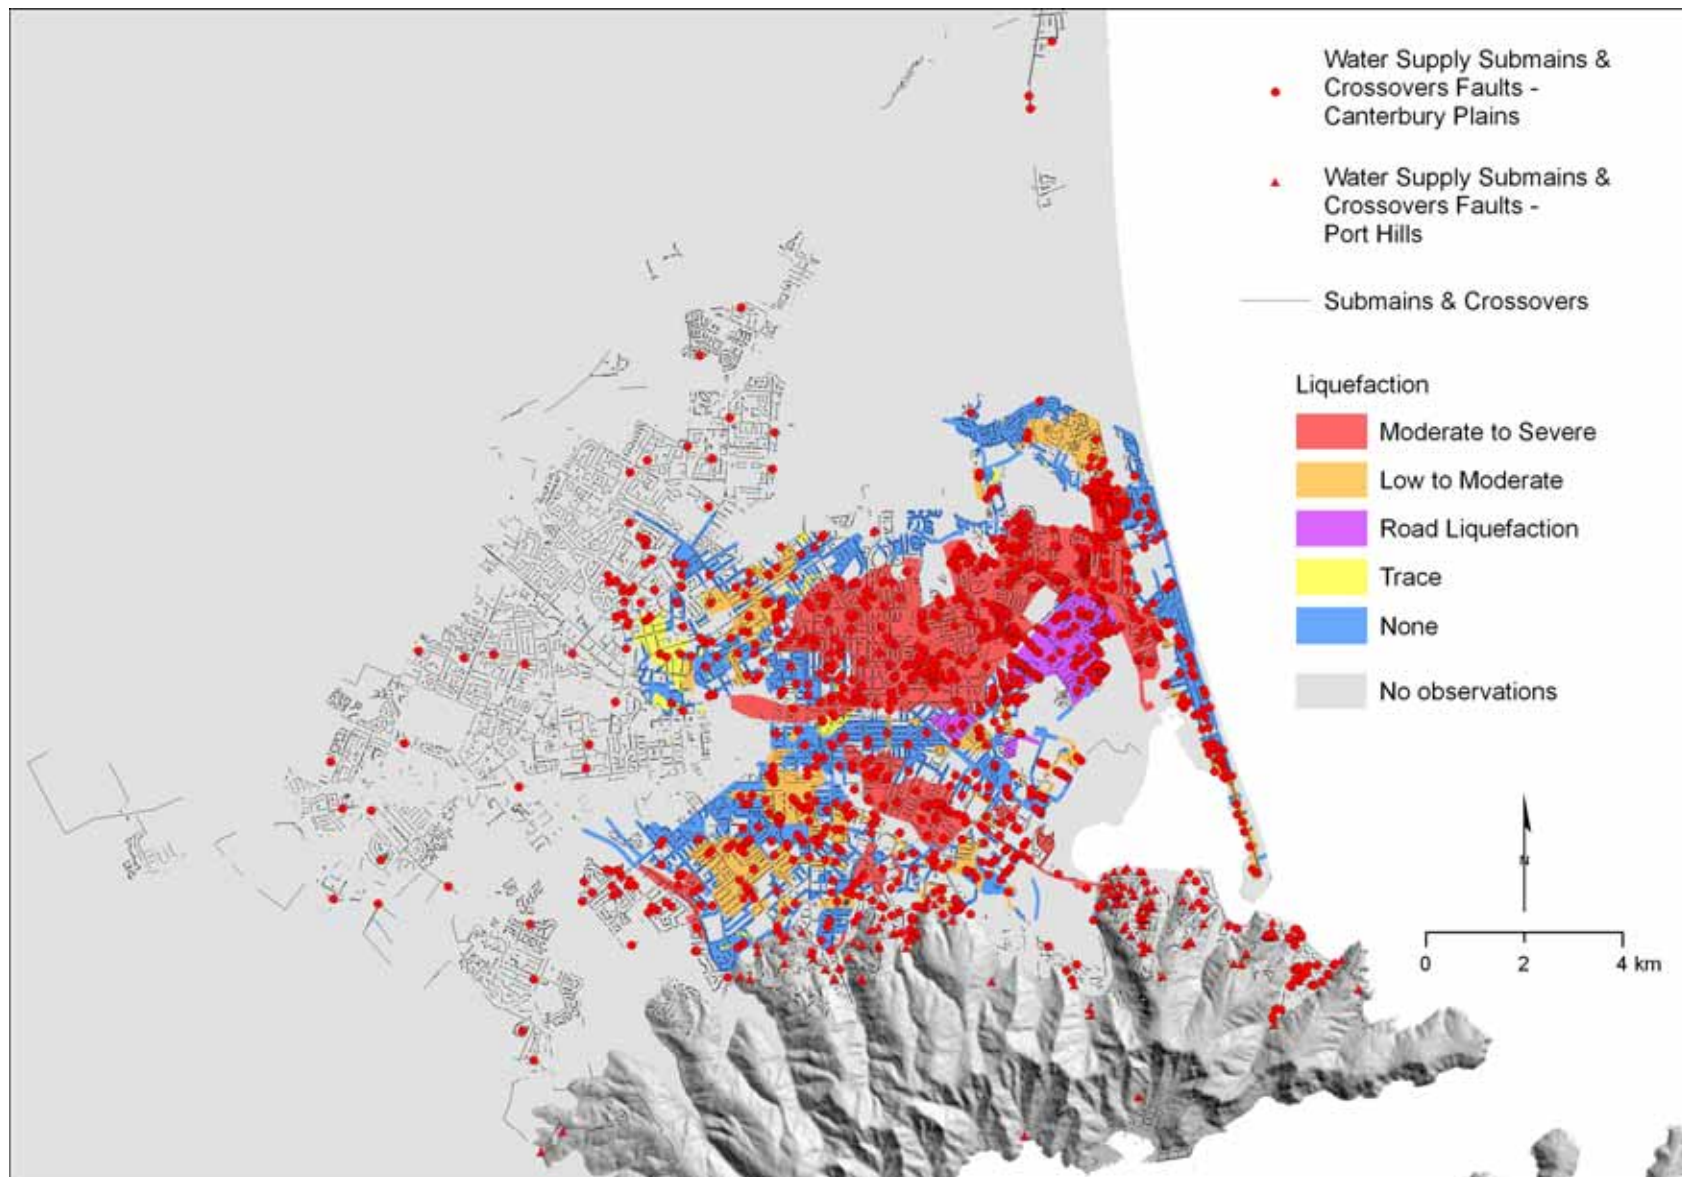
Figure 2. Christchurch City water supply submains and crossovers system, showing in-service pipes as of 21 February 2011. Water supply pipe fault locations on the Canterbury Plains and Port Hills are shown, with liquefaction zones as mapped by University of Canterbury.
